Article

Significance of Tool Coating Properties and Compacted Graphite Iron Microstructure for Tool Selection in Extreme Machining

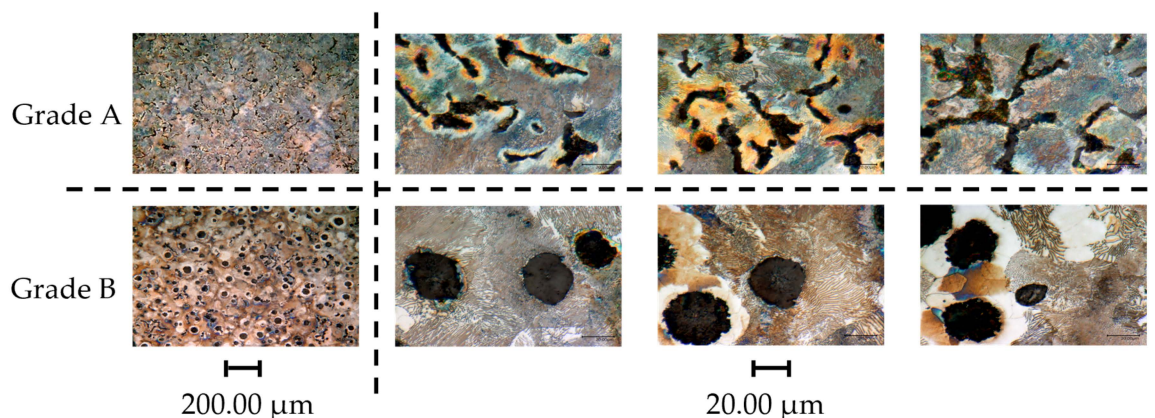
Optical analysis of etched workpiece samples showed significant differences in graphite shape between CGI Grade A and Grade B. In Grade A, graphite was primarily in nodular lamellae, whereas in Grade B, graphite appeared mainly in nodules, as seen by the black regions in Figure 1. For both workpieces, the microstructure was nearly entirely pearlitic, with negligible differences noted between grades.

Figure 1. CGI workpiece microstructure at two different magnifications.

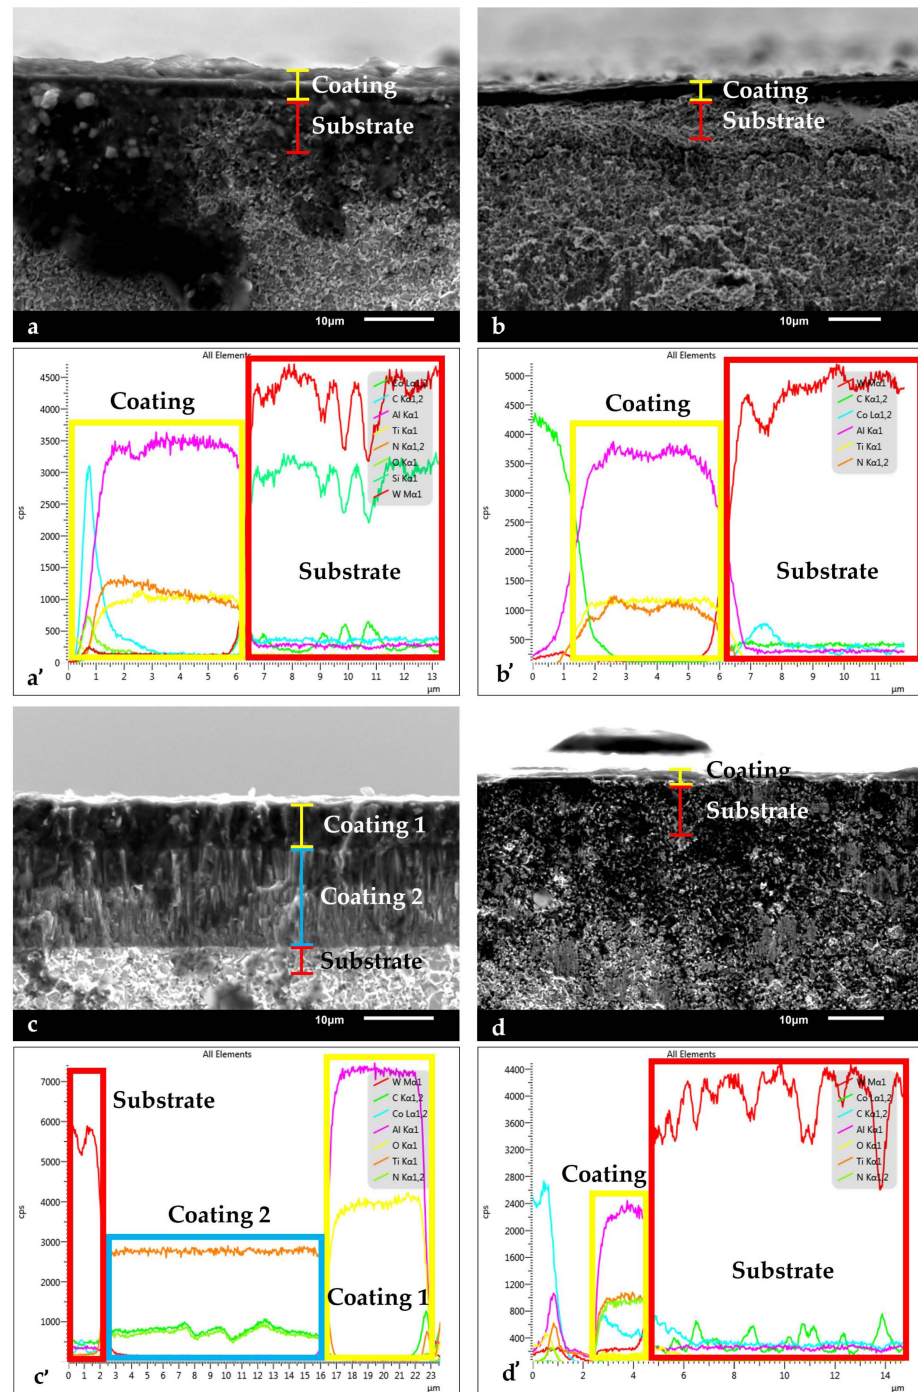
Figure 2 shows the coating cross-section microstructures. In Figure 2c, the columnar structure of the coatings on Tool C can clearly be seen. This phenomenon occurs during the nucleation process, where grains with energetically favorable orientations tend to grow both upwards and outwards. This preferential growth leads to the development of a strong crystallographic texture within the material, ultimately resulting in columnar growth structures [18,19]. Similar structural features are commonly observed in AlTiN-based coatings [20,21]. Despite not showing clearly defined layers, Tools A, B, and D may still have been multilayered. The tools may have been nano-structured multilayered tools, such as those studied by Skordaris [22], in which case the layers would not be identifiable on the SEM scale used. Furthermore, for AlTiN-based coatings with Si as an alloying element, columnar grain growth is inhibited, and grain size is refined due to the presence of Si [11,12]. This can result in an amorphous grain structure, which may have been the case for Tools A and B given that they had Si-containing coatings, as specified by the manufacturers.

The EDS data suggest that the coatings in Tools A, B, and D consisted of many thin coatings, as the amount of each constituent in the coating appeared approximately constant throughout the coating thickness. As a result, it can be assumed that the coatings simultaneously exhibited the beneficial properties of each component of the coating, such as the abrasion resistance of Ti compounds and thermal stability of Al_2O_3 . This assumption does not hold for Tool C, as the thick outer Al_2O_3 layer must be worn before the inner TiCN coating is exposed. Therefore, the TiCN layer was protected from any thermally activated process long into the tool's life. One feature to note is the high amount of carbon around the tool surface for Tool A. One of the tools studied by Zhang had a layer of amorphous carbon near the tool surface, which the author stated mitigated adhesion wear due to the self-lubricating properties of the carbon [12]. A similar resistance to adhesion was therefore expected for Tool A.

Figure 2. SEM/EDS coating and substrate cross-section for (a,a') Tool A; (b,b') Tool B; (c,c') Tool C; and (d,d') Tool D.

cutting temperatures which can lead to rapid deterioration of the tool's surface finish [17]. Tool D had a lower Al content in its coating compared to the other tools (see Figure 2) and thus was lacking thermal protection from Al_2O_3 to maintain its initial hardness value. Substrate effects would have also increased Tool D's thermal sensitivity, as its grain size and binder content led to poor thermal properties. These effects would have increased throughout the rest of the cutting test as temperatures continued to rise.

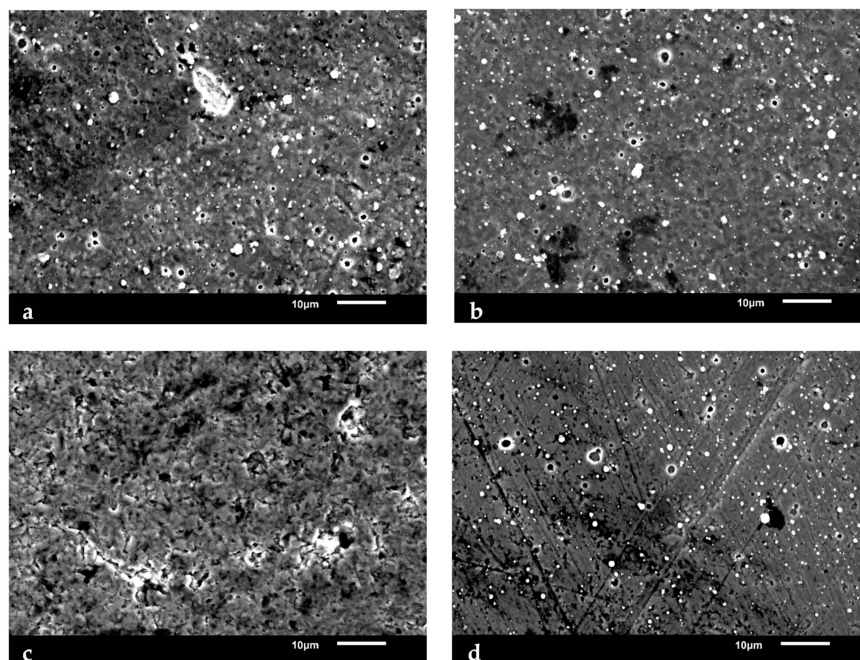
Figure 3 shows the tool top surfaces. It is evident that the top layer of each coating contained droplet defects of different sizes and shapes. Coatings B and D exhibited nearly homogeneous porosities, whereas coatings A and C had some irregularly shaped droplets and porosities. Arcs can emit micro-droplets during coating deposition, which are then integrated into a coating as it develops [23]. Previous researchers have also noted that the coating's mechanical properties, including hardness and adherence to the substrate, may have been impacted by the appearance of the flaws and porosities [21,24]. Surface irregularities, such as those from droplets, can enable crack propagation, which serves to decrease a tool's wear resistance [24]. Furthermore, surface irregularities typically result in a higher surface roughness, which introduces additional frictional stresses while machining and thus can accelerate tool failure [24]. In addition to the surface flaws from droplets, Tool C also appeared to have a scale-like surface topology, which could further impact its mechanical properties. Tool D may not have exhibited flaws from droplets and non-uniform porosity, but Figure 3d shows that its surface was covered in scratches. As such, its mechanical properties may have also been affected by surface defects.

Figure 3. SEM tool surface images for (a) Tool A; (b) Tool B; (c) Tool C; and (d) Tool D.

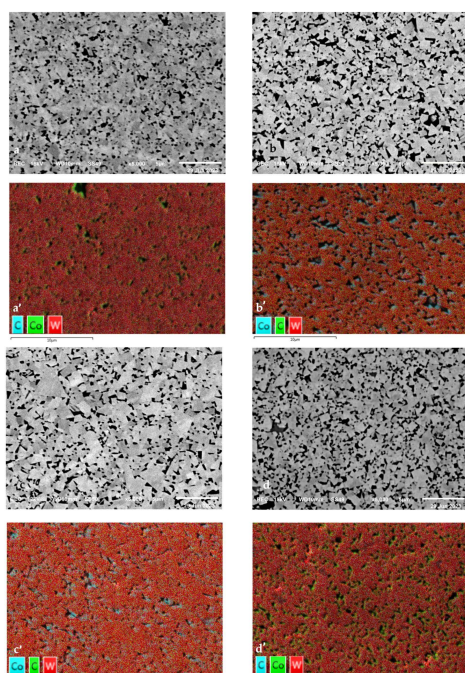
Figure 4 shows the substrate microstructures for each tool. The dark phases indicate the Co binder, and the gray phases indicate the WC grains. The different shades of gray within the WC grains are due to orientation effects. The interaction between WC grain size and Co binder content are most critical to determining substrate properties [25]. A fine grain size and low binder content result in a high tool hardness, a fine grain size and a high binder content result in a high edge line toughness, a coarse grain size and a low binder content result in good thermal properties, and a coarse grain size and high binder content result in high bulk toughness [25]. Tools A, B, and D had a medium grain size, while Tool C had a coarse grain size. From EDS data, Tools A and C had the lowest Co content at approximately 3 wt%. Tools B and D had a Co content of approximately

10 wt%. Therefore, Tool A could be expected to have the highest substrate hardness but low toughness, Tools B and D could be expected to have the highest edge line toughness but poor thermal properties, and Tool C could be expected to have the best thermal properties but poor edge line toughness. Note that for Tool C, the coating comprised 50% of the total tool thickness compared to only 5% for the other tools. As such, most of the cutting load for Tool C was sustained by the coating, leading to a lower significance for substrate properties.

Figure 4. SEM/EDS substrate microstructure for (a,a') Tool A; (b,b') Tool B; (c,c') Tool C; and (d,d') Tool D.

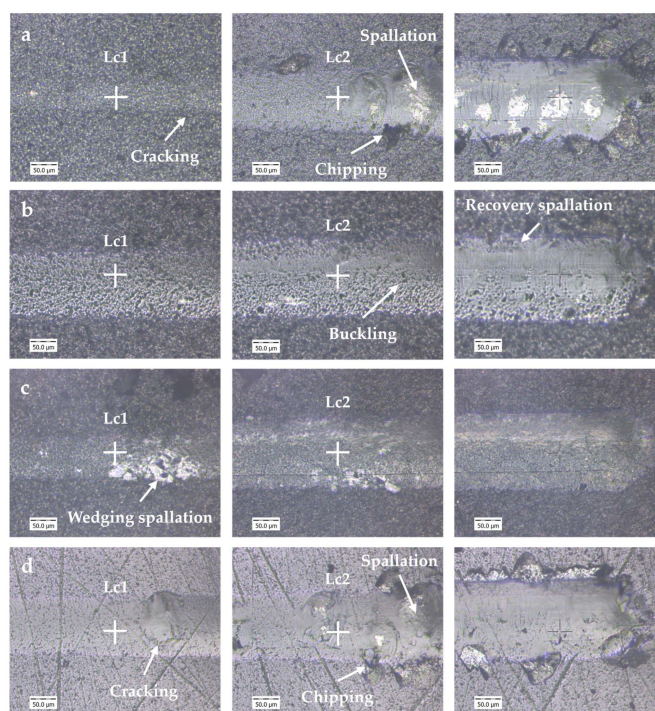
At Lc1, Tools A and D showed evidence of cracking, as seen in Figure 5a,d, followed by gross spallation and chipping at Lc2. For Tool A, the cracks appeared laterally and were minimal, and spallation and chipping occurred both for the coating and the substrate, which is characteristic of a brittle coating and brittle substrate [26]. For Tool D, the cracks appeared Hertzian, and chipping of the substrate was minimal, which is characteristic of a brittle coating and ductile substrate [26]. Given the rapid gross spallation of Tools A and D, it can be concluded that these tools had very poor adhesion to the substrate, particularly Tool A [26]. For Tool D, this can be explained by the phenomenon that when two unlike surfaces are in contact, such as with a brittle coating and ductile substrate, the adhesive bonds between them are lower [27]. For Tool A, the poor coating adhesion may have been a result of its coating composition. The addition of Si in an AlTiN coating, as with Tool A, can reduce coating–substrate adhesion [12,26,28]. For both tools, the presence of surface flaws from droplets (Tool A) and scratches (Tool D) could have also reduced coating adhesion [21,24]. Overall, Tools A and D showed moderate cohesion and poor adhesion with the substrate, suggesting that when exposed to defects or small amounts of cohesive delamination, the tools would be expected to undergo abrupt tool failure.

Throughout the scratch test, Tool B showed very minimal coating delamination, substrate exposure, or cracking. From the scratch pattern in Figure 5b, the coating on Tool B appeared to undergo some buckling, which is typical for thin coatings [26], and perhaps some recovery spallation. The recovery spallation and overall good adhesion performance for Tool B were likely due to the tool's high H/E value. It has been found that coating adhesion increases with increased H/E [12]. This is because the high ductility and strength of the material allow for some elastic recovery [17,21,26]. Furthermore, Tool B had minimal surface flaws, which may have contributed to good coating adhesion [21,24]. Given the strong cohesion and adhesion capabilities of Tool B, it was expected that this tool would have been able to withstand abrasion and adhesion wear well.

Figure 5. Scratch test images for (a) Tool A; (b) Tool B; (c) Tool C; and (d) Tool D.

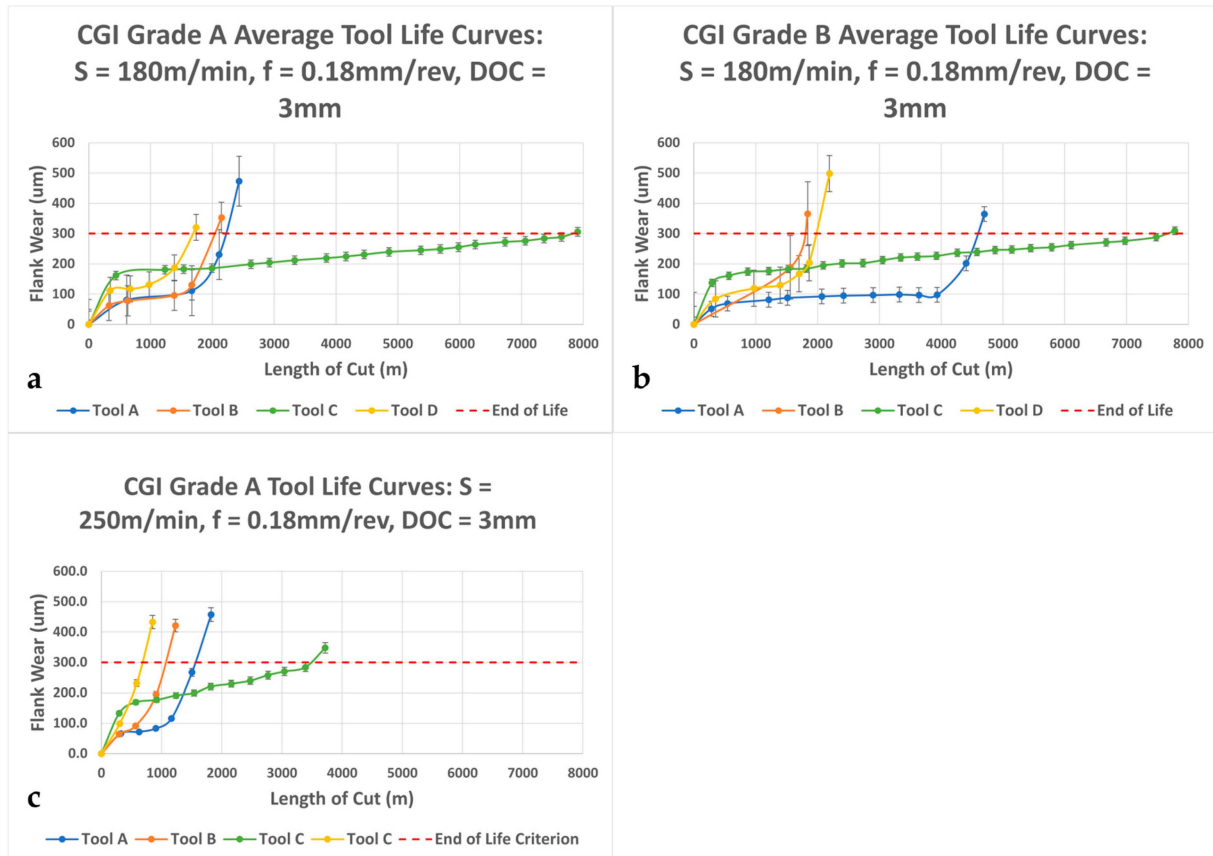
Figure 6 shows the average tool life curves for the CGI Grade A and Grade B cutting tests. The best performing tool was Tool C, which had a high initial wear, but was very stable throughout the remaining tool life for both CGI Grade A and Grade B. It is evident from Table 2 that Tool C's coating was significantly thicker than those of the other tools. While thick coatings can certainly improve tool life by being better able to withstand high loads, they also introduce drawbacks, such as high residual stresses and material costs, that may outweigh their benefits and make them less suitable for industrial applications [7]. In [19], the author found that AlTiN coating thickness did not impact tool performance outcomes. As such, it is critical to consider Tool C's coating thickness in conjunction with its other properties to appropriately evaluate and explain its good performance.

Of the four tools, only Tool A showed a notable difference in tool life when machining CGI Grade A and Grade B. The tool life was about 110% longer for Grade B compared to Grade A. The difference in tool life for Tool A between workpiece grades and the lack of difference for the other tools are addressed in conjunction with their wear analyses in Section 3.5.

Figure 6. Tool life curves for (a) CGI Grade A at $S = 180\text{ m/min}$; (b) CGI Grade B at $S = 180\text{ m/min}$; and (c) CGI Grade A at $S = 250\text{ m/min}$.

The large error bars for Tools A, B, and D indicate high variability in tool life between trials, suggesting that they were sensitive to flaws and workpiece inconsistencies. A sensitivity to defects can also lead to abrupt, or very rapid, tool failure, which was reflected in Tools A's, B's, and D's tool life curves. Abrupt tool failure can occur because of poor substrate adhesion, as was seen in the scratch test results (Table 3, Figure 5), but it can also occur when a tool undergoes diffusion wear if the temperature exceeds the activation energy and leads to an exponential increase in wear [29]. To determine each tool's individual cause for tool failure and how these causes are associated with their properties, wear mechanism analysis should be considered.

When the cutting speed was increased from 180 m/min to 250 m/min , the tool life decreased for all four tools, as shown in Figure 6c. This was expected, as an increase in cutting speed introduces effects such as increased temperatures, shear stresses, and friction. The decrease in tool life was proportional for all tools except Tool A, as those of Tools B, C, and D decreased by 50%, but that of Tool A only decreased by 25%. This suggests that cutting speed was not as influential to Tool A's behavior as it was for the other tools. For this change in cutting speed, the relative performance rankings of the tools did not change from the baseline 180 m/min speed. However, because Tool A's decrease in tool life was proportionally lower than those of the other tools, if cutting speed were to continue to increase, Tool A may eventually overtake Tool C as the best performing tool. The specific effects of cutting speed, as well as workpiece microstructural properties, on each tool are analyzed further in the wear mechanism discussion.

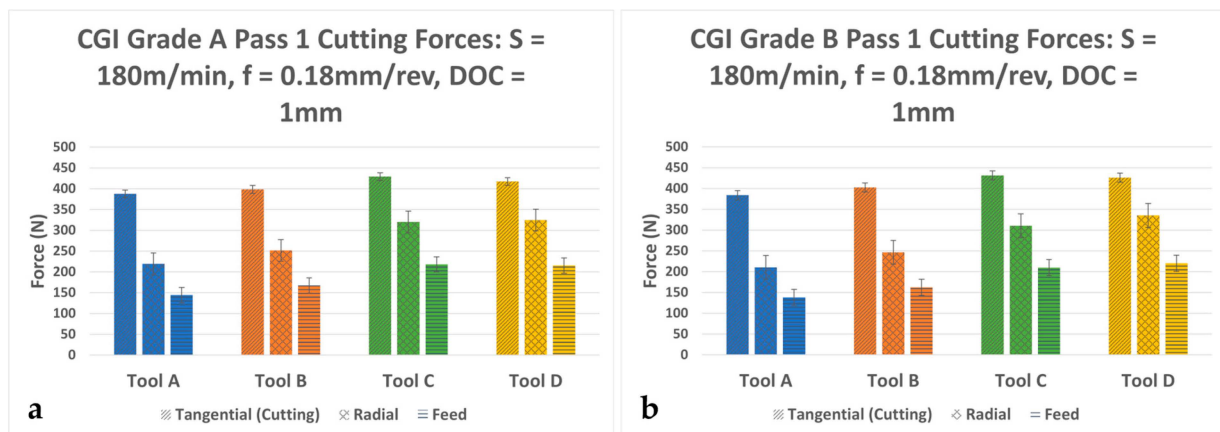
Figure 7 shows the Pass 1 cutting forces for the CGI Grade A and CGI Grade B cutting tests. Given the high initial wear of Tool C, it was expected that it would also have the highest cutting forces in the first pass because, with a larger wear landing on the tool,

friction between the tool and workpiece increases. Furthermore, Tool C had a very large cutting-edge radius which also increases cutting forces. As cutting-edge radius increases, the tool is not only shearing the workpiece material but also plowing it. This requires large amounts of energy and thus increases cutting forces. On the other hand, because the wear on Tool C was stable, a minimal increase in forces can be expected throughout the rest of the tool life compared to large increases in cutting force for the other coatings. Tool C's stable behavior is further explored during the wear analysis in Section 3.5.3. Tool A exhibited the best cutting force performance out of the four tools. However, the margin for the increase in performances was drastically different between tool life and cutting forces. Tool A had a 10% higher performance in tangential force over Tool C for CGI Grade A, but a 250% lower performance in tool life. Similarly, Tool A had a 12% higher performance in tangential force over Tool C for CGI Grade B, but a 70% lower performance in tool life.

Figure 7. Average Pass 1 cutting forces for (a) CGI Grade A and (b) CGI Grade B.

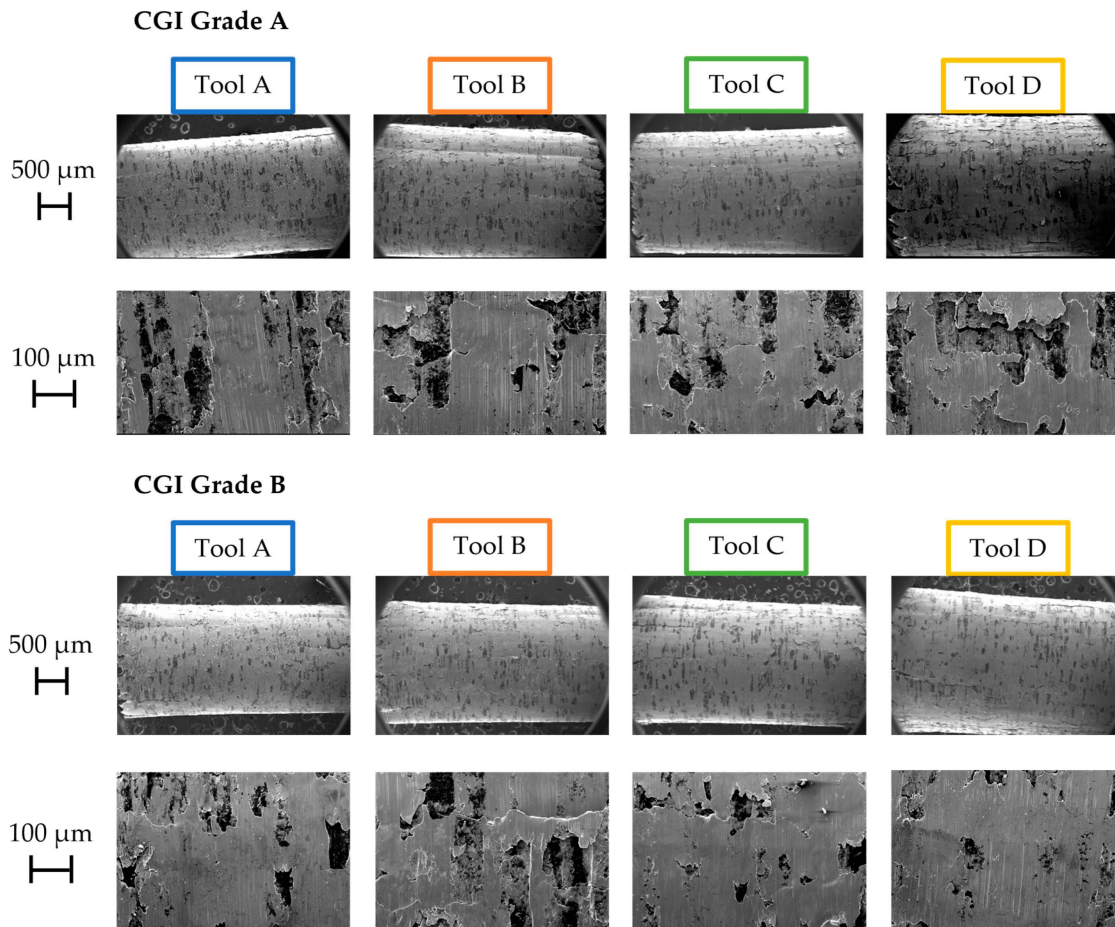
Figures 8 and 9 show the Pass 1 chips collected for each tool–workpiece combination. The three factors of chip morphology examined to characterize tribological properties were chip curling, slipping patterns on the undersurface of the chips, and shear bands. Note that the black marks seen on the chips in the figures are graphite.

In terms of slipping patterns on the underside of the chips, similar trends were seen, with Tools A and C exhibiting continuous slipping patterns and smooth chip undersurfaces, and Tools B and D showing some tears and discontinuities across the slipping patterns (Figure 8). Tears and discontinuities are caused by the “stick and slip” of the chips to the rake face [19]. Under poor tribological conditions, the chip will stick to the rake face until a build-up of material and pressure cause it to be torn away [19,30].

Figure 8. Undersurface of Pass 1 chips.

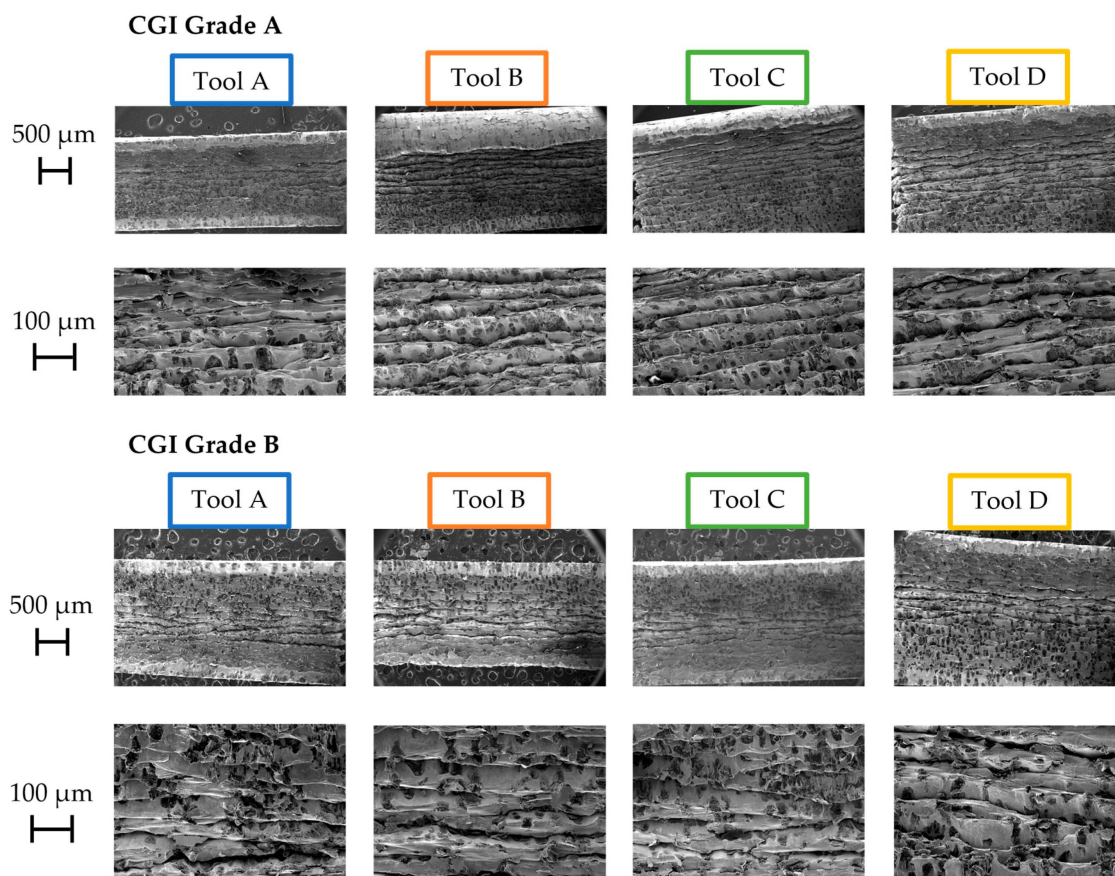
As with the slipping patterns and chip curling, Tools A and C tended to have regularly spaced and unbroken shear bands, while Tools B and D showed more discontinuous shear bands (Figure 9). Regular shear bands indicate that plastic deformation is occurring uniformly across the rake face and that there is an absence of “stick and slip” [17]. If one area of the chip is adhered to the rake face but the rest of the chip continues to slide, the

shear band will be broken, and the width of the shear band may vary along its length. Furthermore, if the entire chip is undergoing “stick and slip”, the thicknesses of the shear bands will be inconsistent overall. Therefore, uniform shear band formation is associated with good tribological performance.

Figure 9. Shear bands of Pass 1 chips.

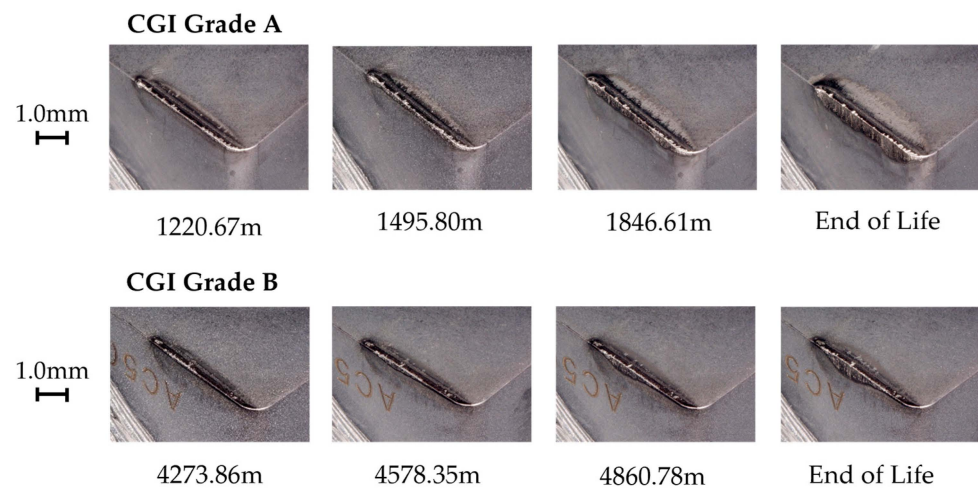
Tool A showed minimal wear for both grades of CGI until the rapid wear stage. Figure 10 shows that wear occurred primarily on the flank face and there was minimal cratering, built-up edge, or chipping, particularly compared to the large amount of scratching. Figure 11 shows that areas of high flank wear originated in areas with high adhesion on the rake face for both workpieces. Therefore, Tool A seemed to be highly susceptible to flaws on the tool. This can also be seen by the high degree of variation in performance between trials in Figure 6. Tool A's flaw sensitivity can be attributed to poor substrate toughness, poor coating adhesion, and thin coating thickness [7]. Because the flaws introduced to Tool A were a result of adhesion, Tool A's good tribological properties (see chip analysis) and cohesively strong coating likely helped mitigate its failure and led to its better performance over Tools B and D [7,9].

Figure 11. Tool A rapid wear progression.

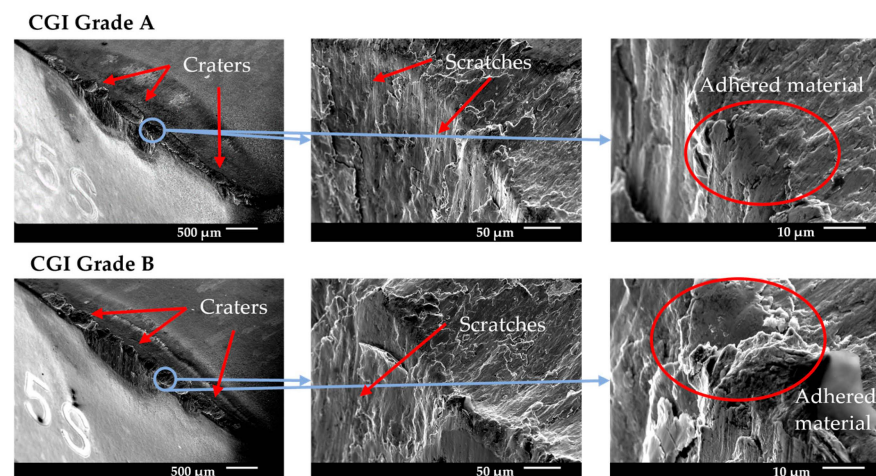
Tool B showed minimal wear for both grades of CGI until the rapid wear stage. Large craters were formed on the rake face and flank wear was localized in areas with more significant cratering, as can be seen by the SEM images in Figure 12. The images of Tool B's rapid wear progression in Figure 13 highlight the negligible wear on the flank face while significant wear was already visible on the rake face, suggesting that flank wear was a response to the cratering and that diffusion was the dominant wear mechanism. It has been reported that the inclusion of Si in AlTiN coatings improves the thermal stability of the tool which is at odds with the observed results of Tool B's cutting tests [11,12,28,31]. As such, the addition of Si to the AlTiN coating had a negligible effect on tool life and performance for Tool B. Rather, it was the high heat generated from its large cutting edge and high hardness that made Tool B susceptible to thermally activated wear mechanisms. In addition, the high Co content coupled with a relatively fine grain size in Tool B's substrate further reduced its thermal stability. Given its thin coating thickness, the substrate was more readily exposed, which would have also accelerated diffusion wear [7,9].

Figure 12. Tool B end-of-life SEM images.

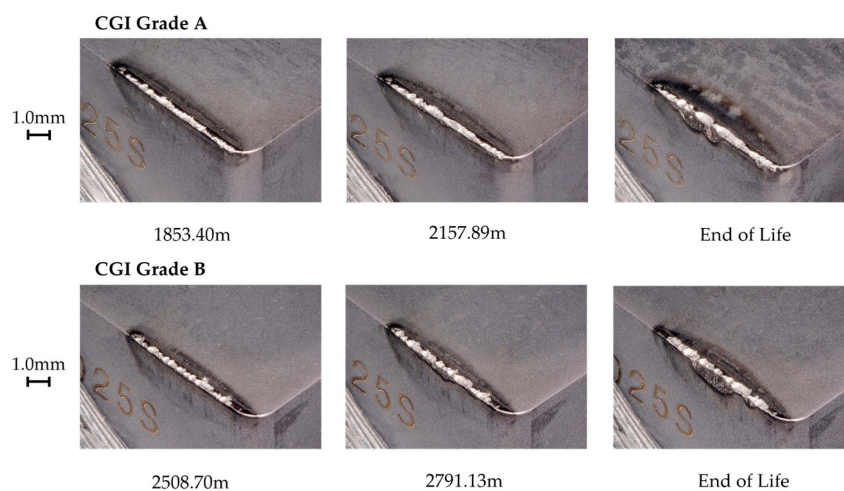
Figure 13. Tool B rapid wear progression.

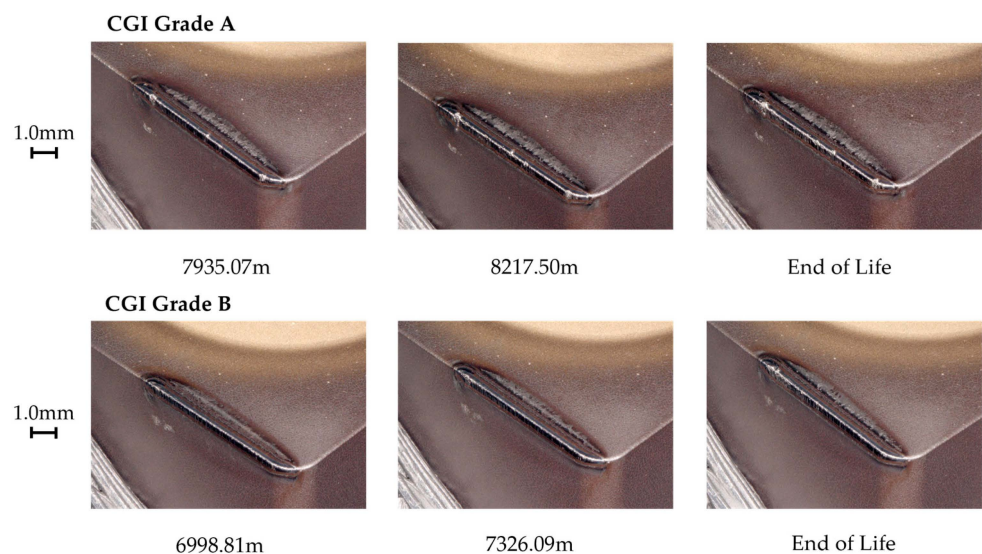
Figure 15. Tool C rapid wear progression.

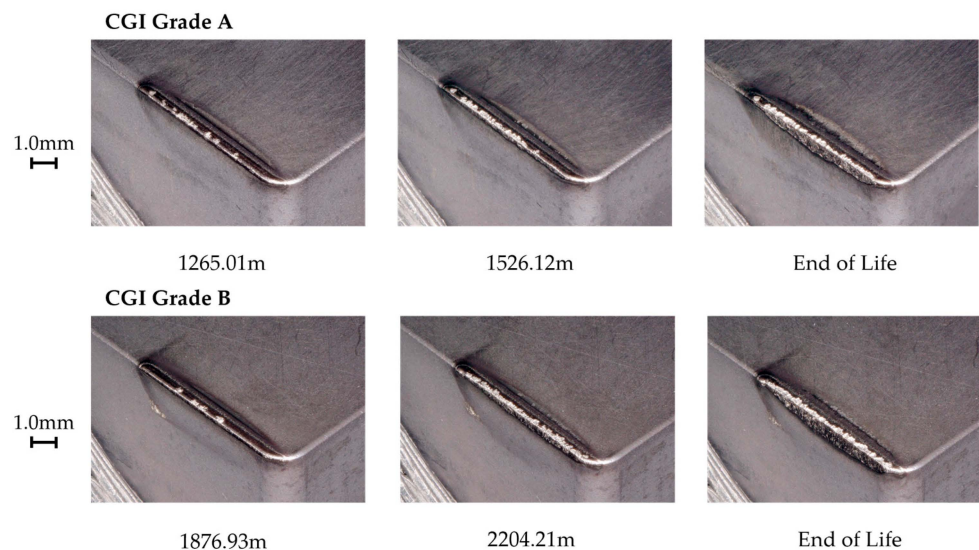
Figure 17. Tool D rapid wear progression.
