# Characterization and Corrosion Behavior of Zinc Coatings for Two Anti-Corrosive Protections: A Detailed Study

**Keywords:** corrosion protection; zinc coatings; S235 steel; corrosion behavior; corrosion products; deposition parameters; performance evaluation; surface roughness; durability; industrial applications

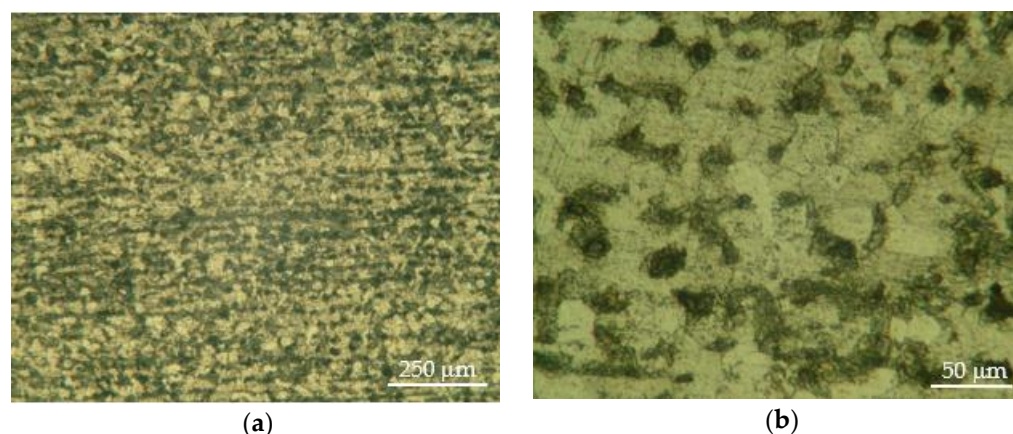
**Figure 1.** The microstructure of S235J0 steel; (a) microstructure of the ferritic–pearlitic substrate; (b) microstructure detail with distinction of the outline of the phases and constituents.

The steel specimens were longitudinally sectioned for microstructure examination, and a metallographic sample was created by grinding, polishing, and etching with a reagent (3% nitric acid in ethyl alcohol). Due to the low carbon content, the structure is a ferrite-pearlite structure, as illustrated in Figure 1, with polyhedral grains, because the material of the specimens was annealed.

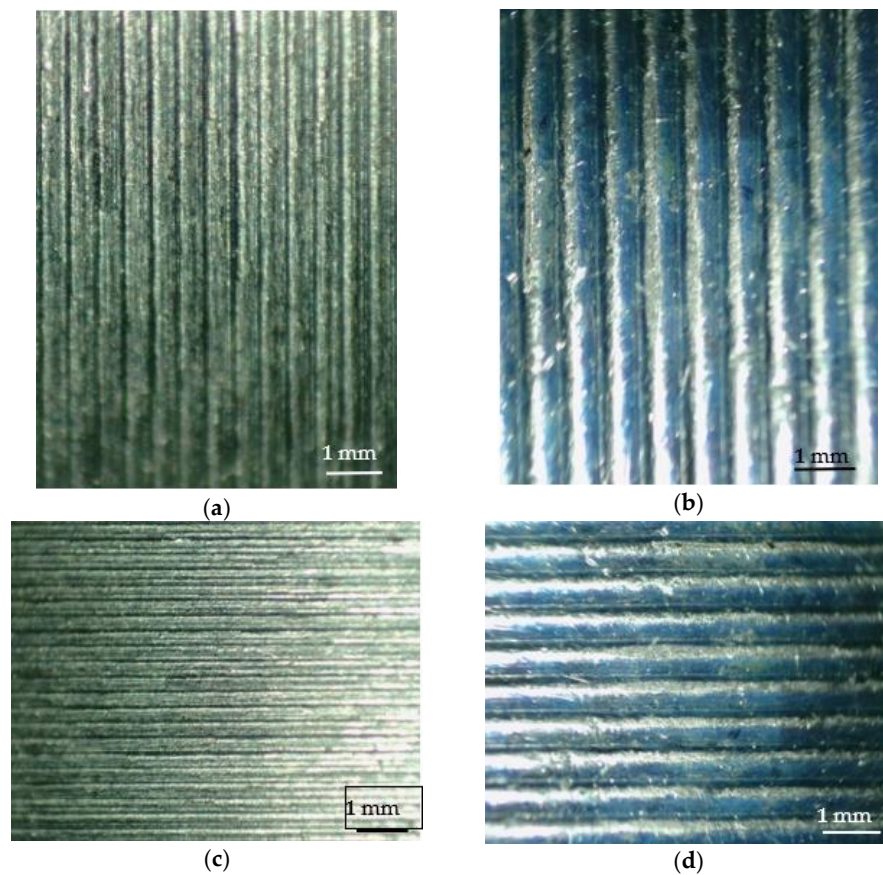
**Figure 2.** Images of the surface of the GE specimens: (a) finely turned (GE1); (b) roughly turned (GE5); (c) GE fine (1–4.5×, Figure 1); and (d) roughly (5–4.5×, Figure 3) stereoscopic images.

A stereoscopic microscope (ZEISS, Jena, Germany) was used to examine the specimens' surfaces. The surfaces of the specimens with the lowest and maximum roughness were examined, and macroscopic pictures of the surfaces were obtained using a stereoscopic microscope, as shown in Figures 1–3. These photos show the surface properties of both the machined and galvanized specimens in detail. The surface quality (roughness) of the specimen may be seen in the photos (Figure 2). The electrogalvanized surface has a bright metallic look and shows minimal variation when compared to the roughness of the substrate surface, whether it has low roughness (Figure 2a) or high roughness (Figure 2b). Electro galvanization produces a pure zinc layer, which is generally a single-phase structure. This method is commonly used for components where the thickness of the coating should not exceed certain limits, typically ranging from 4–15  $\mu\text{m}$  (30 to 100  $\text{g}/\text{m}^2$ ), and in some cases, even thinner coatings of up to 1.5  $\mu\text{m}$  (10  $\text{g}/\text{m}^2$ ) are applied.

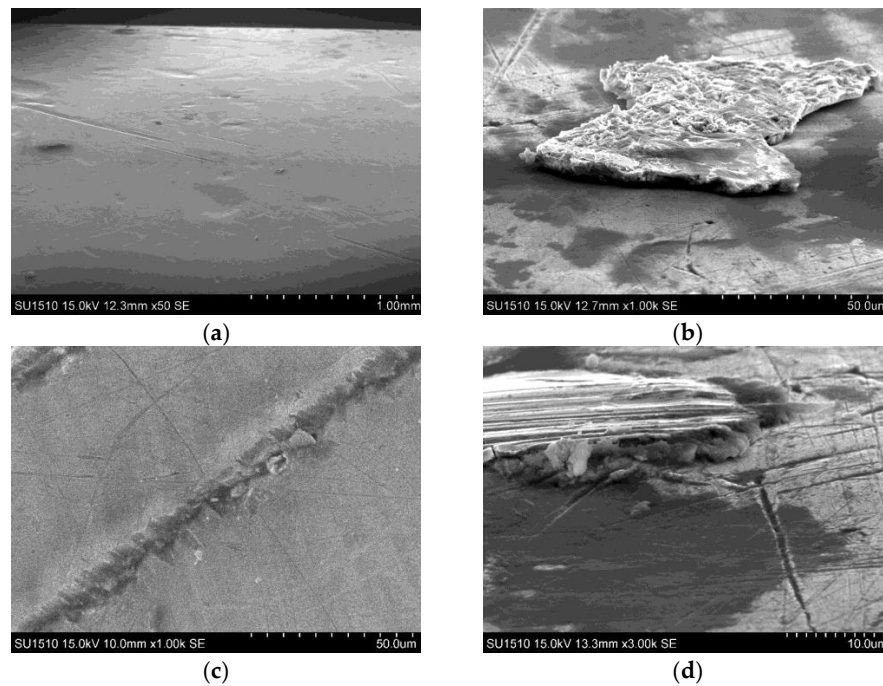
**Figure 3.** Crystal growth of zinc and zinc oxide film on the surface of GE1 parts with low roughness. (a) micro-craters, (b) conjoined prominences, (c) conjoined prominences, (d) intergranular indentations.

SEM examination revealed minor flaws such as micro-craters (Figure 3a), conjoined prominences (Figure 3b,d), and intergranular indentations (grooves) (Figure 3d) on the surface of electrogalvanized samples (GE1). These flaws on the machined surface are like those found on galvanized sheets. Individual crystal formation may be seen in the striations and surrounding the prominences, which are commonly Fe-Zn intermetallic complexes with the phase, FeZn<sub>13</sub> [19].

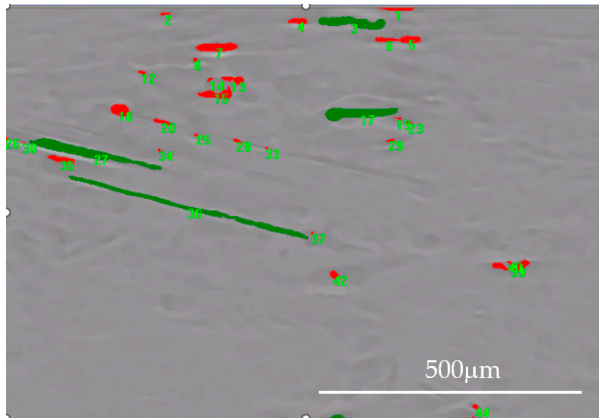
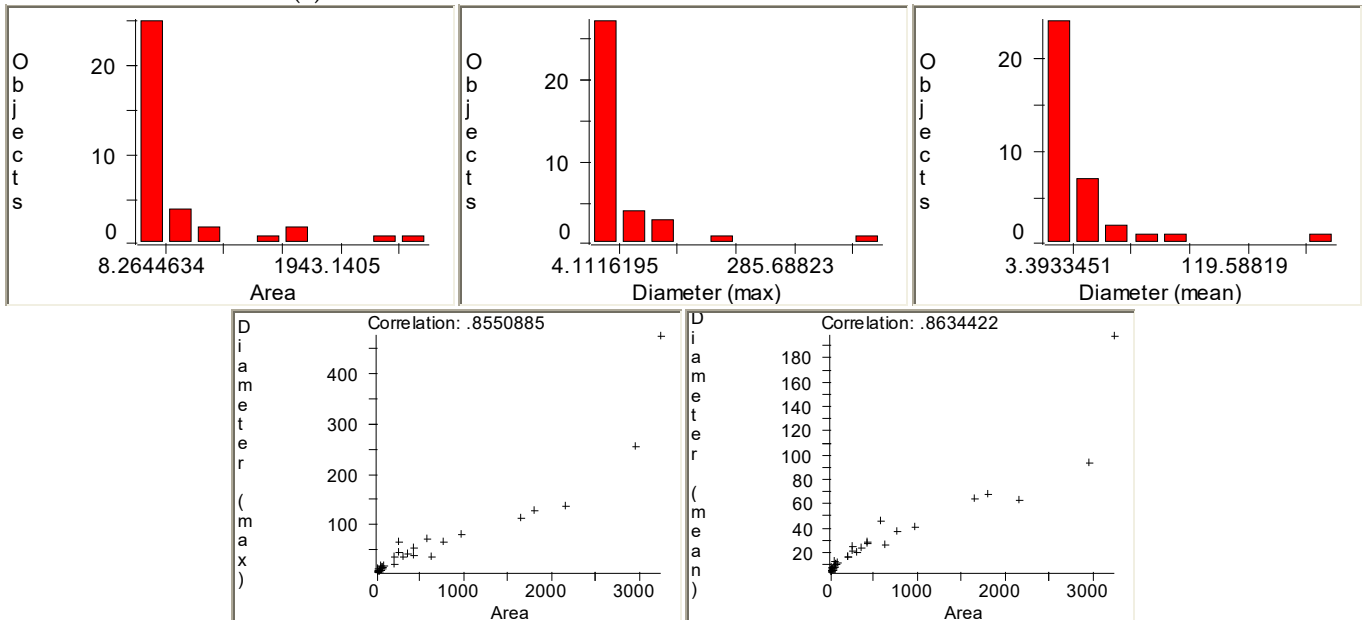
Stats	Area $\mu\text{m}^2$	Diameter (Max) $\mu\text{m}$	Diameter (Mean) $\mu\text{m}$
Min	8.264463	4.11162	3.393345
(Obj.#)	30	33	40
Max	3233.058	473.406	197.0514
(Obj.#)	36	36	36
Range	3224.794	469.2943	193.6581
Mean	494.2608	51.92693	26.29727
Std.Dev	817.3143	87.26173	35.84959
Sum	17793.39	1869.369	946.7016
Sample	36	36	36

**Figure 4.** Surface analysis of GE1 for surface defect quantification: (a) defect numbering; (b) measured values; (c) histograms of the defect diameter to defect area ratio.

As a result, the results of the analysis on the electrogalvanized surface are shown in Figure 4. The total analyzed surface area was  $847,000 \mu\text{m}^2$ , equivalent to  $0.847 \text{ mm}^2$ . Surface defects were counted (36 samples) using software (Figure 4a) and classified into classes based on their maximum diameter (represented in different colors) due to the large variations in their length (striae—grooves versus prominences). From a statistical analysis of the area, the surface area occupied by these defects was  $17,793.39 \mu\text{m}^2$ , which represents 2.1% of the total analyzed surface area of  $847,000 \mu\text{m}^2$  (Figure 4b). The distribution of defects according to their maximum diameter, their average diameter in relation to the surface area, and the correlation between these parameters are presented in Figure 4c.

According to the histogram analysis, most faults have maximum diameter values of less than  $4 \mu\text{m}$ , and the computed average diameter for the majority is less than  $3.4 \mu\text{m}$ . The surface area of most defects is below  $10 \mu\text{m}$  (Figure 3c).

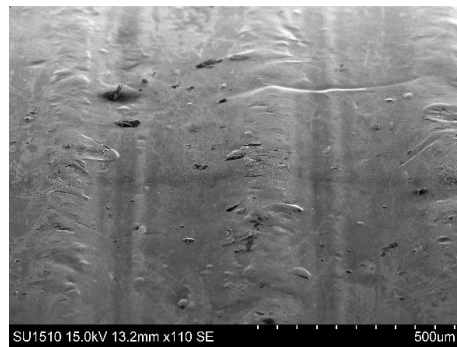
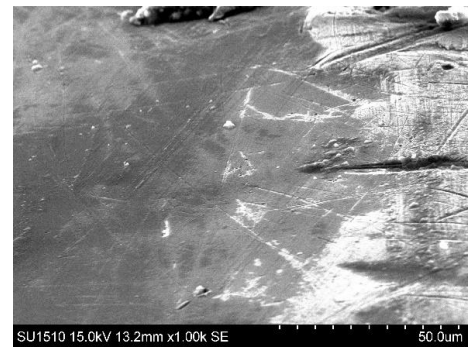
**Figure 5.** Crystal concretions of zinc and zinc oxide film on the surface of the GE5 parts with high roughness.

The coating profile closely followed the substrate surface in the GE5 samples with considerable substrate roughness. The most noticeable flaws were found in places with increased substrate roughness (GE5) along the turning tool's direction, as illustrated in Figure 5.

Similarly, a series of faults were discovered on the surface of the deposited layer in GE samples with greater steel substrate roughness (Figure 5), like the defects reported in samples with smaller roughness. In this case, however, tiny protrusions (Figure 5a) were also noticed, which might be gas blisters. This is feasible because hydrogen emission occurs during the electrolytic deposition of zinc [14]. At a steady rate of electro-deposition, the number of gas blisters (swellings) rises. The rates of development of gas blisters and coating thickness might cause a self-oscillating regime, resulting in the production of a stratified distribution of gas pores (hydrogen carriers) [14]. When heated, the atomic hydrogen in the pores diffuses largely along the borders of the diffuse coating layers and converts into molecular hydrogen, resulting in the production of closed blisters or open craters on the coating's surface [14].

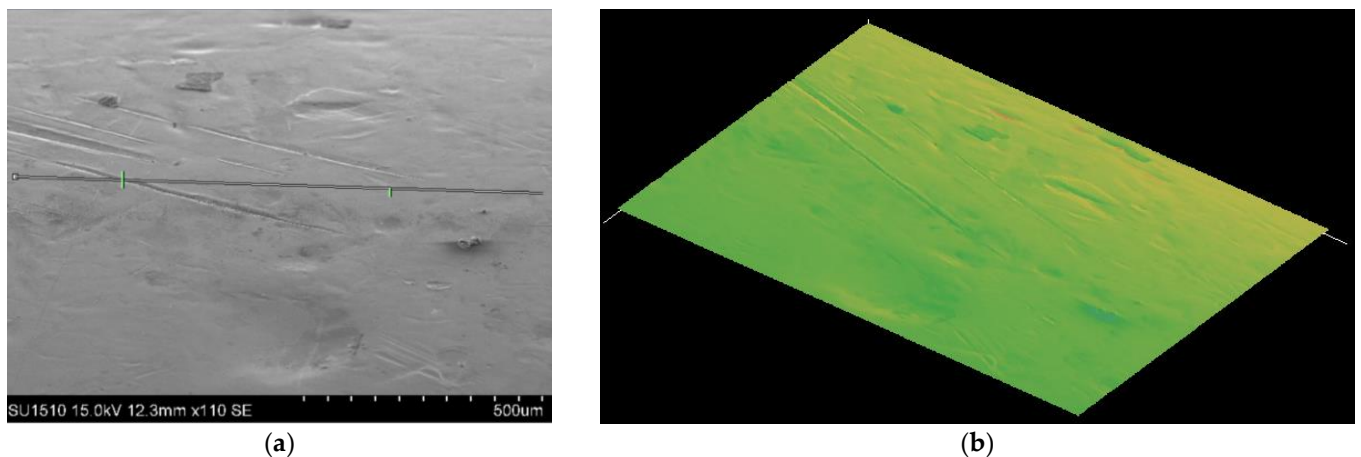
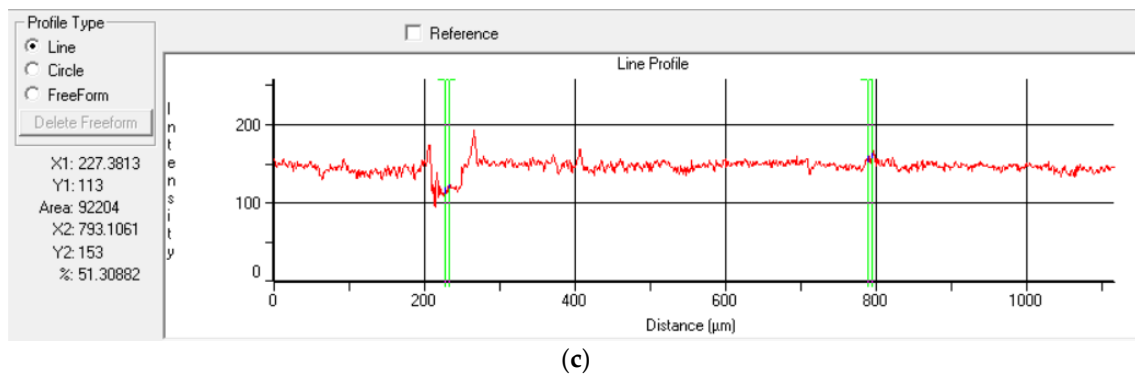
Figure 7. Topography and line profile—sample GE1 (a) SEM image; (b) topography; (c) line profile.

Figures 7 and 8 show surface analysis using ImagePro Plus software to examine the profile in a specified direction and topography.

The study of SEM images and topography profiles of samples GE1 and GE2 (Figures 7 and 8) shows that the difference in substrate roughness is preserved even after zinc coating. Even after zinc coating, the sample with the greater substrate roughness (GE5) had a higher roughness. The surface examination of samples GE1 and GE5 (Figures 7 and 8) indicates that the roughness of the steel substrate affects the quality of the electrolytically formed layer.

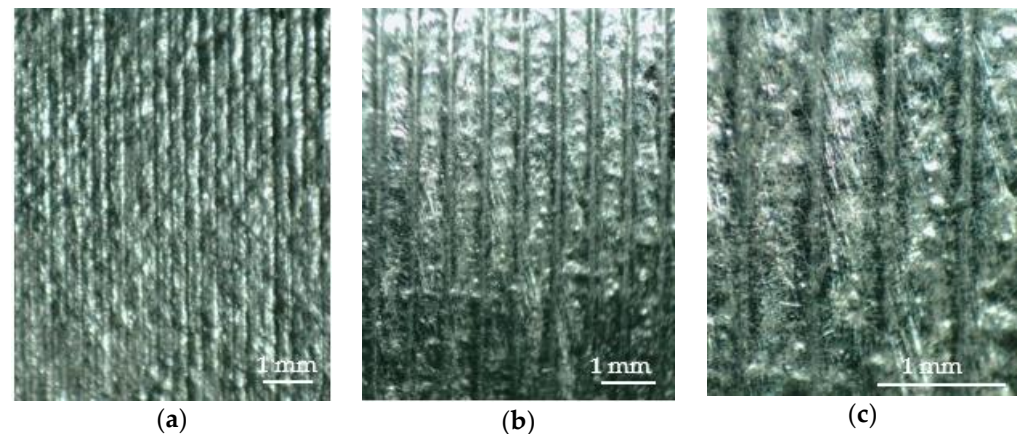
**Figure 9.** Surface images of HDG specimens: (a) finely turned (HDG1), 40 $\times$  magnification; (b) roughly turned (HDG5), 40 $\times$  magnification; (c) roughly turned (HDG5), 80 $\times$  magnification.

The zinc-coated layer deposited during immersion in hot-dip galvanizing (Figure 9) is metallurgically bound (at the atomic level) and integrated with the steel, making it very adhesive. Surface roughness is noticeably different from electrogalvanizing since the surface is not as smooth and does not perfectly follow the profile of the machined specimen. This is due to the creation of an adhering protective layer of zinc and Fe-Zn complexes, which has numerous layers and undergoes varying rates of nucleation and growth [1].

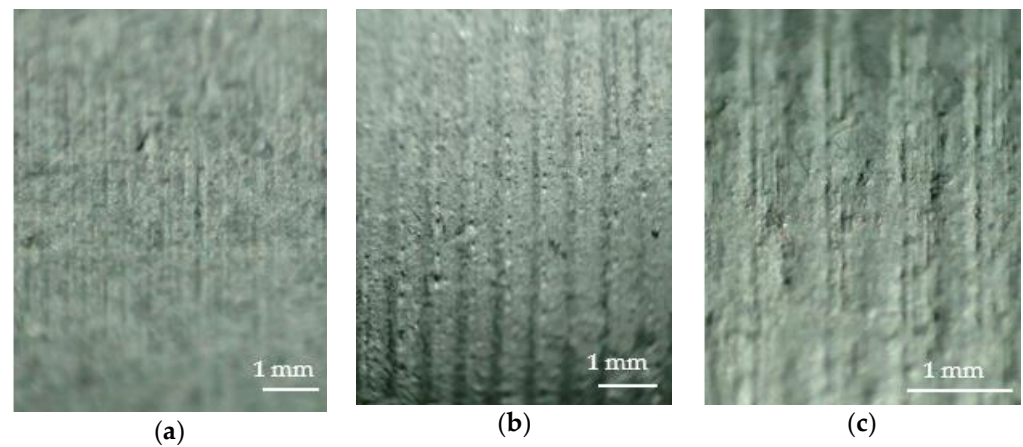
**Figure 10.** Surface images of HDGC specimens: (a) finely turned (HDGC1), 40× magnification; (b) roughly turned (HDGC5), 40× magnification; (c) roughly turned (HDGC5), 80× magnification.

Like immersion galvanization, the deposited coating is metallurgically linked and integrated with the steel in the case of hot-dip galvanization and centrifugation (Figure 10). When compared to the immersed specimens, the surface roughness changes when the excess non-solidified zinc on the surface is drained by centrifugal force, resulting in a matte appearance due to the produced roughness.

The coating surface has a glossy look that alternates with a matte appearance, both on the turned edges and their bases, and follows the profile form of the specimen produced by the turning process. The glossy galvanized surface is the result of dendritic branch growth along the free surface, whereas the matte regions (with pits) are the consequence of primary dendrite arms growing along the steel substrate and the free surface. For the grains to have large diameters and develop along the basal plane, it is expected that the contact angles are about the same for the free surface and the steel substrate and should vary between 17 and 80 degrees relative to the surface in the case of steel sheet [25]. Other studies, however, indicate that the contact angle is equal to or greater than 90 degrees [26]. When the contact angle is equal to 90 degrees, the existence of a boundary changes the preferred growth

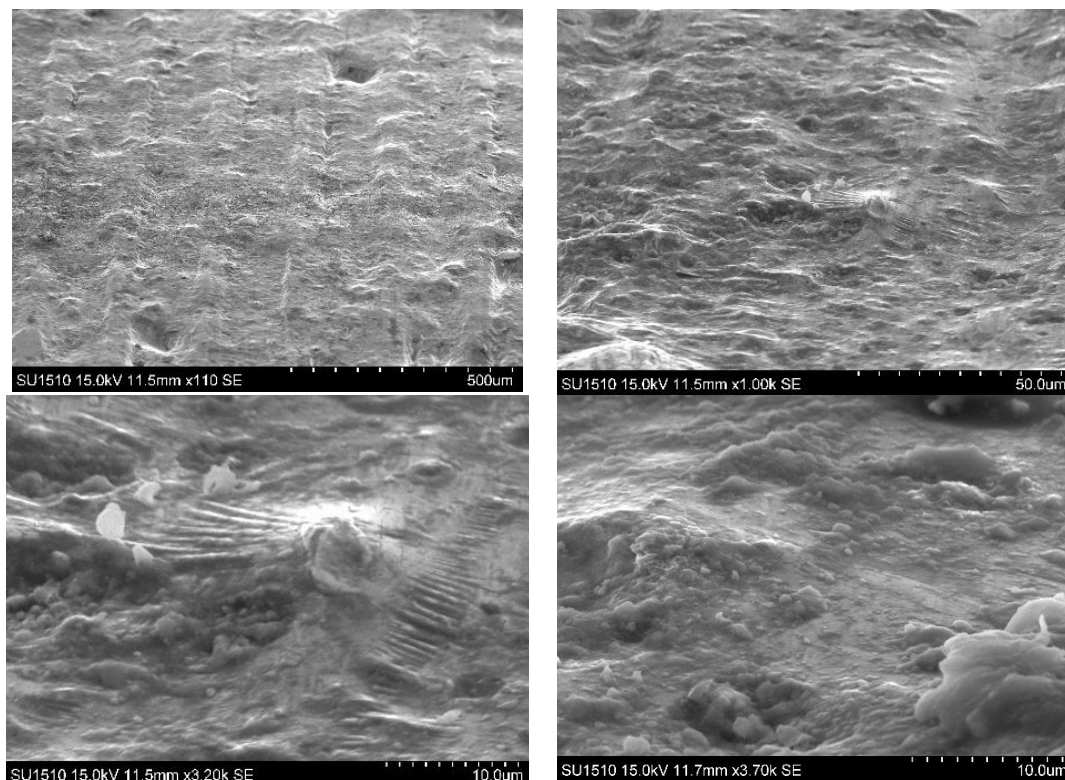
**Figure 11.** HDG 5 SEM image of sample surface.

The SEM investigation of the thermally galvanized surface (Figure 11) offers detailed information about the flaws in the deposited layer, which may also be seen by optical microscopy. Because of the distinct nucleation mode of the Fe-Zn intermetallic phases and the crystal growth mode, which may be impacted by impurities present in the metallic bath, the surface is significantly rougher than the electrolytically formed layer [3]. The number of faults and the irregularity of the surface give the specimens a matte look, as opposed to the shining appearance of the electrolytically coated specimens.

A sequence of streaks may be seen surrounding a protrusion in Figure 11c at a microscopic level. The development mode of both main and secondary dendrites causes the creation of these protrusions. The main dendrites develop parallel to the steel substrate, whereas the secondary dendrites align with the direction of heat flow. Solidification happens more frequently between secondary dendrites, producing glossy surfaces. Dendrites develop slowly and solidify last when they grow in the opposite direction due to heat flow suppression. If there is no more molten liquid available to compensate for solidification constriction, dull dendrites emerge, which may be seen microscopically as streaks [16,17]. Surface morphology (shiny, feathery, and dull spangle) influences surface micro-roughness, surface texture, interdendritic segregation, intermetallic compound precipitation, and, ultimately, corrosion resistance [16,17,27].

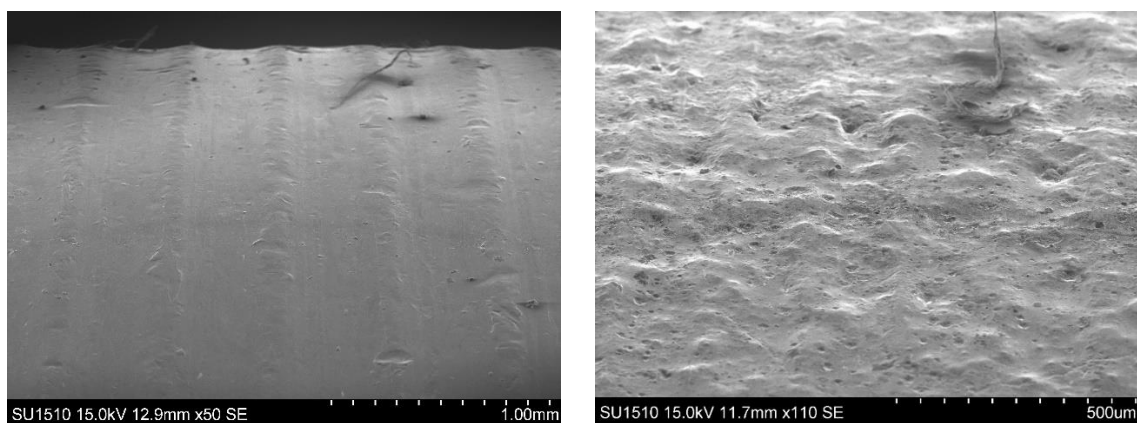
**Figure 12.** Image with filamentous clusters on the surface of the HDG5 sample.

In the case of a thermally galvanized sample (HDG5), microscopic analysis using SEM revealed the presence of filamentous clusters of crystals on the surface of the deposited layer (Figure 12). These clusters are referred to as “outbursts” or “explosions” and represent localized growths of the intermetallic compound  $\xi$ . They occur because of a reaction that initiates after the piece is removed from the bath, as the growth is limited by the surface of the  $\eta$  layer. The  $\xi$  phases are narrow and elongated, with many of them being branched [15].

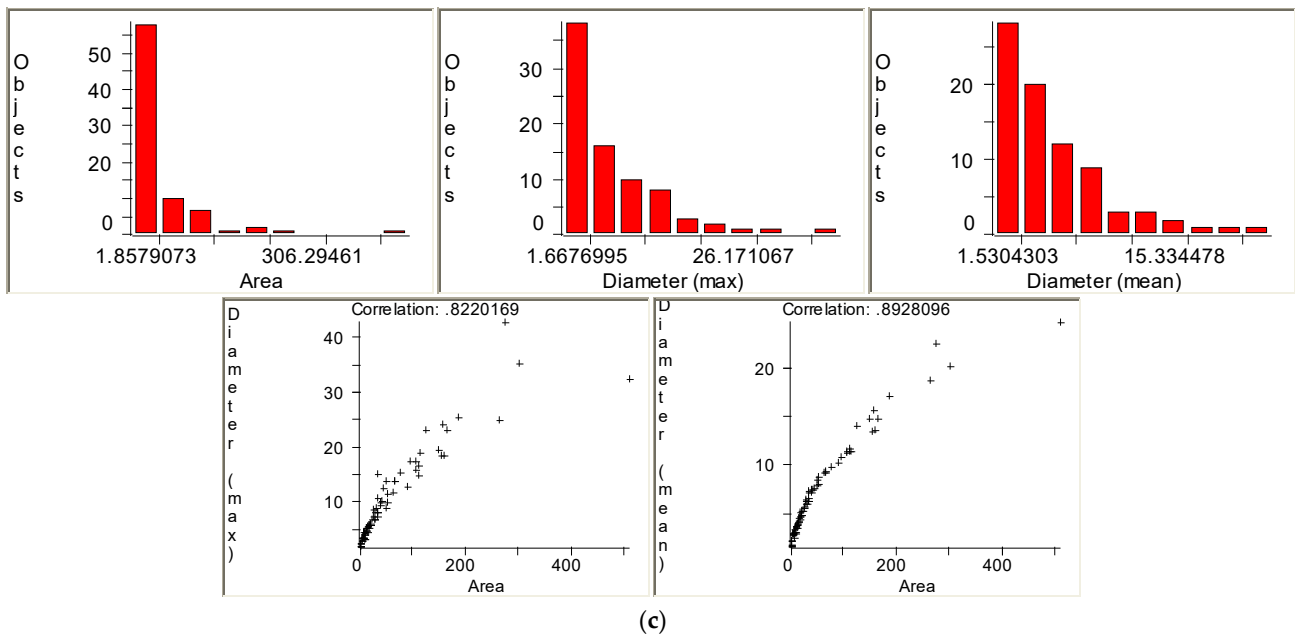
**Figure 14.** Surface analysis of HDG1 for quantifying surface defects: (a) defect numbering; (b) measured values; (c) histogram of the defect diameter/surface area ratio.

For the HDG1 sample (high substrate roughness), the surface defects (Figure 14) observed on the analyzed surface (80 objects—Figure 14b) are small and mainly consist of cavities with a surface area below 1.86 μm<sup>2</sup>. The total surface area of these defects was 4643.468 μm<sup>2</sup>, representing 0.55% of the total analyzed surface area of 847.000 μm<sup>2</sup> (Figure 14b). Most defects (objects) have a maximum diameter below 1.67 μm.

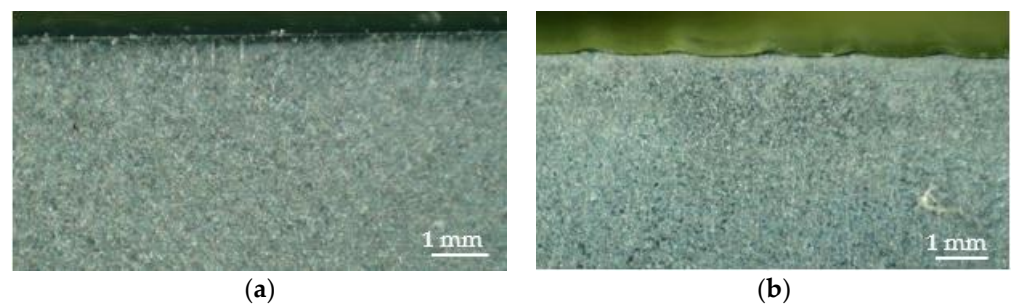
**Figure 17.** Cross-sectional images of GE specimens on a fine substrate (1–4.5×) (a) and on a coarse substrate (5–4.5×) (b).

The GE, HDG, and HDGC samples were examined under an optical microscope using white light (LED) for macroscopic and microscopic analysis. At low magnifications, Figure 17 shows cross-sectional images of the finely machined specimens—GE1 sample (with low steel substrate roughness—Figure 17a) and the maximum substrate roughness GE5 sample (from the series of 5 specimens—Figure 17b), where the profile and configuration of the coating layer following the substrate profile can be observed.

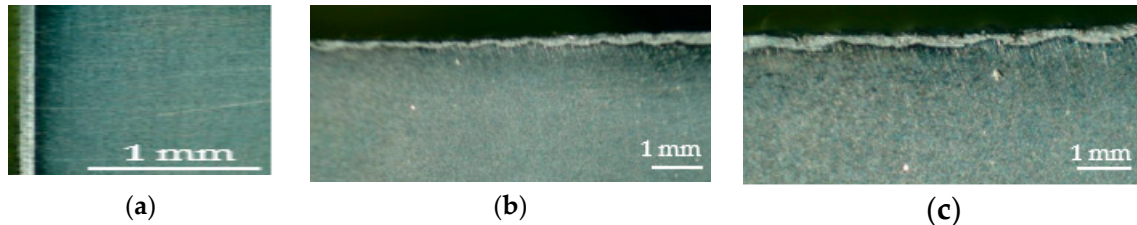
**Figure 18.** HDG section image (a) very fine-end (5–4.5 $\times$ ), (b) s. fine (5–4.5 $\times$ ), (c) coarse (1–4.5 $\times$ ).

Cross-sectional images of specimens galvanized by immersion and centrifugation are shown in Figures 18 and 19. Figure 18a depicts the investigation of the deposited layer on the cross-sectional area of the specimen with a very low steel substrate roughness (achieved by cutting the surface).

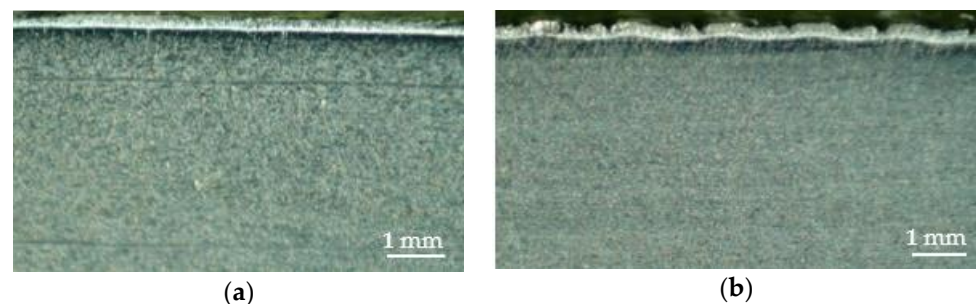
**Figure 19.** Image of HDGC specimen section: (a) fine turned (HDGC1), (b) rough turned (HDGC5).

For the immersion and centrifugal galvanized specimens (Figure 19), the surface roughness is much higher compared to the immersed specimens, as observed through roughness measurements, and confirmed by the cross-sectional analysis of the coating. While in the other galvanizing methods (GE and HDG), the cross-section of the coating showed a relatively continuous surface profile at low magnifications, roughly following the profile of the steel substrate, in the case of the HDGC specimens, there are significant variations on the surface of the coating with increasing substrate roughness, as highlighted in Figure 19b.

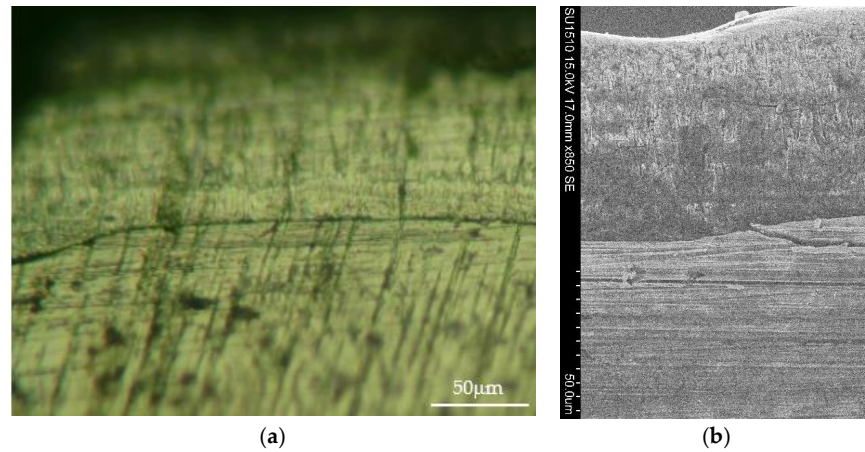
Figure 20. Section image of HDG5 specimen, polished (a) optical; (b) SEM.

In the case of section analysis at high magnification (optical and SEM), the coating layer is distinctly observed, and the profile of the steel substrate interface at the Fe/Zn interface is approximately parallel to the outer layer profile (Figure 20). The plating bath was composed of high-purity zinc (99.97%), without significant concentrations of Al (below 0.1%) that would influence the formation of Fe-Zn intermetallic phases.

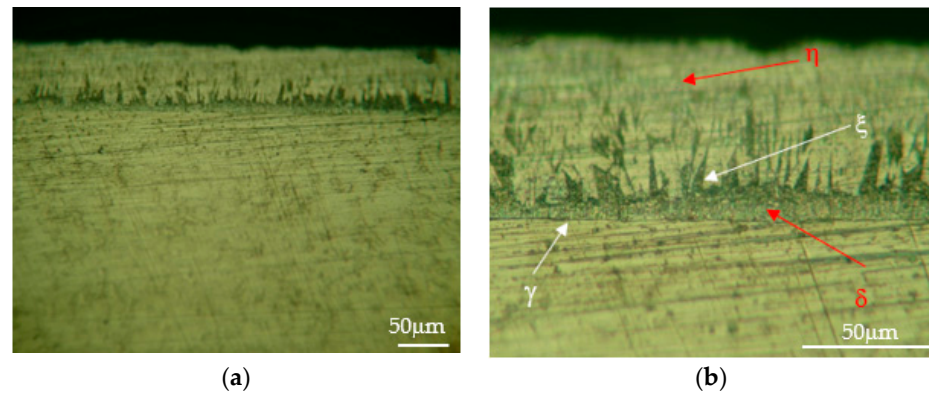
Figure 21. Section image of HDG1 specimen, etched with nital (a). The microstructure in section of sample HDGS1: (a) microstructure with pearlitic ferrite substrate, (b) microstructure with the intermetallic compounds in the coating layer.

The typical morphology of a galvanized steel coating can be seen in Figure 21, specifically in the HDG1 specimen (with fine roughness), where the identified phases (gamma, delta, zeta, and eta) are present. The  $\eta$  phase corresponds to nearly pure Zn (usually 0.03% to 0.08% Fe [28]), and it is situated above the intermetallic compounds  $\zeta$ —FeZn13 (94% Zn) and delta-FeZn7 (88% to 93% Zn). These intermetallic phases  $\zeta$  and delta have a columnar structure and are brittle. The intimate atomic-level interface with the steel is represented by a very thin brittle phase, gamma (FeZn3) [28]. The microstructure of the HDG5 specimen (Figure 22) with high substrate roughness is similar in terms of phases to the microstructure of the HDG1 specimen, with a higher proportion of phase crystals in the section.

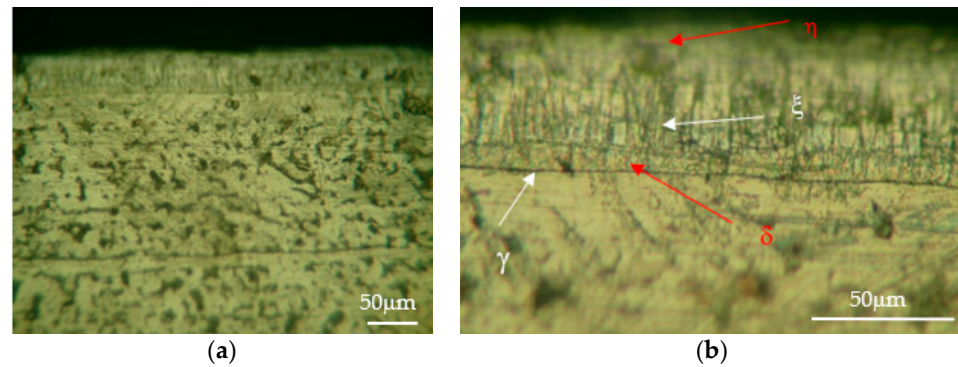
Figure 22. HDGC1s. The microstructure in section of sample HDGS1: (a) microstructure with pearlitic ferrite substrate, (b) microstructure with the intermetallic compounds in the coating layer, nital attack.

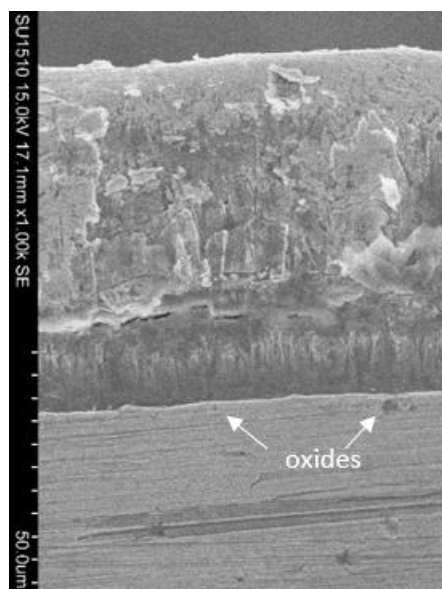
**Figure 23.** Crack in zinc layer between delta and zeta phases in thermally immersed sample HDG5.

The reaction between Zn and Fe forms a series of intermetallic layers of Fe-Zn alloy, metallurgically bonded to the base metal, with properties superior to those of iron. A relatively high proportion of the zeta phase in the iron–zinc alloy can lead to localized microcracking, as observed in Figure 23. The occurrence of microcracks has been highlighted between the gamma and delta phases, with the delta phase being the intermetallic compound with the highest hardness among the Fe-Zn compounds. Under the action of strong impact, torsion, or excessive bending, these microcracks can lead to the delamination of the zinc coating.

Microcracks have been identified at the intermediate phases formed between Fe and Zn (Figure 23). These primary cracks are mainly caused by the growth of the film, primarily due to differences in the coefficients of linear thermal expansion and elasticity between the steel and zinc [28]. The gamma and delta layers, being brittle layers, are prone to the formation of primary microcracks. The composition of the metal bath influences the formation of brittle layers, and as the thickness decreases, the length of the primary cracks is reduced. The quantity or number of cracks increases as stresses are applied to the specimens. If the applied stress is low, the cracks do not reach the steel surface, and the coating maintains its protective function. However, for high and cyclic stresses, the cracks can coalesce and propagate to the surface, leading to the deterioration of the coating. The effect of residual compressive stress on the substrate surface acts as an inhibiting layer for the growth of the coating and prevents atomic diffusion between Fe/Zn interfaces [30,31].

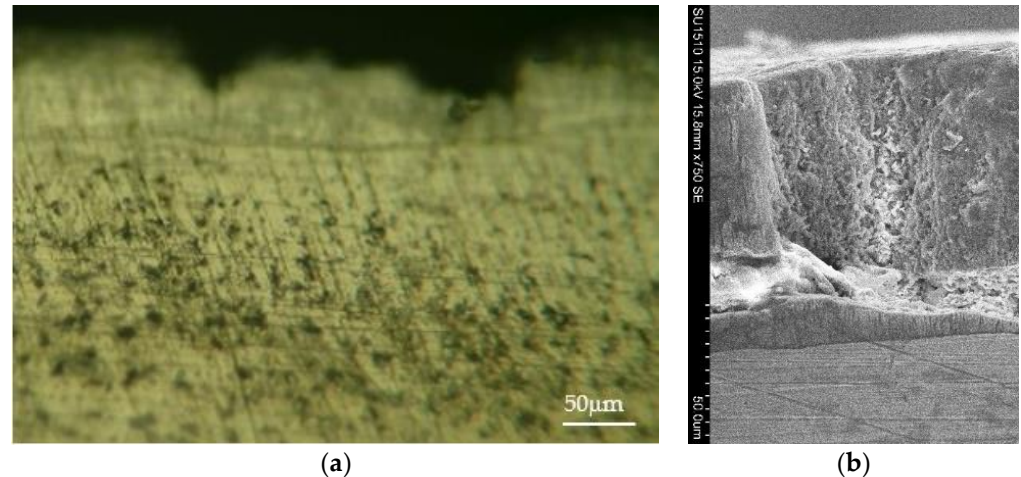
**Figure 24.** Sectional image of sample HDG5 around a crater (cavity); (a) optical image; (b) SEM image.

Another encountered defect is the presence of microcraters on the surface (Figure 24). In this area, a decrease in the thickness of the gamma phase layer is observed from the crater's edge towards the center, accompanied by the absence of other intermetallic phases and the zinc layer.

The existence of oxide patches (films) on the steel substrate, which delays the development of the coating, might explain the creation of cavities (craters). The zinc coating near the crater's base was incredibly thin. This was seen in the instance of a steel coating with 1.7% Si and 2.7% Mn, where oxygen was detected, indicating the existence of silicon and manganese oxides at the crater's base. These oxides hampered the diffusion of Zn and Fe, resulting in the development of craters [32]. Furthermore, the presence of oxides (small oxide grains among the crystalline grains) within the surface layer of the steel substrate was found (Figure 25), which is responsible for the creation of craters on the coated surface [32]. The appearance of striations (grooves) on the coating surface, which rise above the submicron oxide layers situated at the grain boundaries of the steel substrate, can be explained in the same way. The craters' occurrence can be explained by inadequate wetting of the surface by certain kinds of exogenous oxides, resulting in "empty spots" in the zinc layer [21]. The dissolution of the oxide film and slower development of the zinc layer at the base of the groove, as well as the existence of coalesced oxide crystals at the base, explain the decreased thickness of the coating at the base of the groove [21].

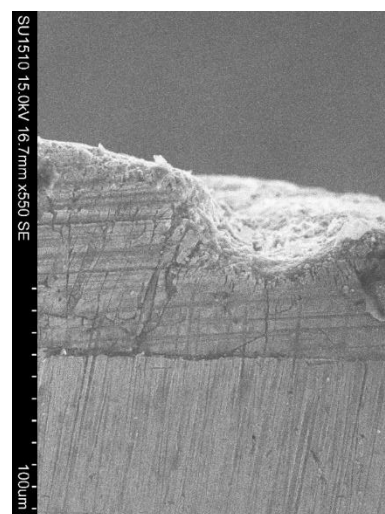
**Figure 25.** Small cavity (indentation) in the zinc layer in thermally immersed centrifuged sample HDGC5.

Microcavities (Figure 25) can appear on the surface of the  $\eta$  phase, but they do not reach the  $\xi$  phase.

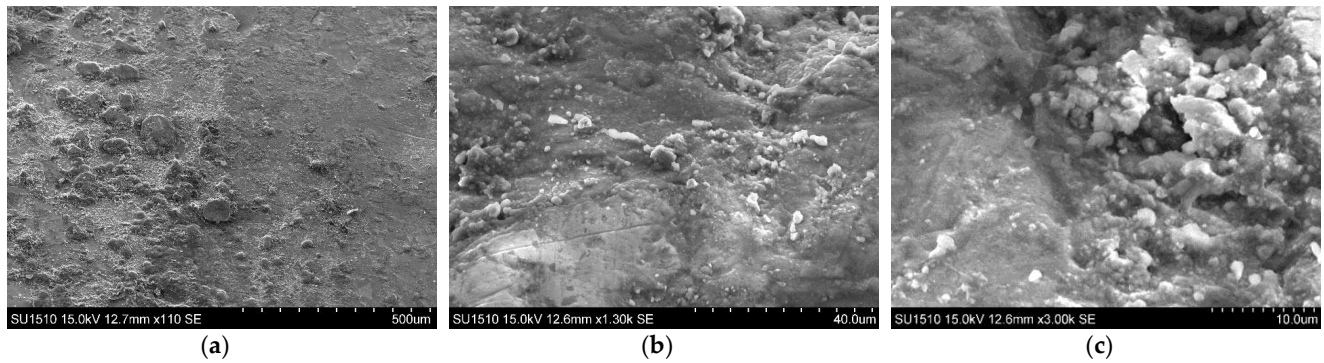
Figure 26. GE (1) with low roughness corroded (a–c).

ucts is more difficult to identify than their chemical properties. Corrosion products are a plethora of zinc-based compounds generated in many types of atmospheres, but only specific compounds dominate in each atmosphere. Oxides and chlorides are the most common corrosion products in the salt spray corrosion testing samples (Figure 26c).

Figure 26a shows globular-shaped crystals with rounded edges on the surface of electrolytically produced zinc (GE1 sample) subjected to corrosion, and Figure 26b shows corrosion products on the surface of and between these zinc crystals. The discrepancy in roughness value might be related to changes in the coating's microstructure [40]. When GE5 samples (with increased roughness of the steel substrate) are electrogalvanized (Figure 24), there is less corrosion product on the surface than with the GE1 sample. Figure 27c crystals had an acicular shape, confirming that after the zinc layer dissolving, there was a cluster of filiform phases identical (but much bigger) to what was seen in Figure 26.

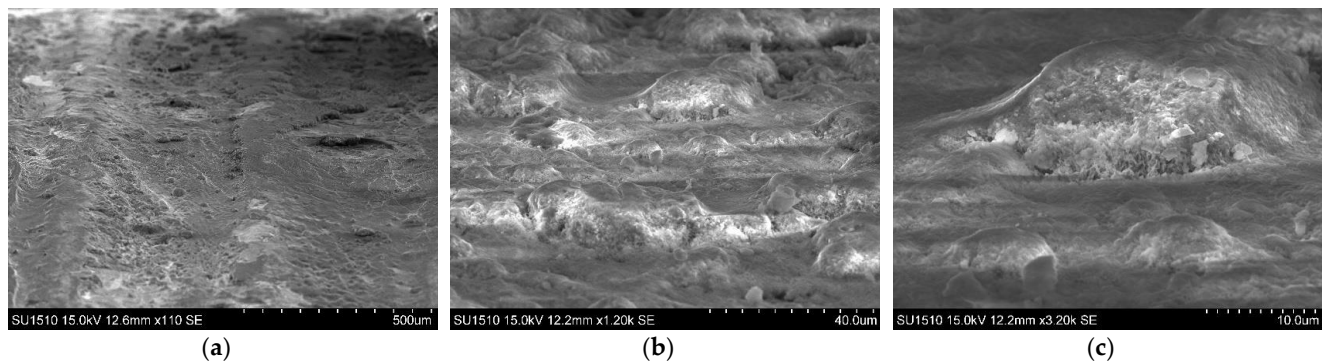
Figure 27. GE (5) with high roughness corroded (a–c).

Various cavities with rounded edges, corroded grains with rounded edges, and different filiform corrosion products can be seen on the surfaces of immersion zinc-coated samples (HDG) and immersion and centrifuged zinc-coated samples (HDGC) exposed to corrosion testing (Figure 27b,c). Because the initial roughness of these samples was substantially higher than that of electrogalvanized samples, the amount of surface corrosion varied greatly. Variations in the microstructure inside the coating, the existence of various intermetallic phases in the coating, and a different fluctuation in the thickness of the Zn layer ( $\eta$ ) [40] might all be linked to the roughness value [40].

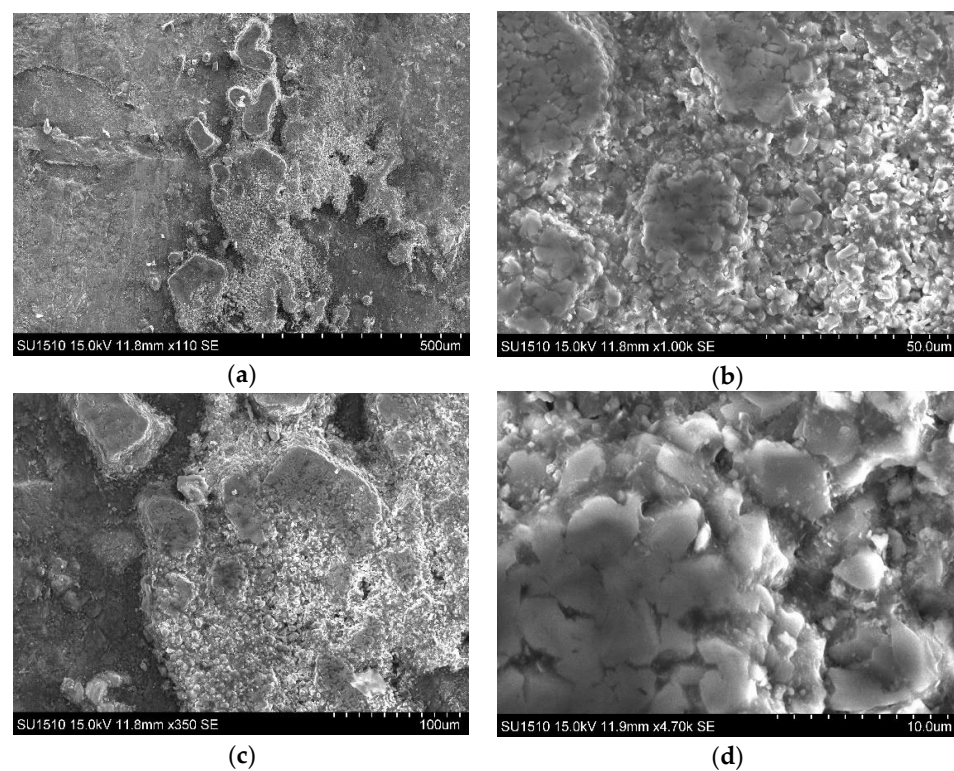
Figure 28. HDG (1) with low roughness corroded (a–d).

The HDG1 sample with low substrate roughness exhibited more intense corrosion and developed a series of reaction products on its surface (Figure 28). This can be explained by the initial roughness of both the coating layer and the steel substrate, as well as the growth of smaller-sized dendritic crystals of  $\eta$  phase. Underneath this layer, columnar crystals of  $\xi$  phase formed, acting as the cathodic region, and leading to faster anodic dissolution of the  $\eta$  phase. This resulted in the formation of corrosion products in various forms, with a higher proportion being represented by prismatic crystals (Figure 28).

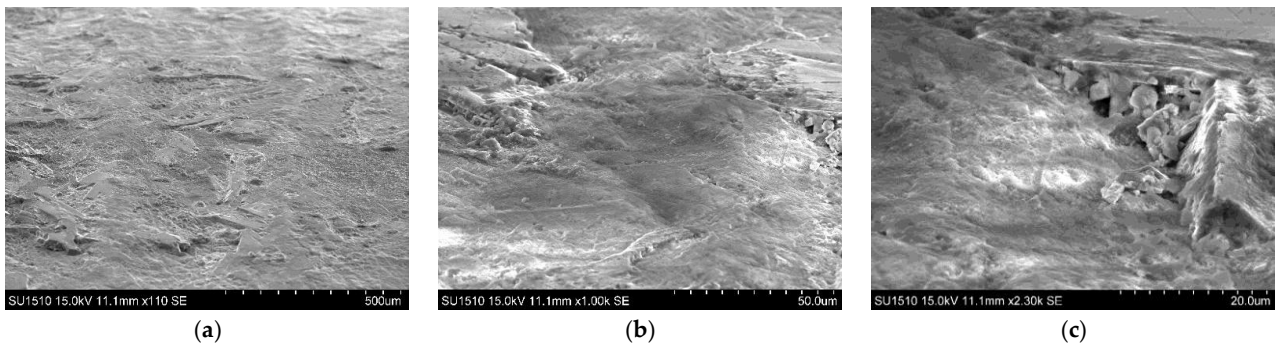
**Figure 29.** HDG (5) with high roughness corroded (a–c).

The  $\eta$  phase in the corrosion process, due to the difference in corrosion potential, acts as an anode at the interface between the  $\eta$  and  $\zeta$  phases, while the  $\zeta$ -FeZn<sub>13</sub> phase acts as a cathode, forming a galvanic corrosion couple [41–43] (Figure 29). During corrosion, the Zn phase preferentially corrodes, while the  $\zeta$ -FeZn<sub>13</sub> phase, the cathode, remains unchanged. With the increasing corrosion cycle, the  $\eta$ -Zn phase is corroded and detached, forming typical galvanic corrosion [28]. In Figure 27, a cavity with a diameter of approximately 50  $\mu$ m can be observed, where the  $\eta$  phase layer has been corroded down to the Fe-Zn intermetallic phases. Once the  $\eta$  layer is dissolved at the base of the crater, the  $\zeta$  phase crystals become visible, which have higher corrosion resistance than the  $\eta$  phase (Figure 30c). On the surface of the sample and at the edge of the cavity, accumulations of corrosion

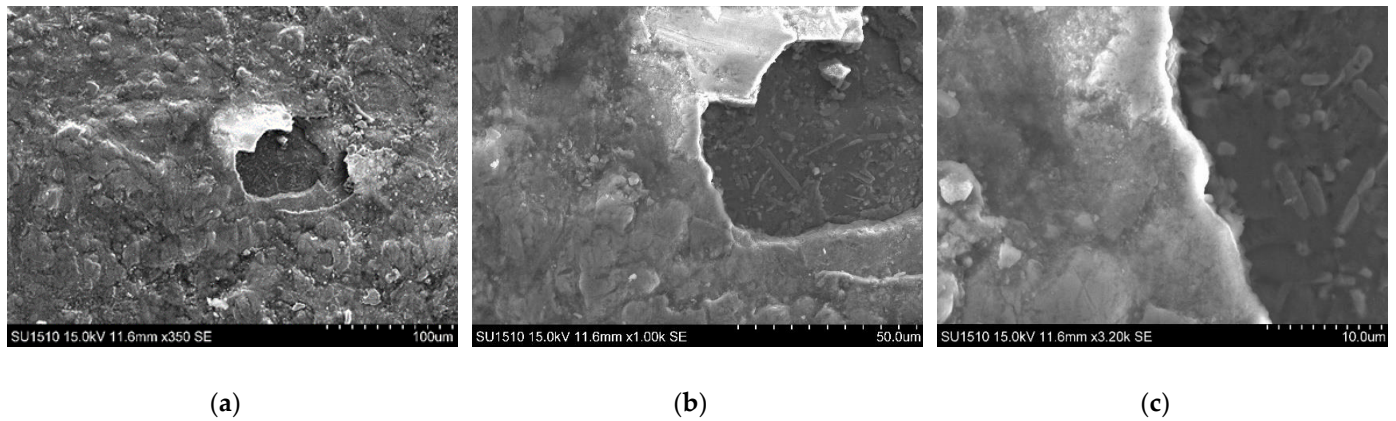
**Figure 30.** SEM image in sample HDG5—cavity (“crater”) in corroded sample at various magnifications (a–c).

products can be observed. It can be stated that Figure 30 exhibits a “difference in level” in a corroded area.

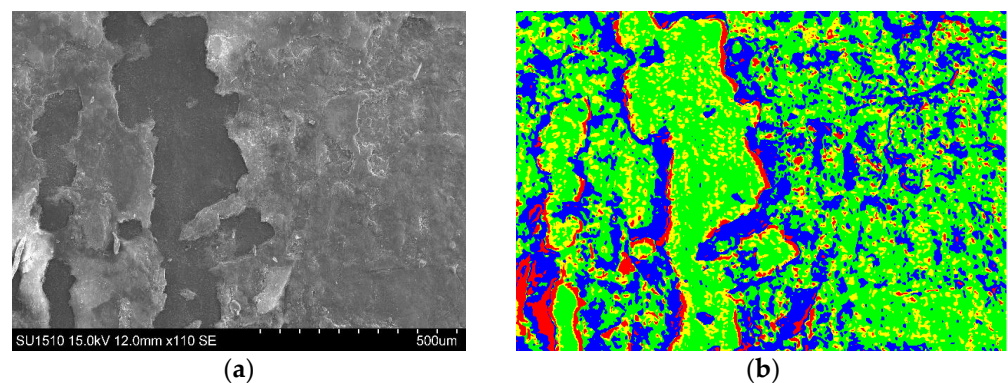
**Figure 31.** Corrosion surfaces sample HDG1. (a) SEM surface image; (b) map of corroded portions.

Figures 31 and 32 illustrate the surface examination of the submerged samples (HDG1, HDG5) using the ImagePro Plus program to highlight the corrosion mode (corroded regions) and corrosion compounds (areas with distinct types of corrosion compounds).

In the case of the HDG1 sample, the deeply corroded areas were much fewer. Green was assigned for the corroded area, yellow for corrosion products, and red for the shallowly corroded area (Figure 31b). The results of the analysis are listed in Table 5.

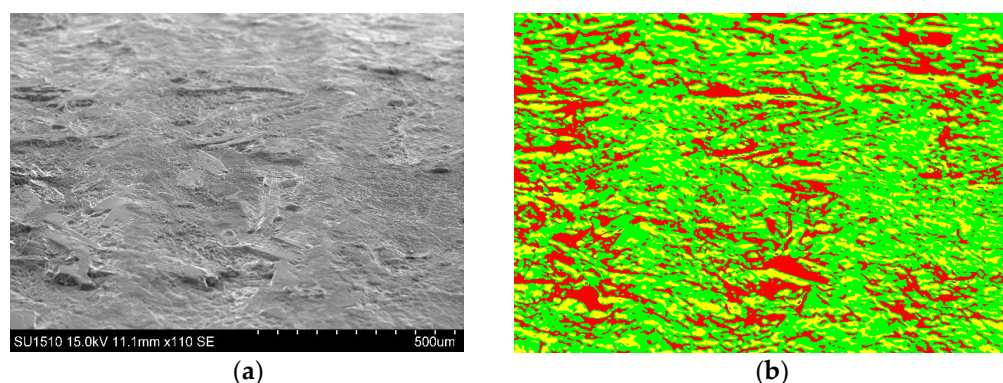
**Figure 32.** Corrosion surfaces sample HDG5. (a) SEM surface image; (b) map of corroded portions.

The analyzed surface area for sample HDG5 was  $847.000 \mu\text{m}^2$ . Different colors were assigned to corroded areas (green) and areas with corrosion compounds, with red representing concreted compounds on the surface, yellow representing isolated crystals, and blue representing less attacked areas. The analysis results for the analyzed surface are presented in Table 4.

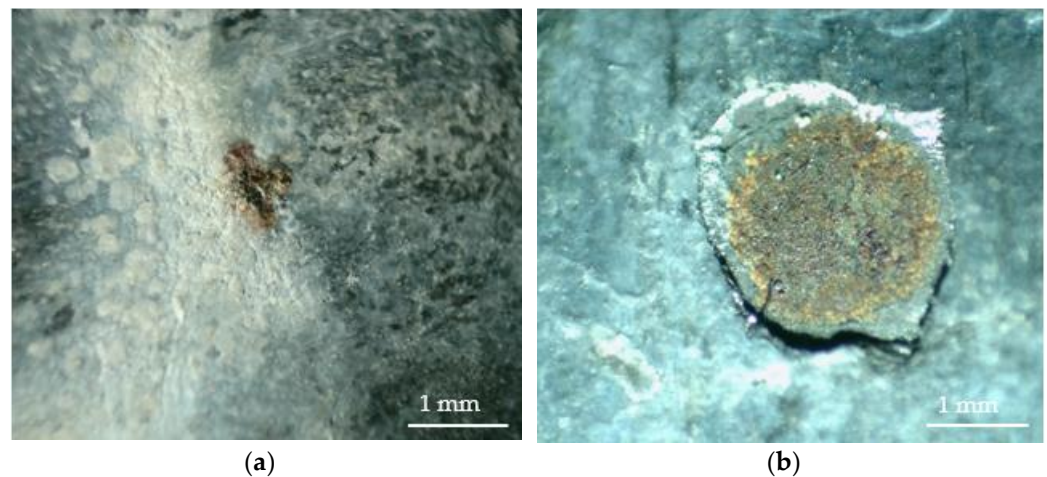
**Figure 33.** Corrosion cavity (“crater”) in oxidized sample: (a) rust under the layer of corrosion compounds; (b) rust cavity in steel substrate.

Very few rust spots were observed on the surface of the galvanized samples. Some spots were observed in areas with high amounts of corrosion products (Figure 33a), or in areas where the protective coating showed cracks; thus, the corrosive environment led to the dissolution of the coating and the appearance of rust (Figure 33b). Rust compounds can be FeOOH on the outside of the substrate and internally Fe<sub>3</sub>O<sub>4</sub> compound [44–47].

Rust on steel is porous and adheres poorly to the surface of the steel substrate. Rust can increase corrosion by acting as a reservoir for water, hence, extending wetting time, or as a catalyst for oxygen reduction, as demonstrated on the surface of a zinc-coated sample using both optical and electron microscopy (Figure 33b).
