# Corrosion Testing of Thermal Spray Coatings in a Biomass Co-Firing Power Plant

**Abstract:** Large-scale use of biomass and recycled fuel is increasing in energy production due to climate and energy targets. A 40% cut in greenhouse gas emission compared to 1990 levels and at least a 27% share of renewable energy consumption are set in EU Energy Strategy 2030. Burning fuels with high content of corrosive species such as chlorine and heavy metals causes deterioration of boiler components, shortened lifetime, limited availability of a plant and hence higher maintenance and investment costs and lower thermal and economic efficiency. Coatings can be applied to protect the critical boiler components against high temperature corrosion. In this study, five thermal spray coatings were tested in an actual biomass co-firing boiler for 1300 h with a measurement probe. The coatings were analyzed after the exposure by metallographic means and scanning electron microscope/energy-dispersive X-ray spectroscopy (SEM/EDX). The deposits formed on the specimens were analyzed by X-ray fluorescence. At 550 °C, the coatings showed excellent corrosion performance compared to reference material ferritic

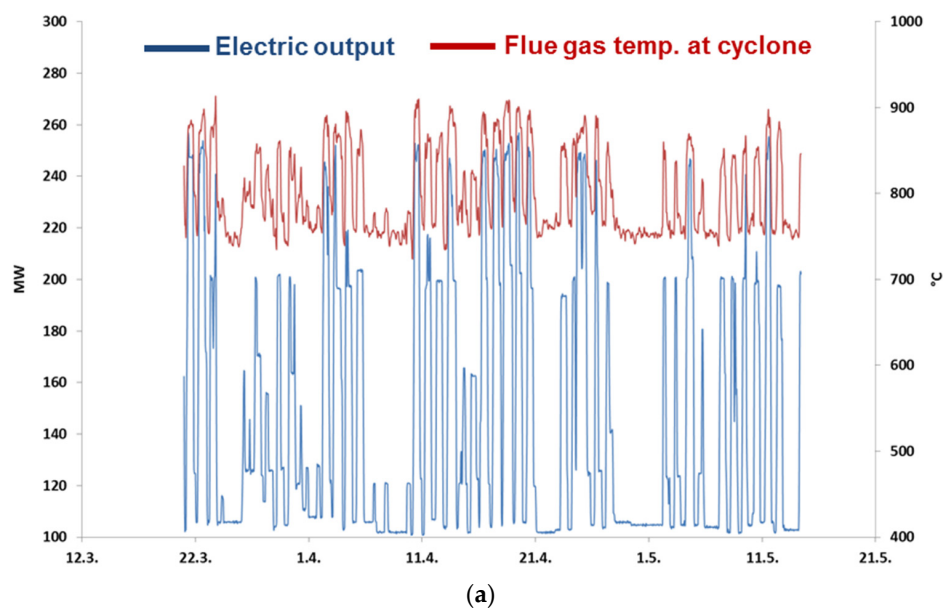
**Figure 3.** Process data during the test exposure: (a) Plant electricity output (MW) and flue gas temperature (°C) at the cyclone; (b) Flue gas data of sulfur dioxide SO<sub>2</sub> and hydrogen chloride HCl during the test (mg/Nm<sup>3</sup>).

Plant electricity output varied a lot in short intervals depending on the electricity markets, which had a strong effect on the flue gas temperatures inside the boiler, and further on the temperatures at the probe surfaces, Figure 3a. Some fluctuations were also present in the flue gas emissions, e.g., the HCl and SO<sub>2</sub> emissions presented in Figure 3b. Due to high variations in the plant load and process temperatures, the probe temperature profiles were fluctuating as well, which influenced the stability of the controlled temperature on the windward surface, as presented in Figure 4a. Hence, the actual material temperatures were lower than planned: 536 °C for the primary and 697 °C for the secondary head in the windward side on average. For the leeward side, the average temperatures were 502 °C for the primary and 609 °C for the secondary head. Minimum values in the probe were in the leeward side; 331 °C for the primary and 566 °C for the secondary head. The maximum values in the windward side were 602 °C (primary) and 764 °C (secondary head). The temperatures are presented in the form of a stability curve, where the fluctuations, which followed the flue gas temperature, are not shown. The diagram shows overall temperature behavior to the exposure period, but not in a chronological order. Three short temperature and pressure changes occurred in the probe during the test period due to shutting the cooling water circulation and cleaning the filter. Operational thermal cycling (627–874 °C flue gas) was caused by the electric output variation. After the exposure, the material testing probe was covered with a light brown deposit, which had partly detached. The probe is presented in Figure 4b.

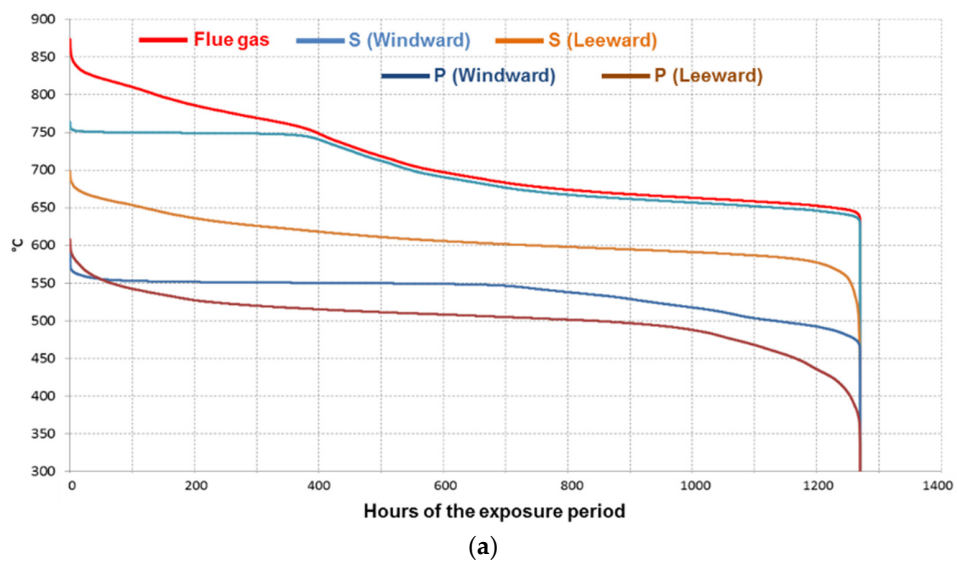
**Figure 4.** (a) Probe measurement data presented in the form of stability curve for flue gas, windward and leeward temperatures (°C) (S = secondary head, P = primary head); (b) Probe after the 1300 h exposure, material samples at metal temperatures of approximately 550 °C.
