Article

Durability Analysis and Experimental Validation of Environmental Barrier Coating (EBC) Performance Using Combined Digital Image Correlation and NDE

Keywords: digital image correlation; tensile test; NDE; CMC; EBC; computed tomography

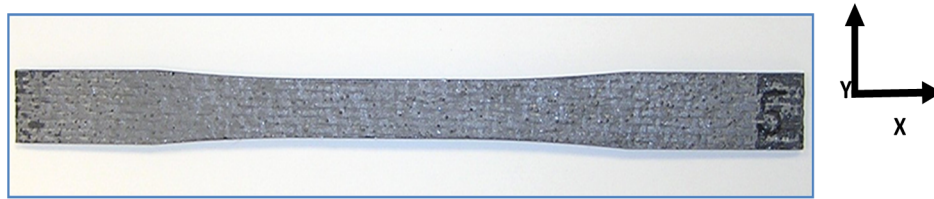
Figure 5. Optical photograph of an environmental barrier coating (EBC) coated melt infiltrated silicon carbide fiber reinforced silicon carbide matrix composite (MI SiC/SiC) composite dog bone specimen.

Figure 5 shows an optical photograph of an EBC coated melt infiltrated silicon carbide fiber reinforced silicon carbide matrix (MI SiC/SiC) composite dog-bone specimen, and Figure 6 depicts a schematic cross-section showing details of the EBC sub-layer and substrate thicknesses.
