# Damage Tolerance of a Stiffened Composite Panel with an Access Cutout under Fatigue Loading and Validation Using FEM Analysis and Digital Image Correlation

**Abstract:** Aircraft structures must be capable of performing their function throughout their design life while meeting safety objectives. Such structures may contain defects and/or damages that can occur for several reasons. Therefore, aircraft structures are inspected regularly and repaired if necessary. The concept of combining an inspection plan with knowledge of damage threats, damage growth rates, and residual strength is referred to as “damage-tolerant design” in the field of aircraft design. In the present study, we fabricated a composite panel with a cutout (which is generally found in the bottom skin of the wing) using a resin infusion process and studied the damage tolerance of a co-cured skin-stringer composite panel. The composite panel was subjected to low-velocity impact damage, and the extent of damage was studied based on non-destructive inspection techniques such as ultrasonic inspection. Fixtures were designed and fabricated to load the composite panel under static and fatigue loads. Finally, the panel wa

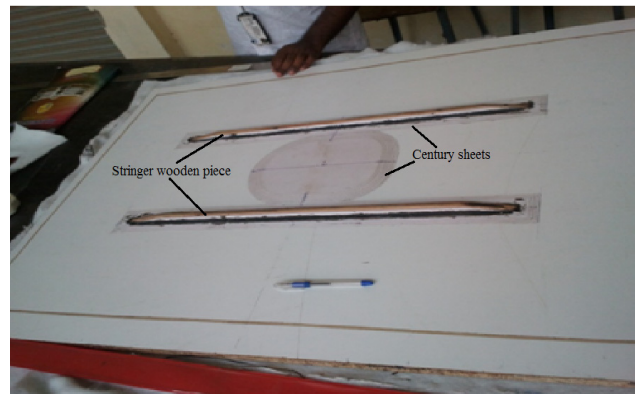
**Figure 2.** Tool for making caul plate.

The resin infusion process requires a mold. The mold contains two halves; the upper half is called a cope, and the bottom is called a drag. In this study, the bottom surface of the panel was flat, so the drag was not made separately; instead, a flat glass plate was used. The wooden tool helps fabricate the mold's cope part (caul plate). A tool is the negative replica of a component to be manufactured, as shown in Figure 2. Similarly, a tool for the stringer was also fabricated to obtain hat shape of the stringer.

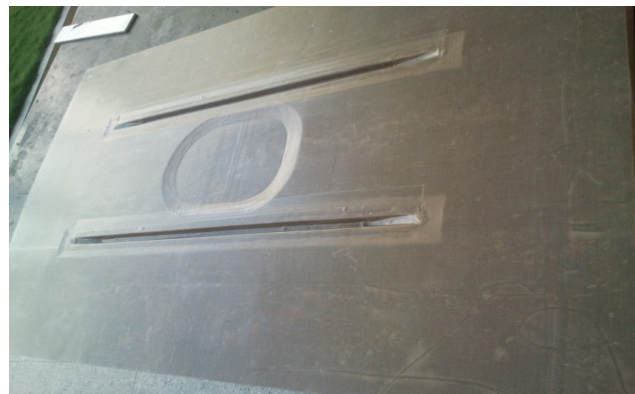
**Figure 3.** Caul plate after applying tool tech.

A flexible caul plate (Figure 3) was fabricated using RTV-4131-P1 Liquid Silicone Rubber and its curing agent in a ratio of 10:1 with a hand layup method followed by vacuum bagging and kept at room temperature for a day for curing. The skin and stringer preforms were fabricated separately and later co-cured in a procedure incorporated in the manufacturing the panel.

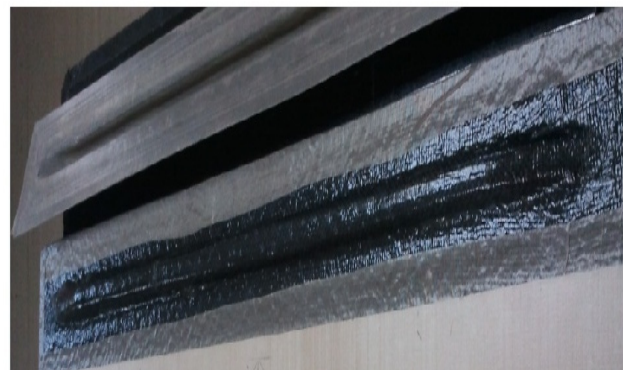
**Figure 4.** Stringer preform tool.

To make the stringer preform, a tool was used. The procedure was similar to the fabrication of the flexible caul plate discussed before. Here, the resin-to-hardener mixing ratio was 100:56. ARL-140(3500) resin was used with A11-419(3502) hardener. The preform tool, which was fabricated (Figure 4) using this resin, was very hard and was used to press against the stringer tool, with carbon layers are placed over it. Therefore, it should possess good stiffness to avoid deformation of the stringer during pressing.

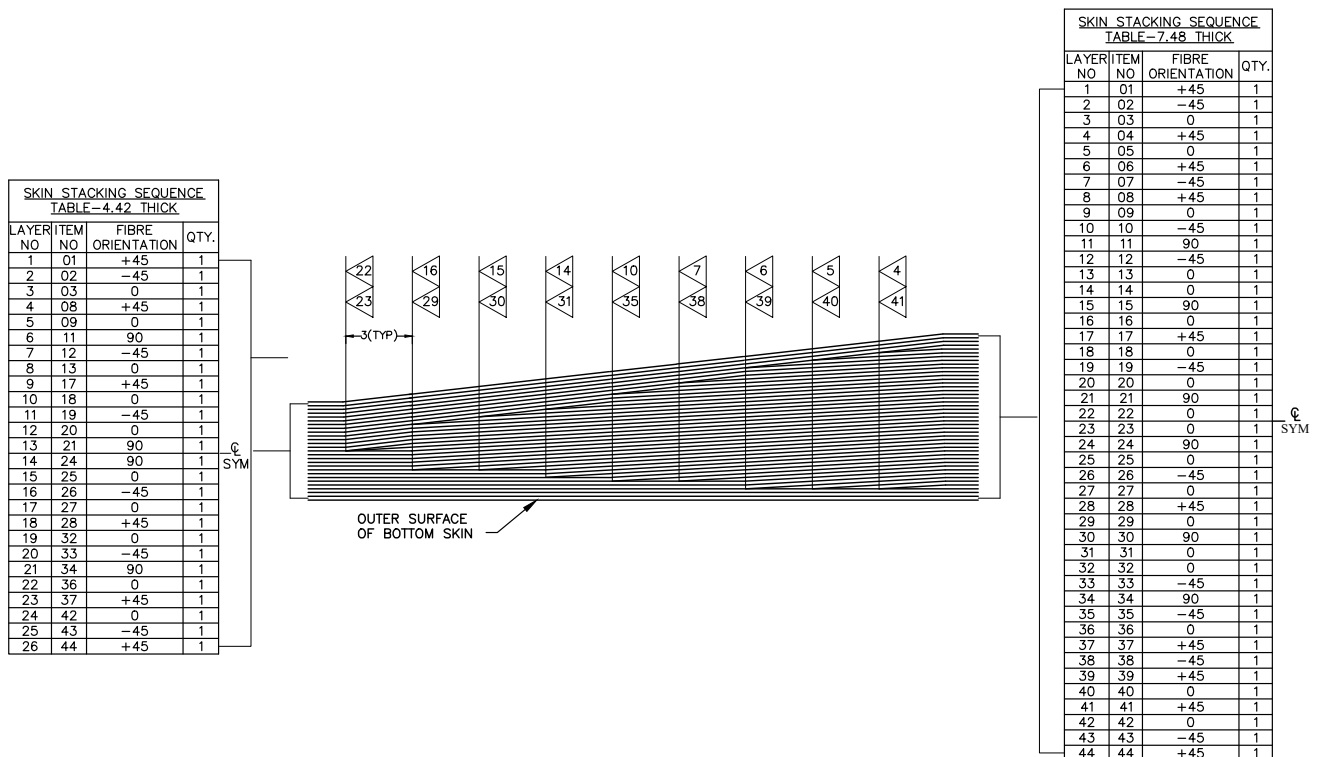
Figure 5. Layup sequence and thickness variation in the skin near the cutout.

The plies were cut to the required dimension and orientation for skin layup using a fiber-cutting machine. The dry unidirectional fabric layers were arranged according to the skin layup sequence (Figure 5). The binder essentially improves the dimensional stability of the fabric and helps in preforming when required. Heat is typically applied through a clothing iron after laying each layer. Furthermore, this process helps to remove air trapped between the layers. Skin layup was carried out on a flat, toughened glass mold. The mold (drag) was adequately cleaned with acetone, and a non-porous release film was placed over it to avoid sticking of the preform to the mold. Dry carbon layers were laid on the glass mold with appropriate edge reference. Generally, a small quantity (2–3%) of binder is present on the dry fabric as supplied by the supplier, which helps in the adhesion of these fabrics during layup. During the layup, care should be taken to ensure that the binder region of one ply comes in contact with the non-binder region of the adjacent ply. The entire layup was vacuum bagged, and preforming was then carried out in an oven at 800 °C for one hour in the presence of a vacuum.

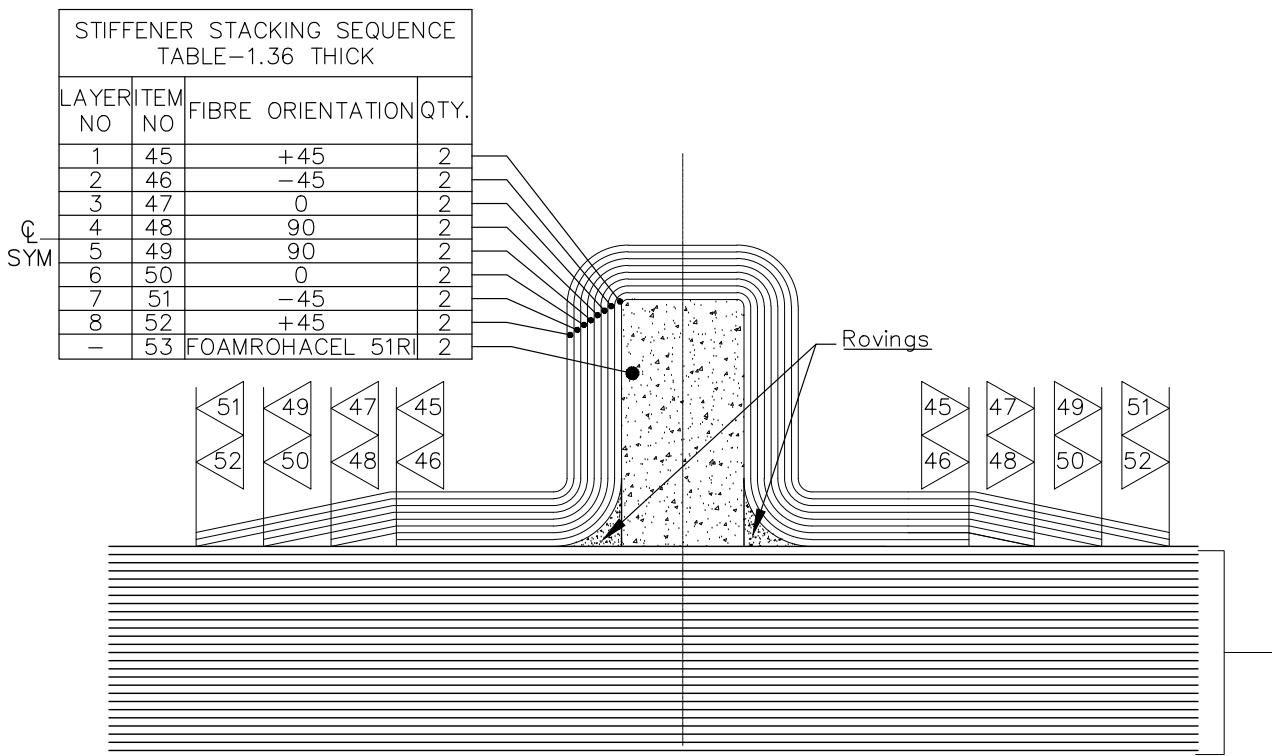
Figure 6. Layup sequence for stringer.

For stringer layup, the dry layers were arranged as per the sequence shown in Figure 6 and placed on the stringer tool described in the previous Section. Carbon UD fabric rovings were used along the length of the stringer between the foam and the stringer near the bottom to avoid a gap, as shown in Figure 6. Later, the stringer preform tool was pressed against the layers to obtain the hat shape of the stringer. Then the entire arrangement was placed inside a vacuum bag, followed by preforming at 800 °C for an hour. Owing to the applied pressure and temperature, the dry layers took the shape of the cavity between the preform tool and the stringer tool. Later, the preform was removed, and layer drops were cut to the required dimensions. The finished stringer was again preformed to achieve the appropriate bonding and shape. The preformed stringer contains a hollow cavity to accommodate the 51RI Rohacell foam (heat treated for 4 h at 120 °C). This foam is a porous, lightweight material with a density of 52 ± 12 kg/m<sup>3</sup> and a compressive strength of 0.4–0.7 MPa. This foam helps maintain the stringer’s shape without adding any noticeable

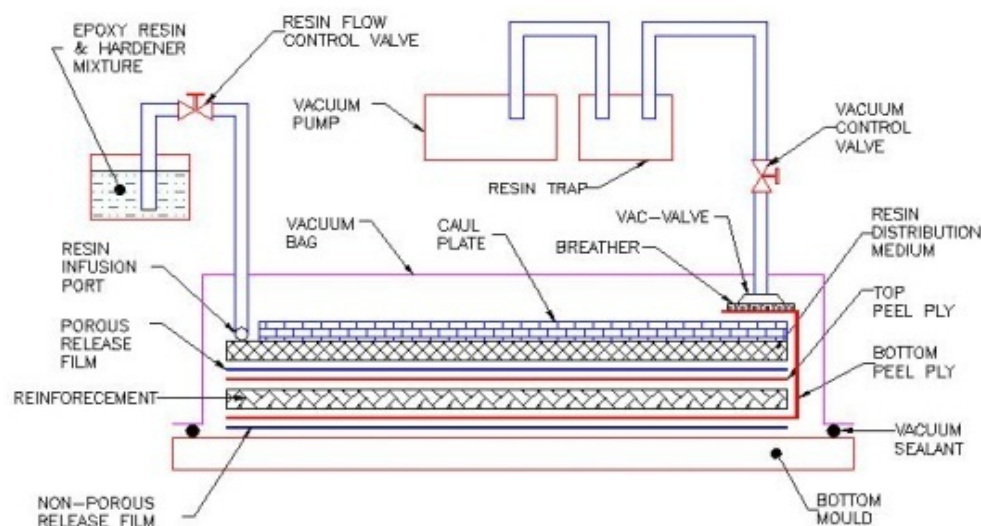
Figure 7. Resin infusion arrangements.

According to the resin infusion arrangements shown in Figure 7, the non-porous release film was placed on a glass mold, which facilitates easy removal of the part after curing. A peel ply is placed over the release film to impart a good surface finish in composite aircraft parts. Using peel ply on composites has many advantages; it causes the fibers to lie flat and increases the adhesion in subsequent bonding and the adhesion of primers. The dry preform was placed over the peel ply. Another layer of peel ply was placed over the preform. The porous release film was placed over this to allow the resin to flow into the preform and for easy removal of the laminate. The resin distribution medium (flow mesh) was placed over the arrangement, which helped the resin flow throughout the preform. The flexible caul plate was placed over the arrangement, which can be called the upper part of the mold and resembles the negative shape of the preform. It is helpful to apply uniform pressure all over the preform. Infusion channels and vacuum valves were sealed to the caul plate to infuse the resin and to avoid the resin flowing outside the mold. A thermocouple was placed between the layers to monitor the curing temperature. A breather was placed to absorb the excess resin and to provide proper suction. Coremat was placed on the suction side to prevent the resin from flowing into the vacuum hose. A braid was placed below the vacuum valve along the length of the preform to provide uniform suction throughout its length. Finally, the entire arrangement was bagged using a thick polythene bagging film and sealed using sealant tape. Vacuum was applied from one end, and the bag was arranged and pressed near the corners to avoid 'Race Tracking'. The presence of high-permeability areas near the mold edges causes race tracking. These highly permeable areas are created by unraveling fiber bundles during the cutting of the preform or by improper preform placement inside the mold.

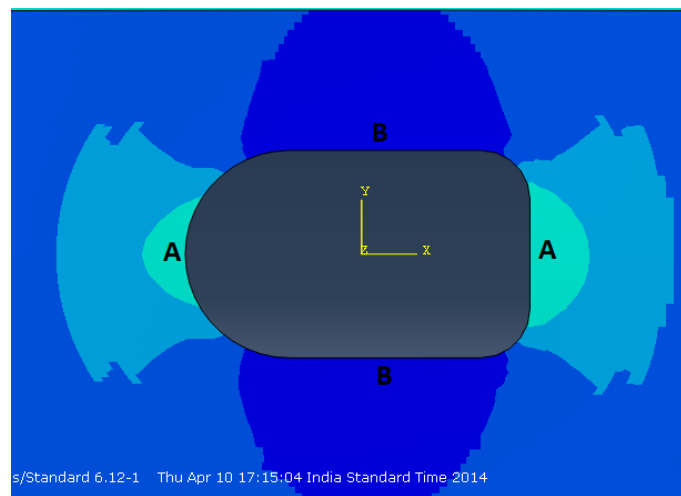
**Figure 8.** Highly stressed regions on the panel (near the cutout).

Before inflicting impact damage to the panel, impact locations needed to be identified. For this purpose, we considered which areas in the panel are highly stressed. The cutout in the panel causes stress concentration in its vicinity and is therefore a straightforward choice for impact. A finite element model of the panel with the cutout was created using the FE package Abaqus/Standard. The variation in stresses around the cutout for a tensile load is shown in Figure 8. Here, the regions with high shear stress are marked as A, and regions with high normal stress are marked as B.

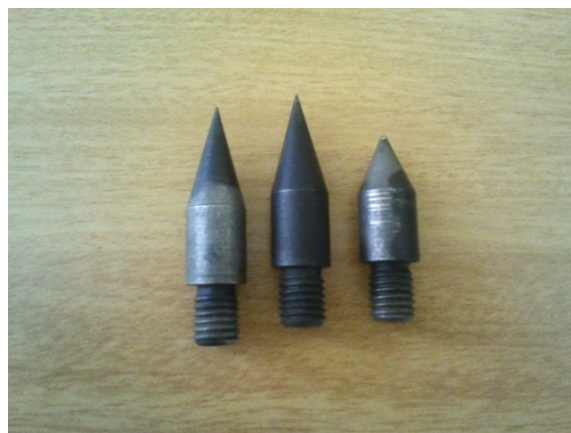
**Figure 9.** Sharp impactors used in this study.

Region B was impacted with a sharp impactor (Figure 9), as it is likely to cut fibers in the panel, which are critical for carrying normal stress. Region A was impacted with a blunt hemispherical impactor, as it is likely to result in delamination in layers/plies with minimal breakage of fibers. Such a damage scenario can lead to increased shear stresses around the damaged area, representing the worst type of damage for both regions. Testing the damage tolerance of the panel in this worst-case scenario is expected to prove its tolerance of other less-critical damage.

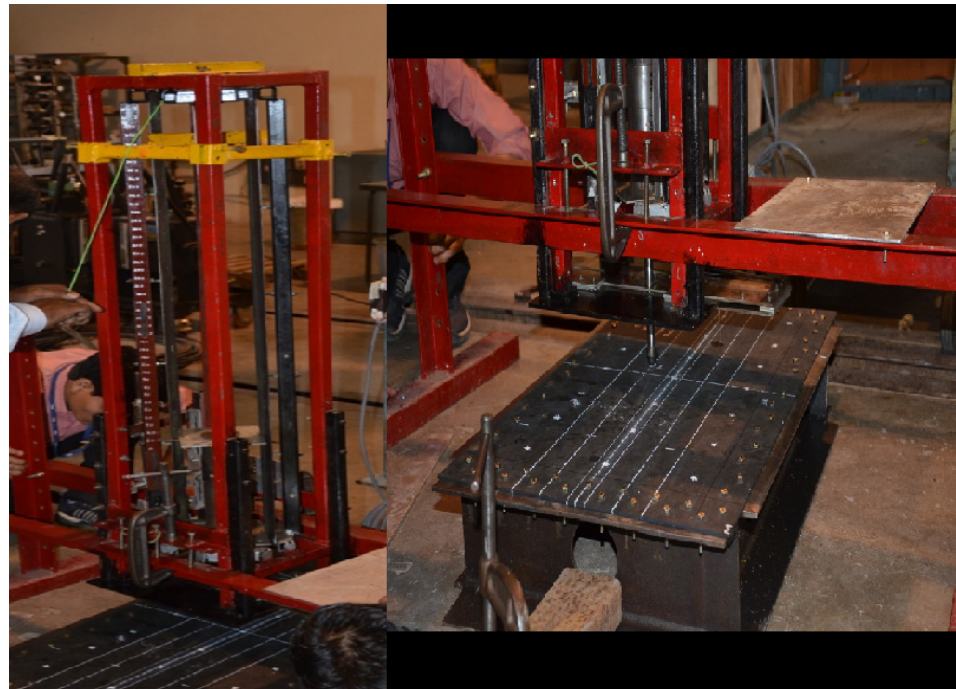
Figure 10. Drop weight impact tower.

It is difficult to conduct impact tests with low-mass, high-velocity projectiles, which also pose additional safety issues. Hence, an alternative method was used, which involved equating the energies, increasing the mass, and reducing the impact velocity. The required impact energy was achieved by dropping a known mass from a known height. This approach has been applied by other researchers in the literature and is considered acceptable [27–30]. Figure 10 shows the drop impact testing machine used in this study.

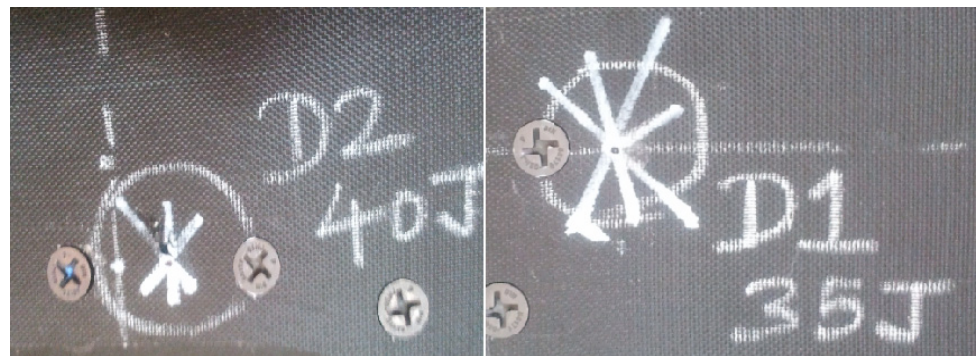
Figure 11. Impact damage on panel 1.

As previously mentioned, this fastening provides clamped boundary conditions on all four sides of the panel. Two instances of impact damage were imparted on panel no. 1, as shown in Figure 11. Panel 2 was also impacted at two locations, as shown in Figure 12.

On panel 1, one impact damage was inflicted by a sharp impactor (40J), and the other inflicted by a blunt impactor (35J), with no visible damage from the 35J impact (BVID) and visible damage from the 40J impact. Panel 2 was impacted with a sharp impactor (40J) and a blunt impactor (95J). Both impacts caused visible damage to the panel. Subsequently, both panels were inspected by ultrasonic scan to determine the damaged area. The results of the ultrasonic scan are presented in Figures 13 and 14.

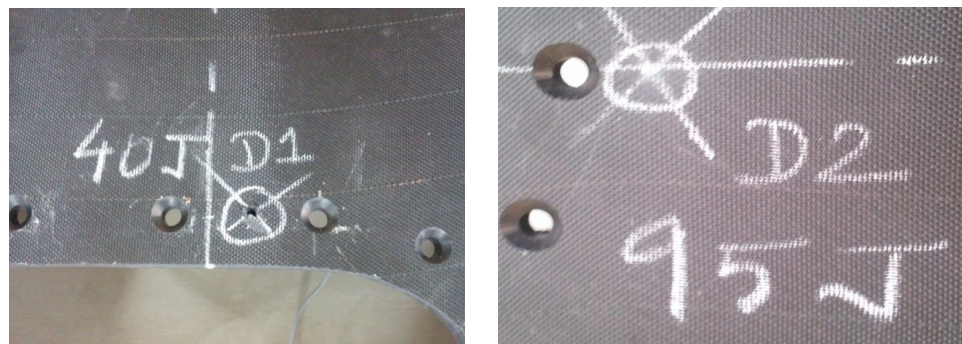
Figure 12. Impact damage on panel 2.

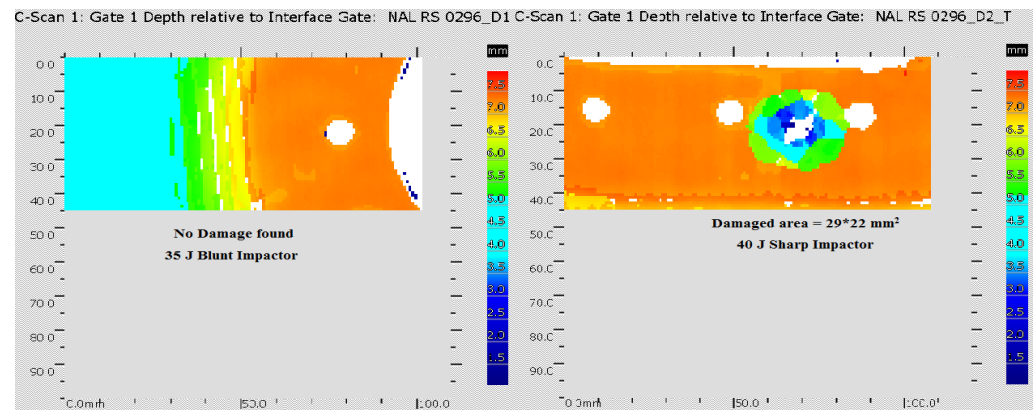
**Figure 13.** Ultrasonic scan of damaged areas in panel 1.

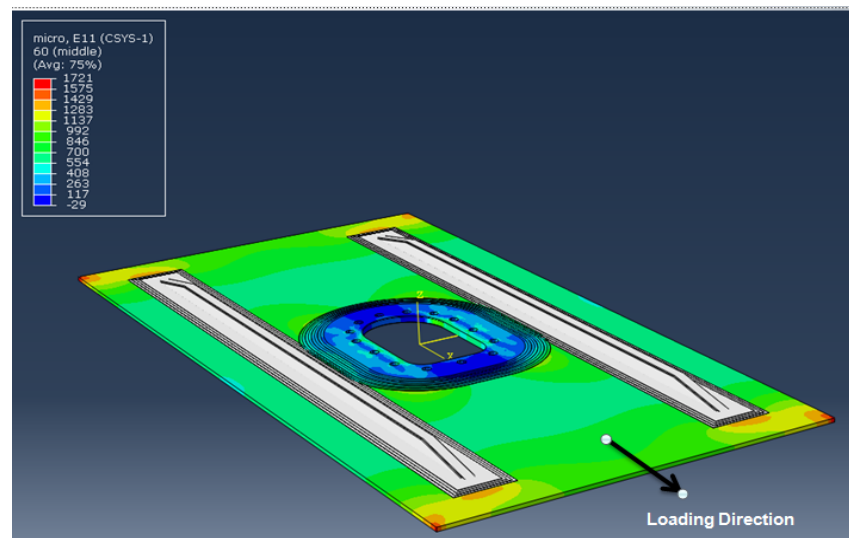
**Figure 15.** Strain distribution in the panel skin under 9000 kgf load: numerical results from Abaqus (V. 6.13).

A finite element model of the panel was created using the FE package Abaqus/Standard. A static tensile load of 9000 Kgf. was applied to the model, and the strain distribution of the panel is obtained (Figure 15). The panel size after trimming off the extra edges was 950 mm × 400 mm. The thickness-related details and the orientation of fiber plies are discussed in Section 2.2. The boundary conditions were precisely designed as the fabricated panel. One end was fixed, and the other end was subjected to tension loading. The material properties, such as Poisson's ratio (0.28) and the density of the composite (2.22 g/cc), were fed to the software for the test. The far-field strains (strains farther from the cutout, which do not have any stress-concentration effect) on the panel were approximately 846 microstrains under this load.

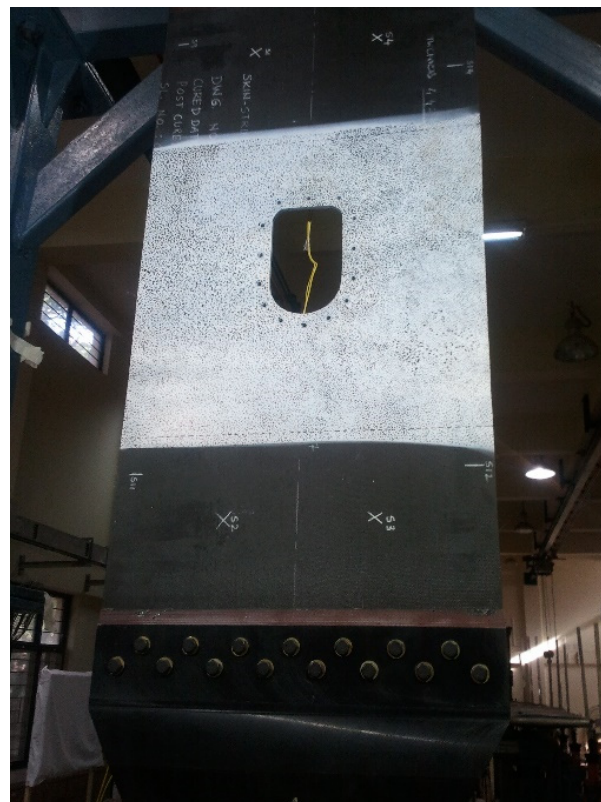
**Figure 16.** Speckling on panel skin for DIC.

Next, the panel was painted white and speckled with black dots on the skin side for implementation of digital image correlation (DIC), as shown in Figure 16. DIC is an optical method that employs tracking and image registration techniques for accurate 2D and 3D measurements of changes in images. It is often used to measure full-field deformations and strains. The advantages of this technique are full-field and non-contact measurements [31]. Eight strain gauges were bonded on the stringer side of the panel to measure strains in the loading direction. The locations of the strain gauges are shown in Figure 17.

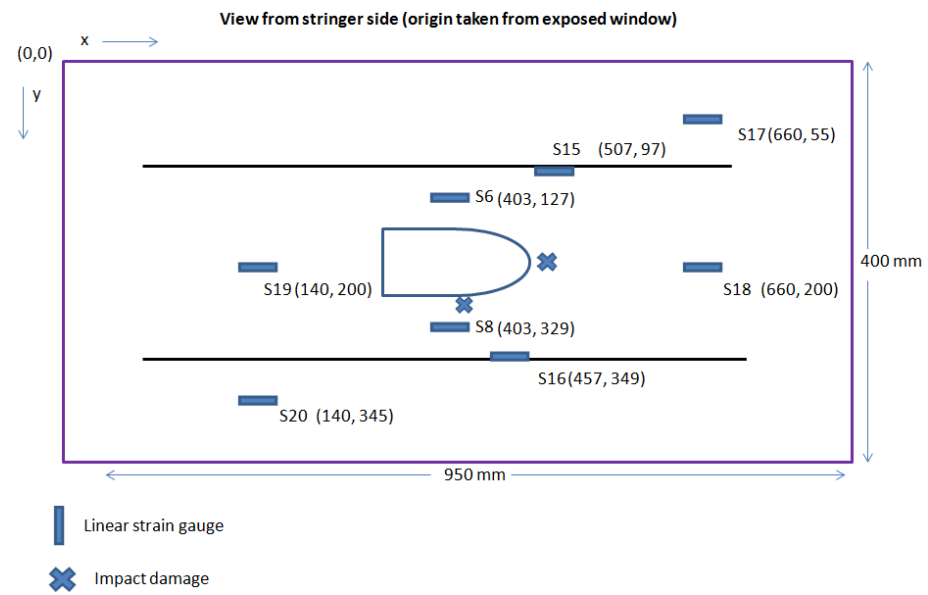
**Figure 17.** Strain gauge locations on the panel (stringer side).

Table 2 presents the strains recorded by strain gages bonded to the panel (on the stringer side) at a load of 9000 kgf. The strains in the corresponding elements in the FE model are also given. As shown in Figure 17, the strain gauges were mounted on the panel, and the corresponding location on the FE model was compared. The strain readings are similar when compared. After the fatigue loading, the panels were analyzed for damage growth, with no change observed in the damaged regions after severe cycles of fatigue loading.

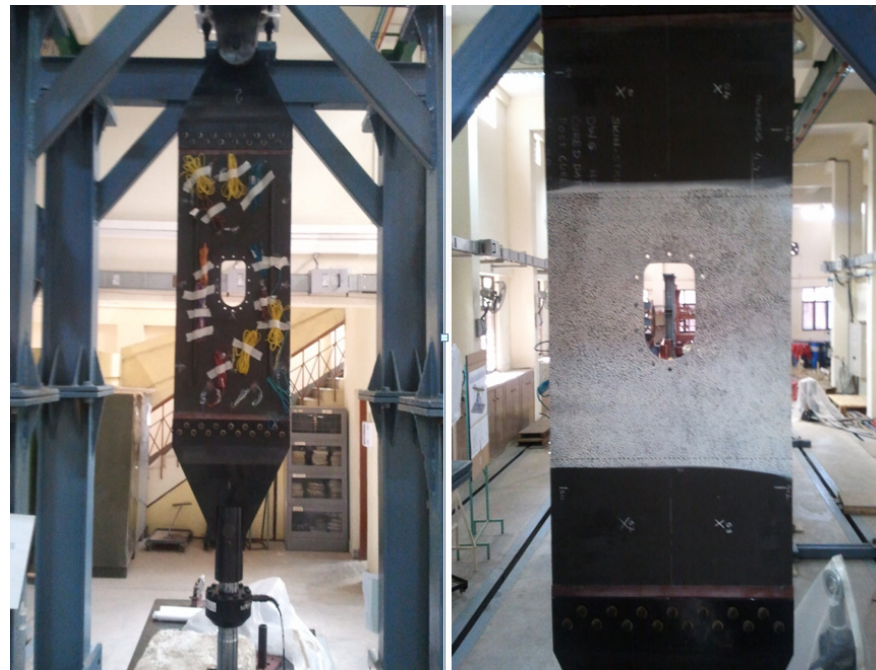
**Figure 18.** Panel subjected to quasi-static tensile loading (front and rear sides).

Next, the panel was subjected to quasi-static tensile loading using a servohydraulic actuator (Figure 18). The load was simultaneously measured by a load cell and strain gauge readings, and DIC images were recorded for post processing.

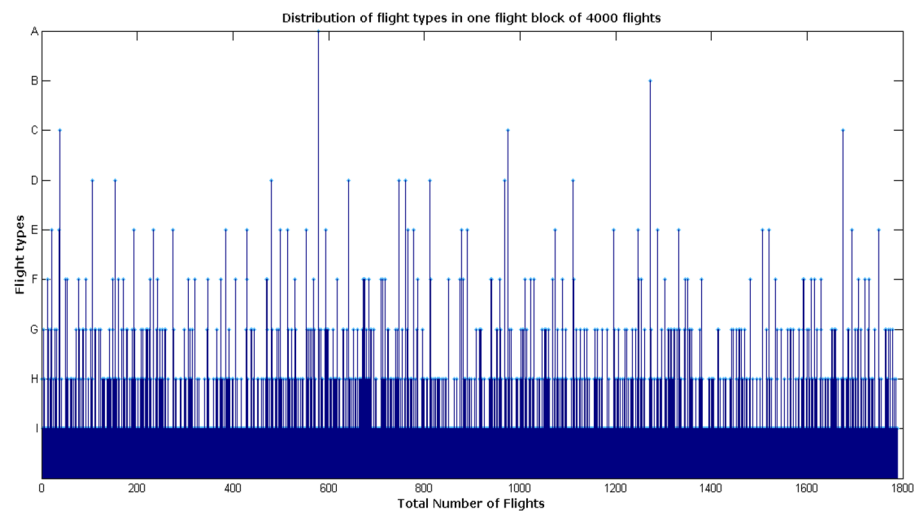
Figure 19. Distribution of flight types in one flight block of 1800 flights (mini-TWIST spectrum).

Table 1 presents the most crucial outcome/feature of the TWIST report: the frequency of each flight type and the frequency of occurrence of each load level within each flight type. A computer program was written in Matlab to randomize the sequence of flights in one block (equal to 40,000 flights). Computer programs were also written to randomize the load sequence within each flight type. Figures 19–21 show the distribution of flight types and load in one block and the load sequences for one flight type, respectively. Load sequences for other flight types are not shown for brevity.

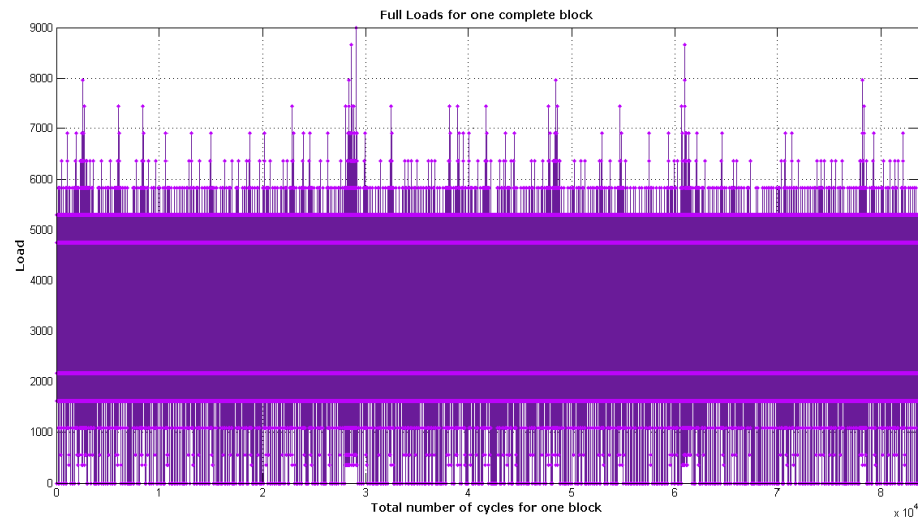
Figure 20. Distribution of loads in one complete block.

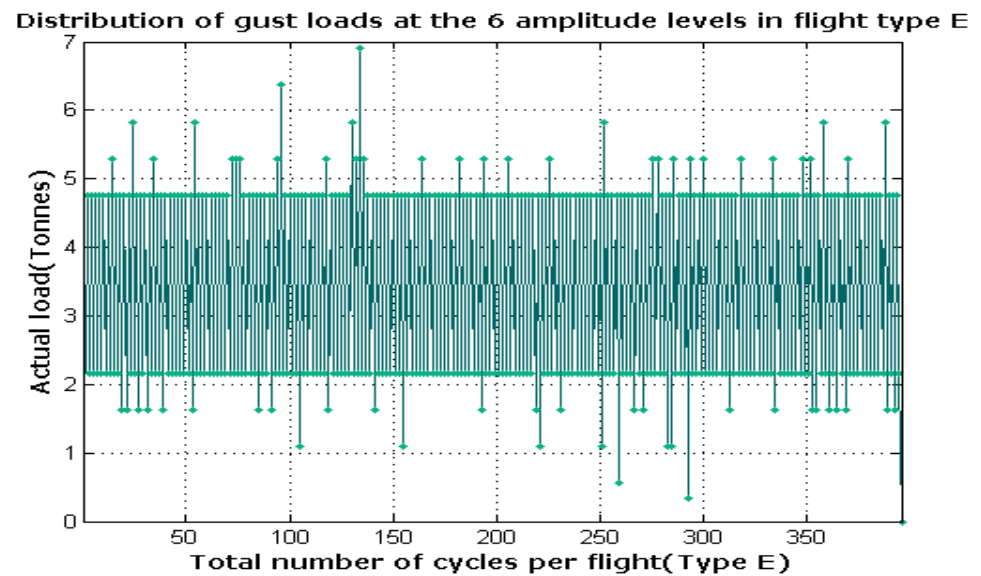
Figure 21. Distribution of loads in flight type E.

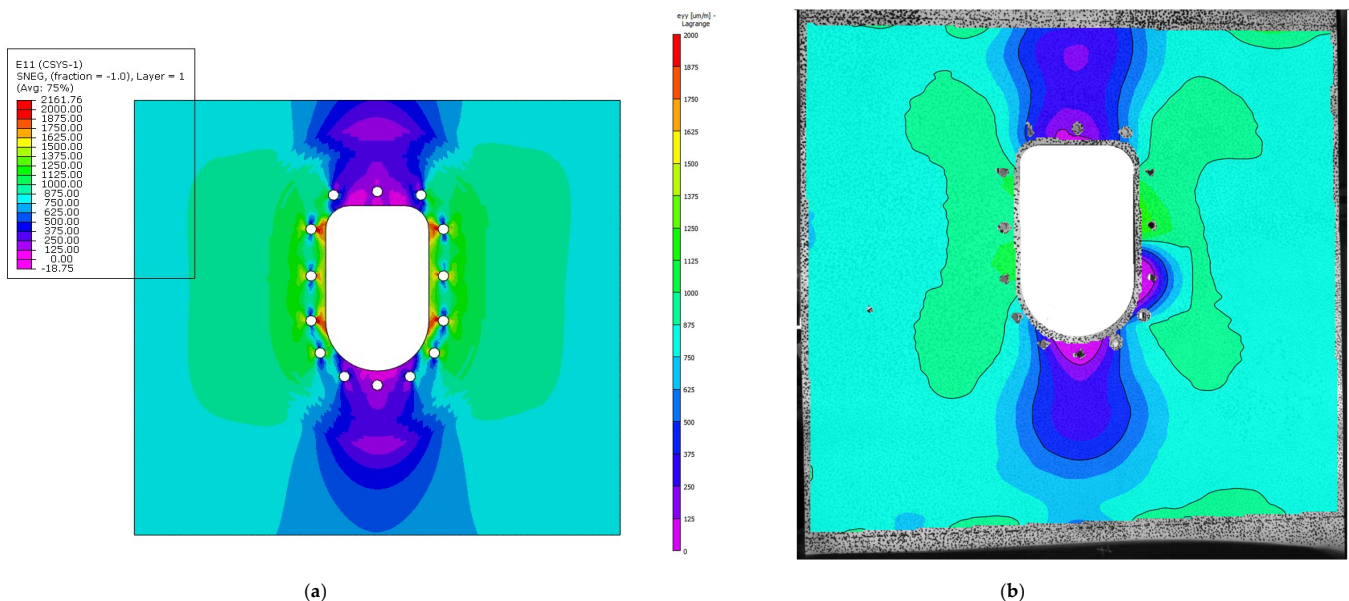
**Figure 22.** (a) Strain contour in the loading direction according FE analysis (9000 kg) and (b) strain contour in loading direction according to DIC (9000 kg).

Figure 22a shows the contours of strain in the loading direction according to FE analysis for the same region of the panel, which is speckled. As expected, strains adjacent to the cutout are higher (stress concentration effect) than far-field strains. Strains immediately in front of and behind the cutout are much lower than far-field strains, owing to the presence of the cutout [35]. Figure 22b shows the strain contours obtained from DIC in the same region. For the sake of comparison, the range of strains in both figures was kept the same, i.e., 0 to 2000 micro strains. Strain distribution according to FE analysis is in agreement with DIC data obtained during the test.

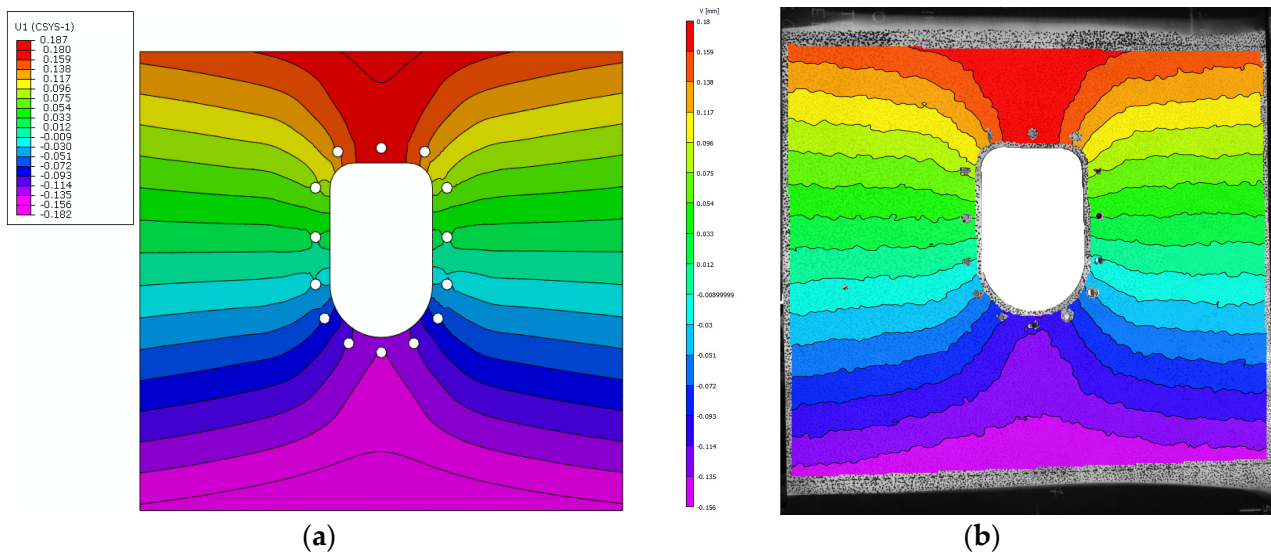
**Figure 24.** (a) Displacement contour in the loading direction according to FE analysis and (b) displacement contour in the loading direction according to DIC.

Figure 24a shows the displacement contours according to FE analysis in the loading direction. Figure 24b shows the displacement contour obtained using DIC in the loading direction. The maximum and minimum displacements were 0.187 mm and  $-0.182$  mm, respectively. Again, analysis and test data are in agreement.
