# An Aging Evaluation of the Bearing Performances of Glass Fiber Composite Laminate in Salt Spray Fog Environment

**Abstract:** The aim of the present paper is to assess the bearing performance evolution of pinned, glass-composite laminates due to environmental aging in salt-spray fog tests. Glass fibers/epoxy pinned laminates were exposed for up to 60 days in salt-spraying, foggy environmental conditions (according to ASTM B117 standard). In order to evaluate the relationship between mechanical failure mode and joint stability over increasing aging time, different single lap joints, measured by the changing hole diameter ( $D$ ), laminate width ( $W$ ) and hole free edge distance ( $E$ ), were characterized at varying aging steps. Based on this approach, the property-structure relationship of glass-fibers/epoxy laminates was assessed under these critical environmental conditions. Furthermore, an experimental  $2D$  failure map, clustering main failure modes in the plane  $E/D$  versus  $W/D$  ratios, was generated, and its cluster variation was analyzed at each degree of aging.

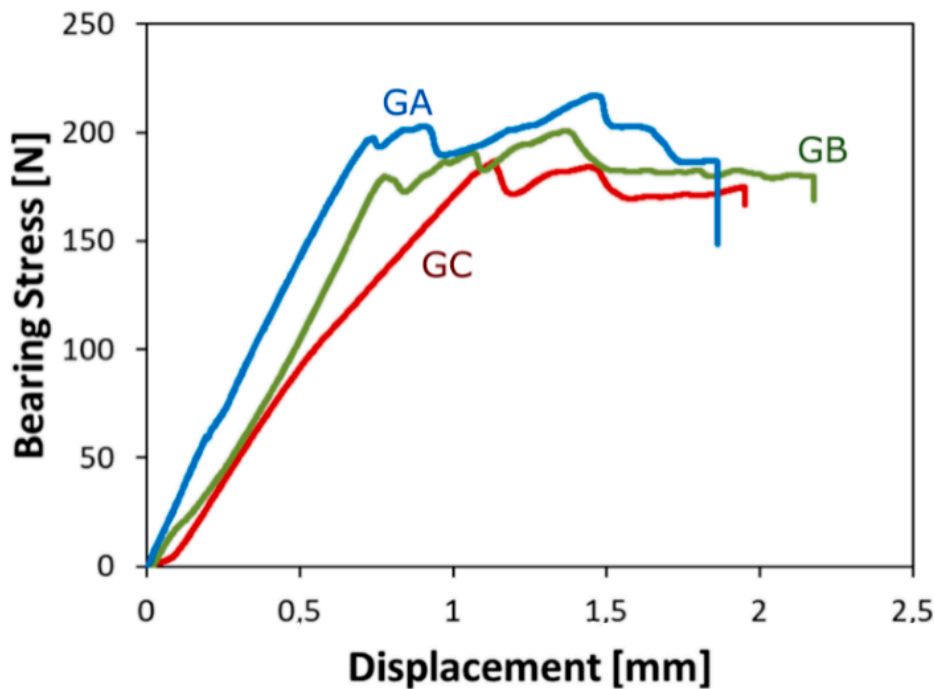
Figure 1 shows the stress versus displacement curves at increasing aging time for pin loaded glass laminates characterized by diameter,  $D = 4 \text{ mm}$ ; width,  $W = 15 \text{ mm}$ ; and edge distance,  $E = 12 \text{ mm}$  (i.e., geometrical ratios  $W/D = 3.75$  and  $E/D = 3.0$ ). Initially, all curves show a linear relationship between stress and displacement. The slope of this trend could be related to the joint stiffness. Afterwards, at increasing displacement, depending on aging time, a gradual deviation from linearity occurs. Finally, all specimens tend to reach a plateau zone at a quite constant stress, beyond which the specimen fails. All the specimens showed a bearing failure mechanism.

**Figure 1.** Stress displacement curves at increasing aging time for pin loaded glass laminates (diameter,  $D = 4$  mm; edge distance,  $E = 12$  mm; width,  $W = 15$  mm).

Due to the applied aging conditions, a slight modification in the stress vs. displacement trend can be evidenced. The unaged glass laminate (sample GA) has good mechanical stability, as identifiable by the acceptable stiffness and strength of the pinned joint. The high stiffness can be argued by the quite stable linear trend in the first part of the curve and by the higher slope in the stress-displacement curve compared to the other batches. Afterward, at about 190–200 MPa, a stress stabilization was reached. A progressive fluctuation in stress at increasing displacement is observed up to reach a maximum stress over 200 MPa, beyond which the failure of the sample occurred. This behavior can be related to the compression collapse of the epoxy matrix just behind the pin/hole contact area.

Instead, analyzing the curve trend on glass laminates aged for increasing exposure time in a salt/fog environment, an evident reduction of their mechanical performances can be shown. A slight reduction of the maximum stress gradually occurs at increasing aging time (about 7% and 14% lower compared to the unaged sample (batch GA) for batches GB and GC, respectively). At the same time, a significant reduction of the linear slope of the curve can be highlighted. This deviation is more sensitive for GC sample where a gradual deviation from linearity can be observed at low stress level. E.g., a stress threshold of about 100 MPa can be identified for GC sample, after which a deviation from the linear trend becomes sensitive. It is widely known that glass-fiber reinforced composites gradually absorb water under salt/fog exposure. This favors softening phenomena of the matrix; thus, leading to the decrease of composites mechanical properties [21,22]. In addition, the loss of fiber-matrix adhesion due to the physical and chemical effects of water molecules on both fibers and the fiber-matrix interface contributes a lot to the deterioration; i.e., the limited capability of the interface area to transfer the stresses implies an irreversible reduction of both strength and stiffness of the aged composites.

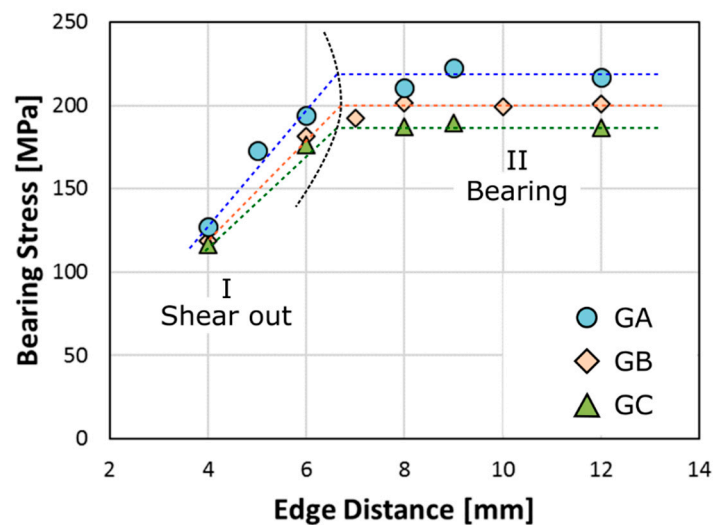
Further information can be acquired by evaluating the maximum bearing stress evolution at increasing edge distance,  $E$ , for pin loaded laminates with hole diameter  $D = 4$  mm and width  $W = 15$  mm ( $W/D = 3.750$ ) for all batches (Figure 2). A gradual increase of the maximum bearing stress ( $\sigma_b$ ) occurs with an increasing  $E/D$  ratio until a critical threshold value can be observed, accordingly to previous results [23,24].

**Figure 2.** Bearing stress evolution at increasing edge distance,  $E$ , for pin-loaded laminates with hole diameters  $D = 4$  mm and widths  $W = 15$  mm ( $W/D = 3.750$ ) for all batches.

In the experimental evolution of the curves, a bilinear trend has been identified. Each segment can be attributed to a specific and distinct fracture mechanism. In particular, the triggering of damage phenomena related to shear out fracture mechanisms are favored at low edge distance (region I). This phenomenon occurs considering the high stress level generated in the region just behind the pin contact area. This area is very restricted (edge distance,  $E$ , is in the range 4–6 mm), stimulating localized stress that activate a catastrophic shear fracture at very low stress values. This fracture mechanism is strongly dependent on the distance of the hole center from the laminate edge. This is confirmed by the high slope of the linear trend in this region, for which it is clear that there is a significant increase in bearing stress due to a slight increase of distance  $E$  ( $\sigma_b$  increase about of 50%, for all batches due to an increase of  $E$  distance from 4 toward 6 mm). A slight reduction of the slope of the shear out trend can be identified at increasing aging time. Although the reduced diameter of the pin (4 mm) significantly exalts the stress concentration in the pin/hole contact area stimulating the bearing failure mechanism [12].

Afterward, for edge distance higher than 6–8 mm (i.e.,  $E/D > 1.5$ –2.0) the bearing stress reaches a plateau (region II). In this region, the prevailing failure mechanism is bearing mode [10] and, for this reason, the stress value reached is indicated as bearing stress at failure. As can be seen from the horizontal trend of the curve of the region II, the bearing stress is also independent by  $E$  and remains almost constant at increasing the edge distance. For this joint configuration, as clarified also in Figure 1, a progressive compression collapse of the composite laminate just behind the pin-hole contact area takes place.

At the same time, it is possible to point out that the maximum stress gradually decreases with increasing aging time. GB and GC batches exhibit a lower bearing stress than the unaged one. In particular, after two months of aging in salt fog environment, a failure stress reduction of 16% can be identified in comparison to unaged samples (about 220 MPa and 185 MPa, for GA and GC, respectively).

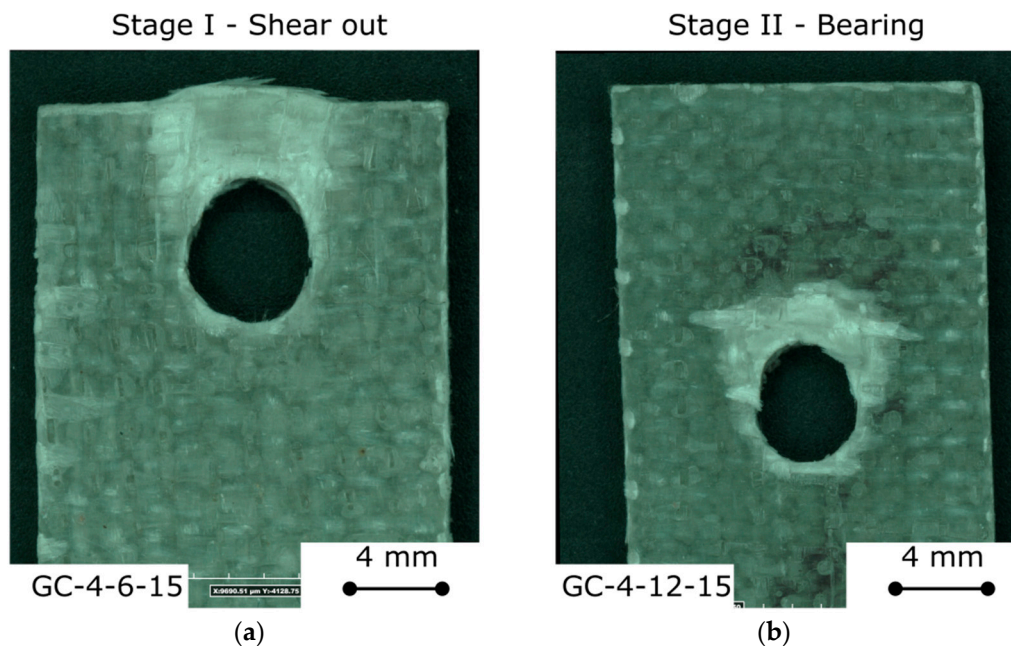
**Figure 3.** Fracture images of (a) GC-4-6-15 (b) GC-4-12-15 samples.

The fracture image of GC-4-6-15 sample, used as reference sample of stage II damaging for shear out, is reported in Figure 3a. In the upper section of the joint toward the free its edge a shear crack longitudinally propagated along the applied load direction are clearly identified. This premature damage mechanism was triggered due to the proximity of the hole from the sample free edge that significantly reduced the shear out resistance limit for this type of joint geometry.

The fracture image of GC-4-12-15 sample, used as reference sample of stage II damaging (i.e., bearing) is reported in Figure 3b. The sample shows a large and localized compression collapse area on the pin/hole contact surface area due to the occurrence of bearing failure mode. Moreover, it was shown that some kink bands evolve radially from the hole edge, thus indicating a progressively extension of the damaged zone and favoring the laminate collapse through damage mechanisms such as delamination [25]. Furthermore, the kink bands induce local deformations at the fiber-matrix interface thus activating secondary failure premature modes [26]. As a consequence, a mixed damage process due to fiber plies kink bands, shear cracks and layers interface delamination evolve to large-scale delamination phenomena, reducing the joint's mechanical stability [10]. The softening of the epoxy matrix due to the water absorption, favors the formation of a large compression collapse area on the pin/hole contact surface area without the occurrence of shear cracks. As already shown by Malmstein et al. [27], the failure mechanism of composites becomes more ductile after hygrothermal aging due to the long time exposure under salt/fog, reducing the occurrence of cracking phenomena, and at the same time, favoring the fiber/interface through dominated fracture.

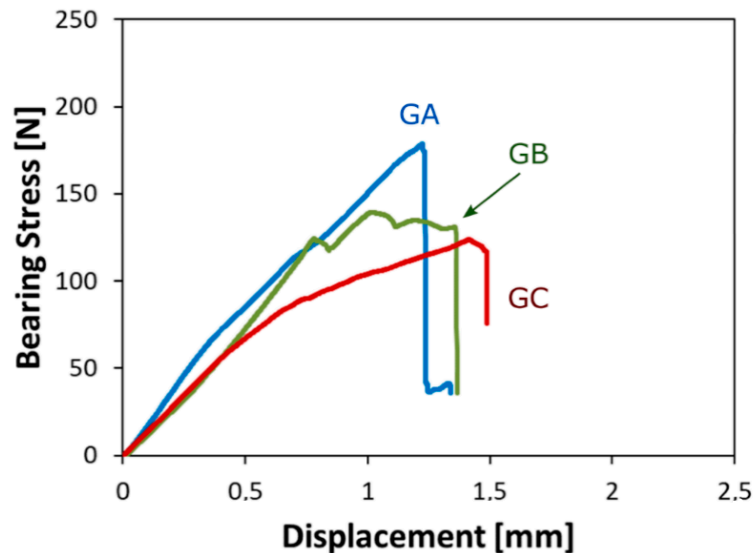
Figure 4 shows the stress versus displacement curves for all batches with diameters and edge distances 8 mm and 14 mm, respectively. It is possible to note that at varying aging cycles, the maximum stress gradually decreases. In particular, reductions of 19% and 28% were observed for batches GB and GC, respectively, due to the salt/fog exposure.

**Figure 4.** Stress displacement curves at increasing aging time for pin loaded glass laminates ( $D = 8$  mm;  $E = 14$  mm;  $W = 15$  mm).

At the same time, a softening effect, due to salt/fog aging, can be argued by evaluating the reduction of the bearing stress/displacement slope at low displacements (indirectly associated to the pinned joint stiffness). In particular, after 60 days of aging (sample GC-8-14-15), the glass composite laminate is characterized by a maximum bearing stress of 123.8 MPa, compared to the GA-8-14-15 unaged sample that showed a bearing maximum stress of 171.1 MPa. Furthermore, a slight increase of the displacement at failure can be observed comparing aged and unaged samples, although this variation can be considered not mechanically significant. After 60 days of aging GC sample showed a displacement at failure about 25% longer than GA-unaged one.

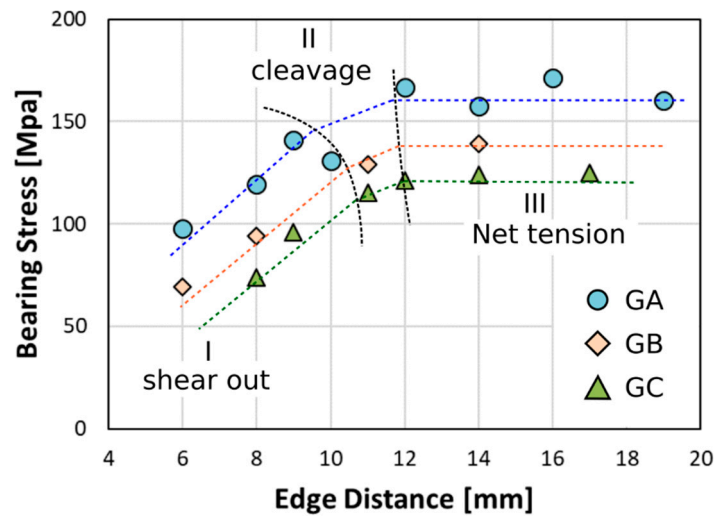
Further information can be argued evaluating the bearing stress evolution at increasing edge distance for pin loaded laminates with a hole diameter  $D = 8$  mm and width  $W = 15$  mm ( $W/D = 1.875$ ) for all aged batches (Figure 5). At short edge distance,  $E$ , a premature fracture occurs at a low stress level, due to shear out mechanisms regarding the limited distance of the hole from the specimen free edge. Afterwards, the bearing stress gradually increases at increasing the edge distance up to 8–10 mm. Above this threshold, a slight change in the slope trend can be shown for all batches. In this region, a main cleavage fracture mode takes place. Finally, for an  $E$  over 12 mm ( $E/D > 1.5$ ), the net tension mode becomes the predominant failure mechanism and the bearing stress trend reaches a plateau region (stage III).

**Figure 5.** Bearing stress evolution at increasing edge distance,  $E$ , for pin-loaded laminates with hole diameters  $D = 8$  mm and widths  $W = 15$  mm ( $W/D = 1.875$ ) for all batches.

As is widely known [12,35], cleavage can be considered as a mixed mode between shear out and net tension because it is caused by a combination of shear and tensile stress out [12]. Frequently, it starts from the laminated edge rather than in the area surrounding the hole [5]. Due to the catastrophic nature of shear out and net tension mode, cleavage can also be considered a premature and sudden fracture mode, leading to noticeable and abrupt reduction of the joint load capacity. Moreover, it is worth noting that when a pinned laminate fails through this mixed mode, the mechanical strength of the joint is still influenced by edge distance ( $E$ ), even if a lower slope variation can be observed in comparison to the slope variation found in the shear out region.

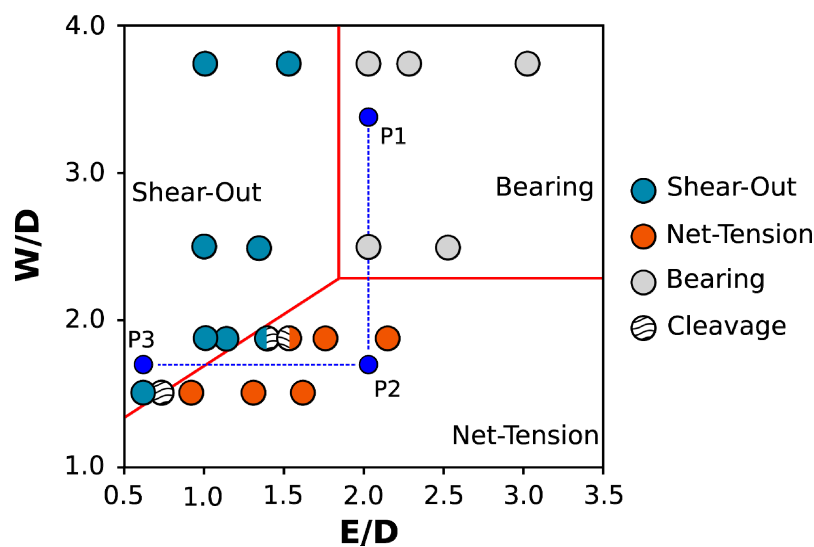
In order to better assess the effect of the joint geometry modification on the failure mechanisms of the pinned joint, a 2D topological failure map of the GC aged glass composite laminates (aged for 60 days in the salt/fog environment), at varying  $E/D$  and  $W/D$  ratios ( $x$ - and  $y$ -axes, respectively), is shown in Figure 6. To better evidence the representative groups of each failure mode, a specific marker color was applied for each observed failure mechanism. Combined color markers are related to mixed failure modes.

**Figure 6.** Failure mechanisms in  $E/D$  versus  $W/D$  plot for GC (60 day) batch.

The bearing fracture, gray circle marker, becomes the main failure mechanism for high  $W/D$  and  $E/D$  ratios (see point P1 in Figure 6). Although, due to a reduction of  $W/D$  ratio, maintaining the constant  $E/D$  ratio (this is achievable making a larger diameter, but keeping the distance of the hole from the edge,  $E$ , constant) at point P2 was where a net-tension fracture occurred. In particular, a transition from bearing to net tension failure mode can be highlighted at about  $W/D = 2.2$ . When hole diameter  $D$  is increased, maintaining at the same time-constant laminate width  $W$ , the reduced cross section induces a higher stress concentration. That, in turn, favors a premature fracture of the sample through net tension mode afterward, inducing a reduction of  $E/D$  ratio, and keeping constant the  $W/D$  ratio (this is achievable applying a lower edge distance, preserving a constant diameter). Then, point P3 is reached, where a premature fracture due to shear-out mechanisms was observed. Indeed, lowering the  $E$  value, and keeping constant the other joint geometrical parameters (i.e.,  $D$  and  $W$ ), makes the distance of the hole from the sample's free edge decrease. The reduced shear cross section favors a premature shear out fracture, even if a mixed mode (i.e., cleavage) can be observed, as evidenced by the transition region at the boundary between net tension and shear out fracture mechanics [5]. When this combined fracture mechanism happens, it means that neither net tension nor shear out mode is predominant [5,12].

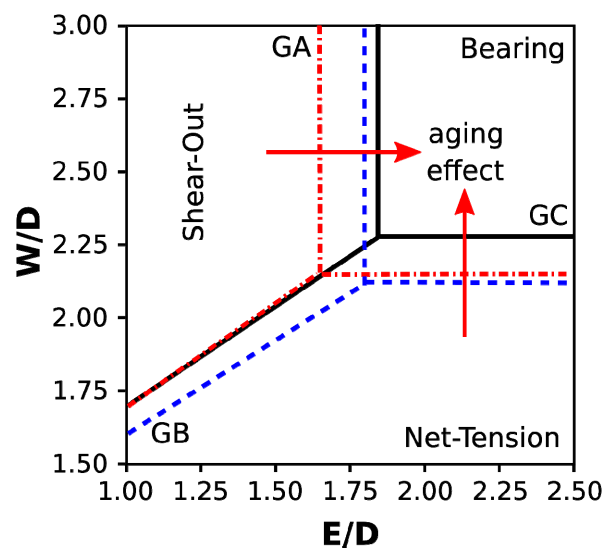
Relevant information on how the salt and mist chamber's aging conditions affect the damage to fiberglass joints can be traced by correlating the evolution of fracture line transitions at varying aging times. In this sense, Figure 7 shows the failure map in the  $E/D$  versus  $W/D$  plot for the pinned-glass composite joints with increasing aging time.

**Figure 7.** Failure map in  $E/D$  versus  $W/D$  plot for pinned-glass composite joints over increasing aging time.

The composite laminate degradation, imposed by the critical salt/fog environment to which it was subjected, led to a gradual reduction of the bearing region, located in the upper right corner of the map. In particular, for GA samples (unaged specimens), the bearing region was identified in the  $E/D$  and  $W/D$  ratios 1.64 and 2.15, respectively. Instead, as previously discussed, due to 60 days of aging in a salt/fog environment, those threshold values increased up to 1.84 and 2.28 respectively. This indicates that a reduction of threshold geometrical ratio of about 10% can be identified for glass composite joints aged in the critical environmental conditions.

After only 30 days of aging (blue straight lines, GB batch), the  $W/D$  threshold that defines the transition between net tension and bearing is almost constant compared to unaged one (i.e., from 2.15 to 2.12). Instead, a relevant modification of  $E/D$  threshold ratio can be observed (about 9%, from 1.64 to 1.80). This indicates that shear-out is the mechanism of fracture that is most affected by critical environmental conditions at short aging times. In fact, analyzing this region for the GA and GB batches shows that a significant increase in its area occurs. This behavior was due to a significant reduction in the fiber/matrix interfacial adhesion, which favors the triggering and propagation of shear cracks in heavy stressed areas.

A further increase in the aging time up to 60 days (i.e., GC batch) favors a net-tension fracture. In this case, long aging time stimulates high water adsorption by glass-fibers, which progressively degrade [29,39,40]. Due to the low hydrophilic behavior of glass-fibers, the high sorption phenomena are triggered by preferential pathways at the fiber/matrix interfaces, induced by debonding, delamination or matrix swelling [31,41,42]. It is worth noting that, initially, the degradation phenomena act at the fiber/matrix interface, causing mainly, a shear-out resistance decrease. Subsequently, due to long aging times, the degradation phenomena more effectively affect the net-tension mechanism. Therefore, the predisposition of the aged joint for these two fracture mechanisms (shear-out and net-tension) takes place, reducing the effective bearing region claimed in the joining design phase.
