Study on the Corrosion Behavior of Graphite Materials in Molten CuSn Alloy

Abstract: Graphite, a critical material for furnace walls, is pivotal to the reliability of the carbon-free hydrogen production industry through methane pyrolysis catalyzed by molten metals. This study systematically investigates the corrosion behavior of molten CuSn alloy on three typical commercial graphite materials—low-density graphite (LDG), high-density graphite (HDG), and pyrolytic graphite (PyG)—with a focus on their corrosion resistance and the underlying mechanisms responsible for graphite corrosion over a period of up to 1000 h at 1100 °C. The experimental results show that LDG suffered the most severe corrosion, with a mass loss of up to 60.09% and a hardness decrease from 0.73 GPa to 0.17 GPa, whereas PyG demonstrated the best corrosion resistance, with only a 5.64% mass loss and a hardness drop from 0.52 GPa to 0.35 GPa. SEM and XRD analyses revealed that the porous structures of LDG and HDG suffered significant macroscopic corrosion, caused by the stress from molten metal infiltration and aggregation in the pores, leading to structural collapse. Interestingly, all three types of graphite, inc

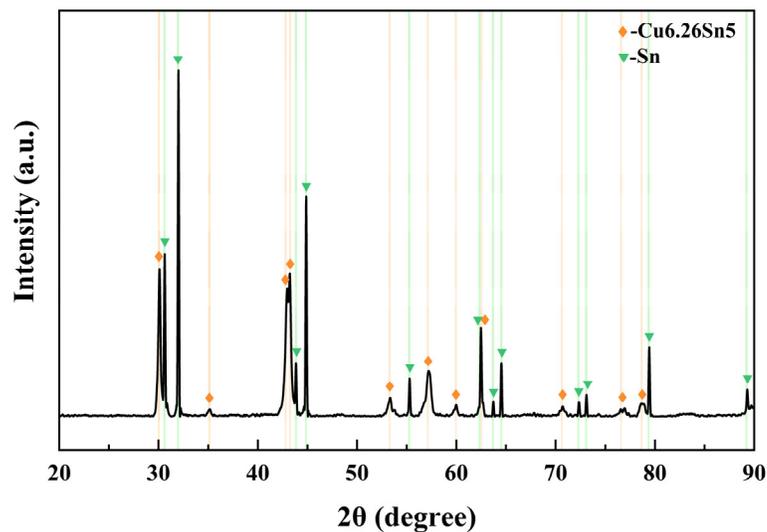
**Figure 1.** XRD pattern of the alloy prepared by melting copper granules and tin blocks in a molar ratio of 1:1.

The performance indicators of the LDG, HDG, and PyG used in this study are presented in Table 1. The three graphite samples were cut into sheets, with LDG and HDG having a 2 ± 0.1 mm thickness and PyG being 1 ± 0.05 mm thick. The CuSn alloy used in the experiment had a molar ratio of 1:1 and a melting point of approximately 620 °C from the phase diagram. The alloy was prepared by heating and melting 99.999% pure copper granules and 99.999% pure tin blocks in a ZHGP-30 integrated smelting furnace. After thorough mixing, the metal melt was poured into a mold to cool, forming the required experimental block. The oxide layer on the surface was removed using a grinding wheel. The block was ultrasonically cleaned in distilled water for 10 min and then placed in a drying oven for further use. Figure 1 shows the X-ray diffraction pattern of the CuSn alloy at room temperature. The diffraction results indicate that the alloy consists of metallic Sn and the intermetallic compound $\text{Cu}_{6.26}\text{Sn}_5$, with no other impurities present.

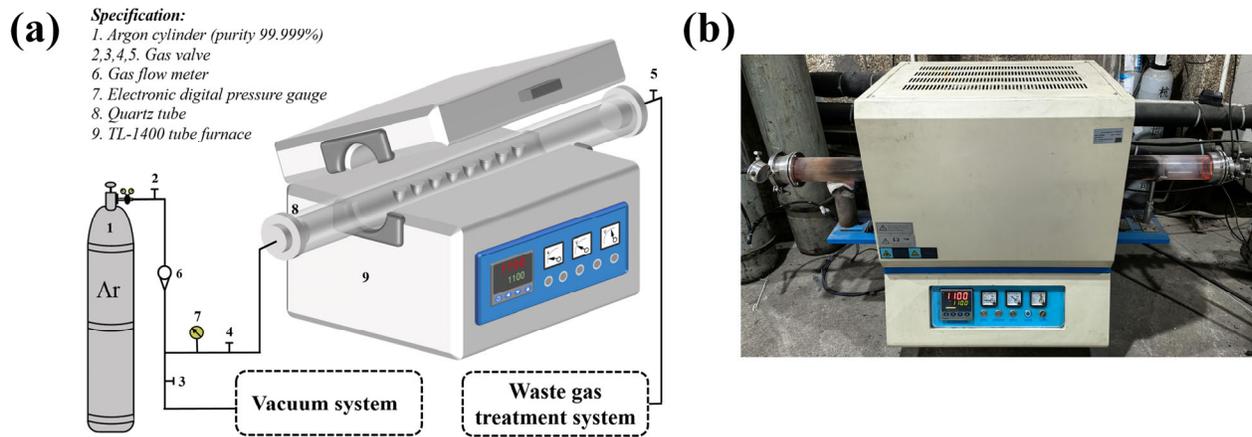
Figure 2. (a) Schematic of the experimental setup. (b) Photograph of the actual experimental apparatus.

The graphite corrosion test was conducted in a tube furnace, as depicted in Figure 2. As the temperature for catalytic methane decomposition with molten CuSn alloy typically ranges from 800 °C to 1100 °C, the compatibility test was performed under the extreme condition of 1100 °C. Prior to the test, the three graphite samples were ultrasonically cleaned in deionized water for 10 min, dried, and weighed. The samples were then placed with 30 g of CuSn alloy blocks in a truncated cone-shaped corundum crucible and inserted into the tube furnace for testing. Before heating, the gas in the tube was replaced three times with ultra-high purity Ar, and the chamber was evacuated to below 10⁻³ Pa. Ultra-high purity Ar was then refilled to 30 kPa above standard atmospheric pressure. This step aimed to maintain an oxygen-free environment in the container and simulate the pressure conditions for methane pyrolysis. This experiment aimed to investigate the compatibility of graphite materials in molten CuSn alloy; therefore, the effect of reactive gasses such as methane was not considered. Additionally, to study the effect of exposure time on the corrosion of graphite, six samples of each type were prepared for tests lasting from 0 to 1000 h. Samples were collected every 200 h for testing. After each sampling, a perforated crucible was used as a funnel, and the samples were heated to 750 °C under experimental conditions to melt the metal, allowing it to drip off and separate from the graphite. Finally, the graphite samples were ultrasonically cleaned in deionized water for 10 min and dried under argon for subsequent characterization.

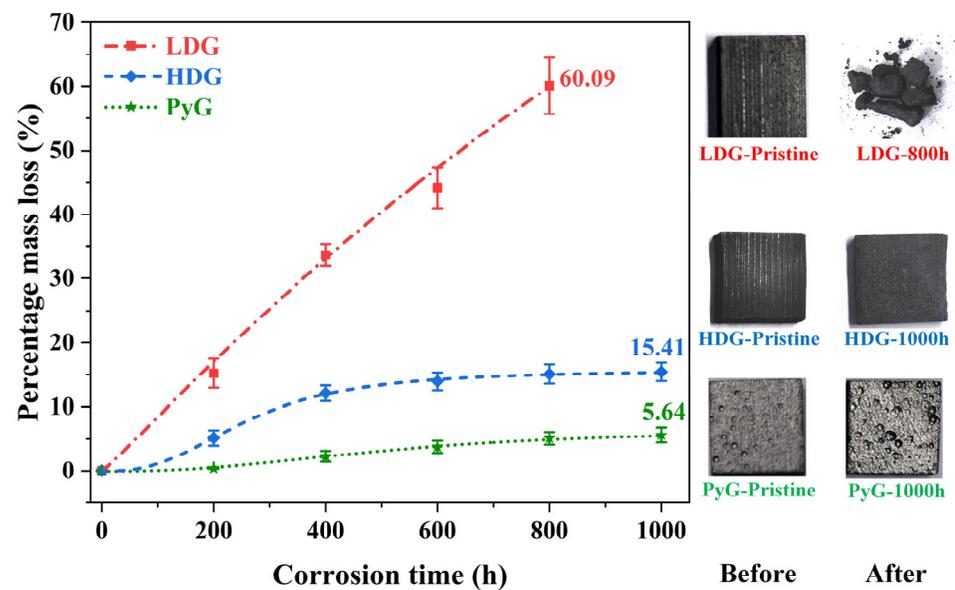
Figure 3. Percentage mass loss of graphite samples after exposure to molten CuSn alloy at 1100 °C for various durations, accompanied by photographic images of selected samples.

where m_0 and m_x represent the mass of the graphite sample before corrosion and after x hours of corrosion, respectively. The results are shown in Figure 3, where each data point represents the average weight of multiple measurements at the corresponding contact time for all samples. Two phenomena contribute to the measured mass change: (1) an increase in mass from molten metal infiltration into the pores and retention within the graphite, and (2) a decrease in mass due to the detachment of carbon particles from corrosion. The results show that the percentage mass loss for LDG (powder after 800 h) and HDG (after 1000 h) reached 60.09% and 15.41%, respectively, while PyG (after 1000 h) had only 5.64%, corresponding to the observed shedding of carbon particles from the graphite surface.

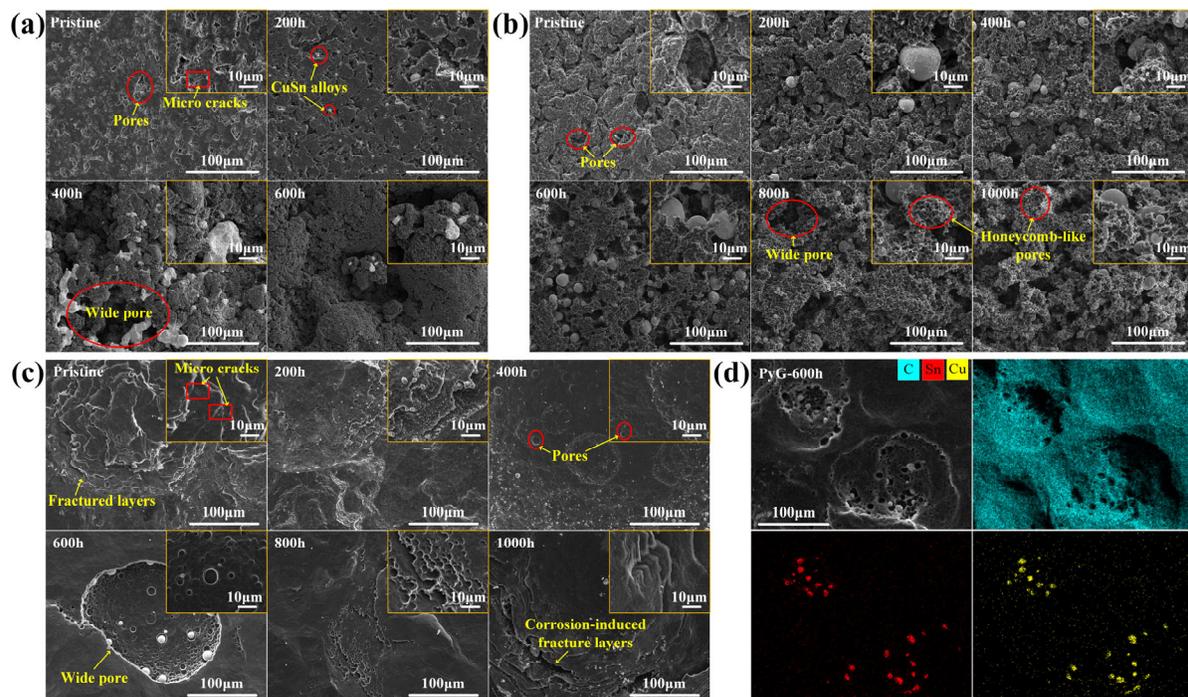
Figure 4. SEM images of (a) LDG, (b) HDG, and (c) PyG samples after exposure to molten CuSn alloy at 1100 °C for different durations. (d) Mapping images of PyG-600h sample.

Figure 4 shows SEM images of the graphite surface before and after corrosion by molten CuSn alloy. LDG and HDG are fabricated by applying uniform high pressure to compress graphite powder. As a result, the surface of the pristine sample typically contains numerous pores and microcracks, as shown in Figure 4a,b. These features serve as active sites for molten metal infiltration and subsequent graphite corrosion. According to Zhao He et al. [19], molten metal penetration into graphite is influenced by porosity, temperature, pressure, and exposure time. Under identical temperature and pressure conditions, the degree of metal penetration positively correlates with both graphite porosity and exposure time. For both LDG and HDG, the pores and microcracks on the graphite surface were filled with metal particles after the corrosion experiment, and the carbon particles were detached from the graphite surface, resulting in the expansion and deepening of the surface pores. LDG exhibited the most severe corrosion damage, with wide pores caused by corrosion clearly visible on the sample after 400 h of corrosion, as depicted in Figure 4a. In contrast, HDG experienced less corrosion damage than LDG due to its superior density and lower porosity, with wide pores forming later on its surface.

After 800 h, the surface of HDG developed a honeycomb-like porous structure. PyG exhibits a high degree of graphitization and a nearly non-porous layered structure due to its chemical vapor deposition (CVD) manufacturing process. However, defects in the manufacturing process introduced local fracture layers and microcracks in PyG, which serve as active sites for the corrosion of molten CuSn alloys. The corrosion of PyG is non-uniform. At the surface structural defects, corrosion forms regional pores or even fracture layers, as shown in Figure 4c. Additionally, the corrosion on the PyG surface is uneven, as illustrated by the SEM image of a larger area in Figure 5. Wide pores readily form at fracture layers or micro-crack sites on the sample, while the corrosion at flat, defect-free areas is significantly less severe.

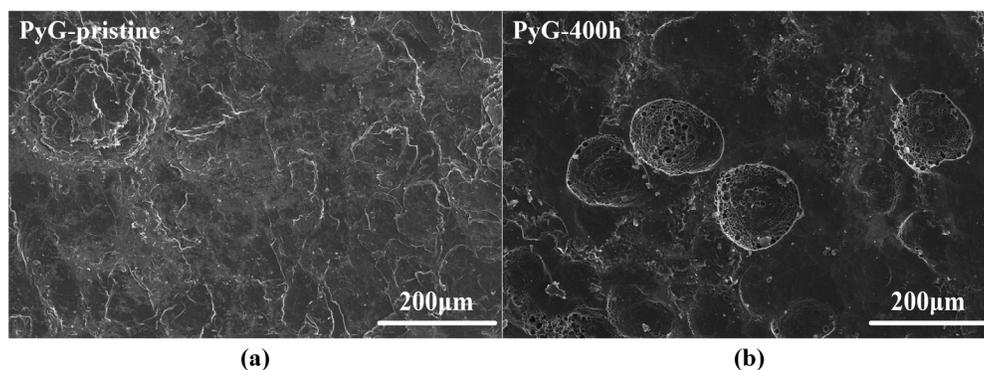
Figure 5. SEM images of PyG surface with a magnification of 500×. (a) Before corrosion and (b) after 400 h of corrosion.

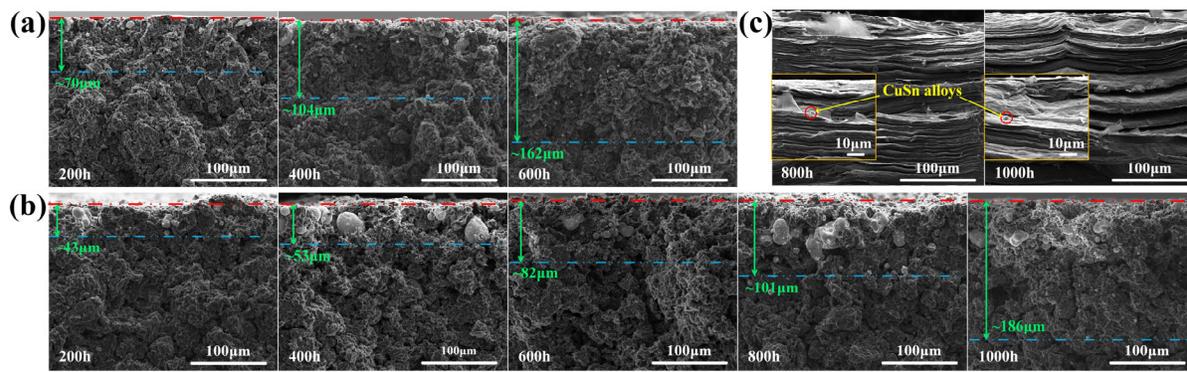
Figure 6. Cross-sectional SEM images of graphite samples after exposure to molten CuSn alloy at 1100 °C for different durations. (a) LDG, (b) HDG, (c) PyG. The green number in the figures represents the approximate maximum depth of the internal metal particles from the contact surface.

The cross-sectional SEM images of the three graphite samples after corrosion are shown in Figure 6. The maximum depth of the internal metal particles from the contact surface is marked in the figures. The penetration depth of the molten CuSn alloy into LDG

and HDG increased with exposure time. After 600 h, the maximum metal penetration depth in LDG was approximately 162 μm , whereas in HDG, it was about 82 μm , roughly half of that in LDG. After 1000 h, the metal penetration depth in HDG reached approximately 186 μm . In the LDG and HDG samples, a significant amount of large metal particles accumulated in the near-surface layer, where the graphite suffered more severe corrosion, resulting in the fragmentation of graphite particles into finer pieces or even powders. Fewer metal particles and less pronounced corrosion were observed in the deeper regions, farther from the surface. The nearly non-porous layered structure significantly prevents the penetration of molten CuSn alloy into PyG. Even after 1000 h of exposure, corrosion-induced pores only form at the outermost structural defects. No metal particles or signs of corrosion were observed in the far surface layers. This suggests that the faultless layered graphite structure can effectively hinder the penetration of the molten CuSn alloy into the deeper graphite layers.

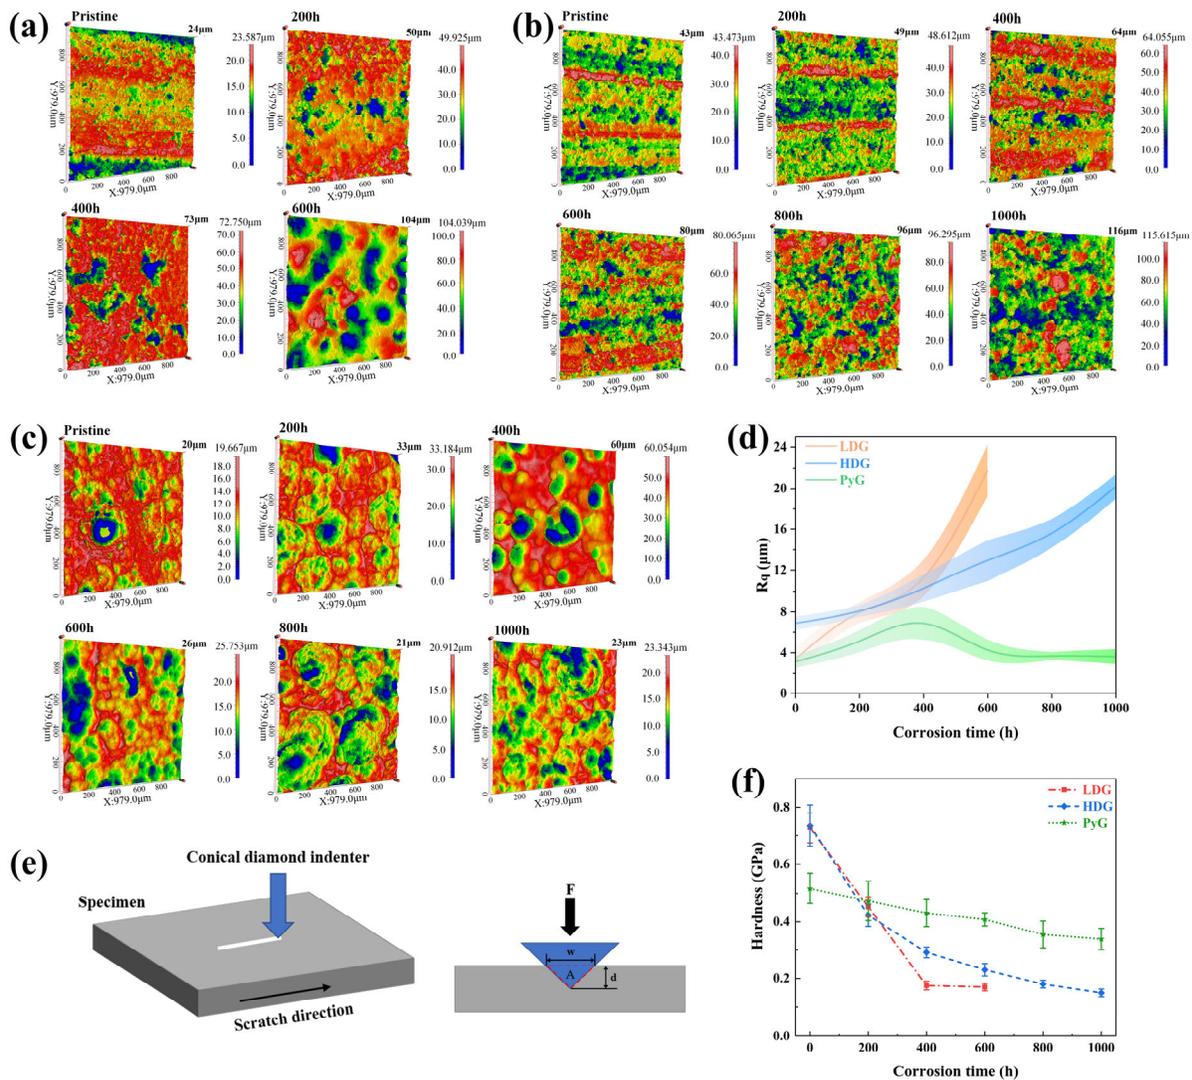
Figure 7. (a–c) 3D optical profilometry maps of LDG, HDG, and PyG. (d) R_q of the three graphite samples. (e) Schematic representation of the scratch acquisition process for graphite samples. (f) Scratch hardness of the three graphite samples.

where Z_i represents the height of each point, \bar{Z} is the average height of all points, and n is the number of data points in the image area. The total height of the profile (R_t) was indicated directly above the right scale in the 3D optical profilometry map in Figure 7a–c. To minimize the influence of measurement location, measurements were taken at the sample center and five surrounding areas, and the values were then averaged.

The 3D optical profilometry map shows that all three graphite samples were corroded by molten CuSn alloy, causing significant surface defects. Morphologies of LDG and HDG show that corrosion caused the detachment of graphite surface layers as carbon particles, leaving wide pores. PyG appears to have undergone pitting corrosion by molten CuSn alloy, with larger and deeper pore defects forming at the surface. These morphological characteristics are aligned with those observed by SEM. The R_q of the samples is presented in Figure 7d. After 1000 h of corrosion by molten CuSn alloy, the roughness of all three graphite samples increased. The roughness of LDG and HDG continued to increase with exposure time, while PyG's roughness initially increased and then decreased, likely

where H_s is the scratch hardness, F is the applied load, and A is the area of the scratch groove cross-section, which was approximated as an isosceles triangle during calculations. The results of the scratch hardness calculations are shown in Figure 7f. The hardness of LDG decreases most rapidly with increasing exposure time, indicating the most significant reduction in mechanical properties. Compared to the LDG-400h sample, the LDG-600h sample exhibits a little change in hardness, primarily due to the exfoliation of the carbon particles caused by severe surface corrosion of the graphite matrix. Small graphite flakes were observed splattering during scratch acquisition in PyG, resulting in higher scratch width and depth measurements and lower hardness values. However, PyG exhibited the slowest rate of hardness decay, demonstrating its superior ability to maintain mechanical properties under corrosion by molten CuSn alloy. The hardness degradation of HDG was intermediate between that of LDG and PyG. The scratch hardness test of graphite shows that corrosion by molten CuSn alloy degrades its mechanical properties. The extent and rate of mechanical property degradation significantly affect the application of structural materials. The high degree of graphitization, layered structure, and high density of PyG enhance its long-term resistance to penetration and corrosion by molten CuSn alloy. The manufacturing method of HDG is identical to that of LDG, and its low porosity, which corresponds to high density, leads to a slight improvement in corrosion resistance after the same corrosion period.

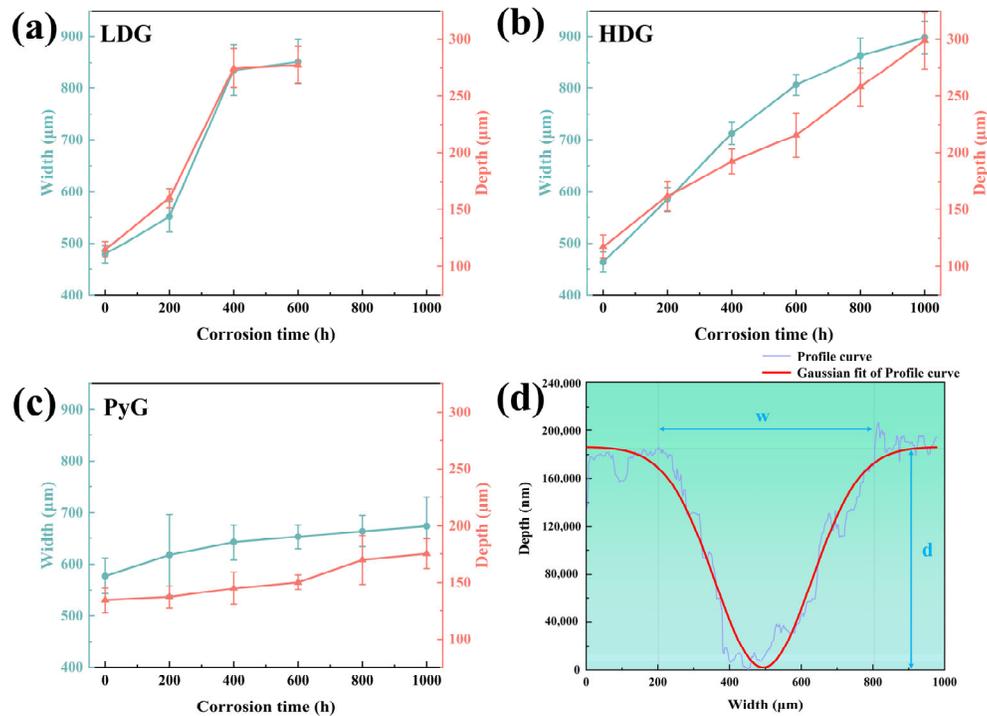
Figure 8. (a–c) Width and depth of scratches on the corroded surfaces of LDG, HDG, and PyG samples, respectively. (d) Example of a scratch profile curve collected by a profilometer along with the corresponding Gaussian fitting curve.

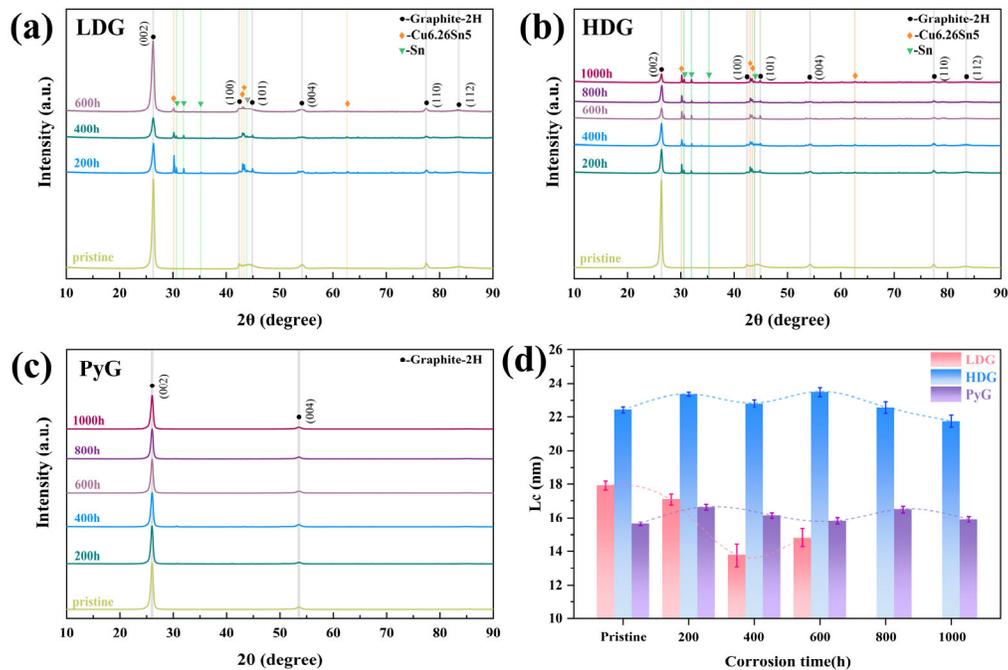
Figure 9. XRD patterns of graphite samples after exposure to molten CuSn alloy at 1100 °C for different durations: (a) LDG, (b) HDG, (c) PyG, and (d) the mean dimension of crystallite perpendicular to the (002) diffracting plane (L_c).

XRD patterns were measured to investigate the phase composition and crystal structure changes in the three graphite samples after corrosion, as shown in Figure 9. The corresponding graphite characteristic lattice plane has been marked in the figures. In addition to the characteristic graphite peaks in the XRD patterns of LDG and HDG, peaks corresponding to metallic Sn and the intermetallic compound $\text{Cu}_{6.26}\text{Sn}_5$ appeared after corrosion. These peaks corresponded to the SEM morphology of metal particles filling the graphite pores. No diffraction peaks for metals or compounds are observed in the XRD pattern of PyG. This may be because the corrosion of PyG occurs locally, and the X-ray measurement detects the uncorroded area rather than the pores formed by the corrosion of molten CuSn alloy. After 1000 h of corrosion, no diffraction peaks for Cu-C, Sn-C, or intercalation compounds were detected in the XRD patterns of the three graphite samples.

After the corrosion of LDG and HDG by molten CuSn alloy, the intensity of the (002) diffraction peaks for both samples significantly decreased, indicating a reduction in graphite crystallinity. This suggests that graphite may transform into amorphous carbon during the corrosion process. The mean dimension of crystallite perpendicular to the (002) diffracting plane (L_c) was calculated using Equations (4) and (5) [33,34] to reflect changes in the graphite crystal structure after corrosion.

where k is a constant (0.89), λ is the X-ray wavelength (0.15418 nm, Cu, K_α), β_{002} and θ_{002} represent the FWHM and the corresponding Bragg angle of the graphite (002) diffraction peak, respectively, and β_I is the instrument broadening (measured in this work as 0.1047°). The L_c calculation results are shown in Figure 9d, and the L_c of the graphite samples fluctuated within a certain range after corrosion. Studies have shown that high temperatures can promote grain growth and defect healing in materials, leading to an increase in grain size [35]. During cooling, the mismatch in the thermal expansion coefficients of metal and graphite generates compressive stress, which closes the Mrozowski cracks in artificial graphite and increases L_c [19,36]. The decrease in L_c may be linked to the corrosion degradation in the graphite crystal structure, which will be further discussed in the next section. LDG suffered the most severe corrosion in this research and decreased L_c noticeably. After 600 h, the severely corroded graphite particles on the surface of LDG completely detached. XRD detected a region with lower corrosion in the inner layer, and L_c showed a slight recovery. Due to the relatively mild corrosion of HDG and PyG, as well as the challenges in maintaining consistent sample areas during measurement, deviations were observed

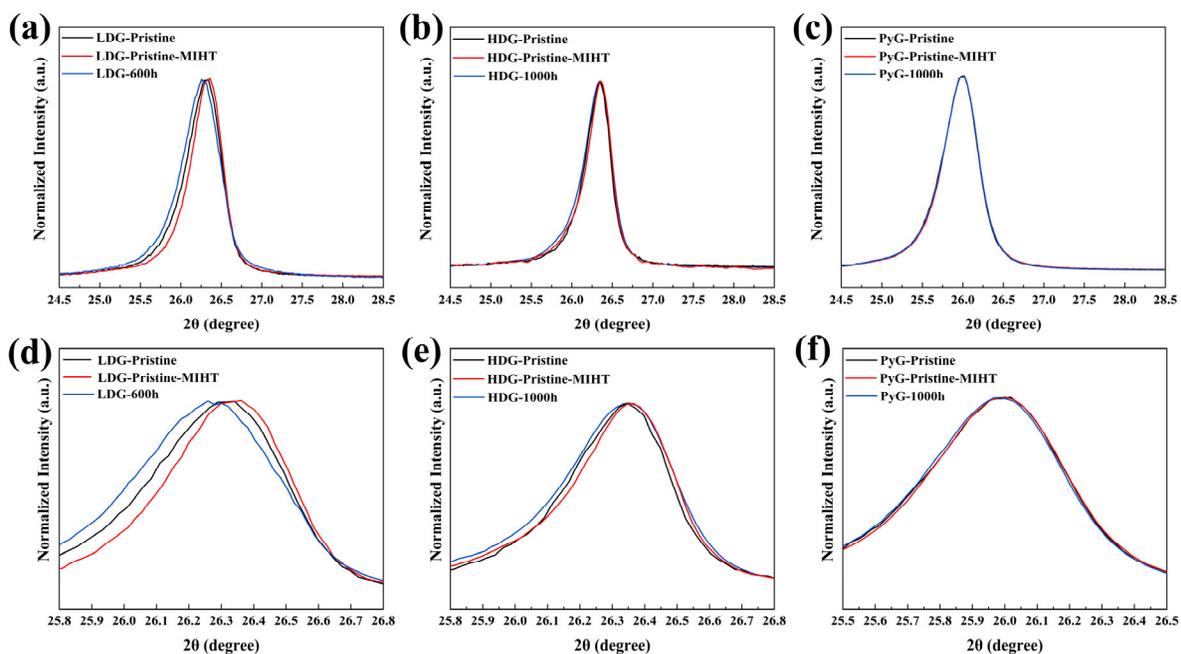
Figure 10. The (002) diffraction peaks of three graphite samples before and after the MIHT experiment, along with magnified views: (a), (d) LDG; (b), (e) HDG; and (c), (f) PyG.

To investigate the effect of metal on the crystal structure of graphite during heating and cooling, a metal infiltration and heat treatment (MIHT) comparative experiment was conducted. The control experiment setup was the same as the corrosion experiment, except that cooling occurred immediately after heating to 1100 °C. Figure 10 compares the (002) diffraction peaks of the pristine samples of the three graphite before and after the MIHT experiment under normalized intensity and includes the (002) diffraction peaks of the graphite samples with the maximum corrosion time. The results show that after the MIHT experiment, the (002) diffraction peaks of LDG and HDG shift slightly to a larger 2θ angle, while the FWHMs decrease. This suggests that some structural defects in the graphite crystals were healed during the MIHT process. In contrast, compared to the pristine sample, the (002) diffraction peaks of the corroded sample shift to the left, and its FWHMs increase. This indicates that corrosion damage caused by the molten CuSn alloy generates numerous structural defects in the graphite crystal structure, which could not be fully healed during the heating and cooling process [37]. The more porous structure of LDG results in greater metal penetration and retention. Therefore, the defect healing (indicated by the diffraction peaks shifting to the right) caused by high temperature or thermal expansion coefficient mismatch between the metal and graphite is more pronounced. The increase in defect content caused by corrosion (indicated by the diffraction peaks shifting to the left) is also more pronounced. The diffraction peak shifts in HDG are smaller than that of LDG, and the change in structural defect content is also less pronounced. After the MIHT experiment and 1000 h corrosion, the position and FWHM of the (002) diffraction peaks of PyG remain almost unchanged, and the content of crystal defects shows minimal variation. The XRD characterization results demonstrate that no chemical corrosion occurred, which is consistent with previous studies [38,39]. However, the shift in the diffraction peak position, changes in crystallinity, and L_c suggest that the crystal structure may have been damaged by the molten CuSn alloy, leading to an increase in defect content.

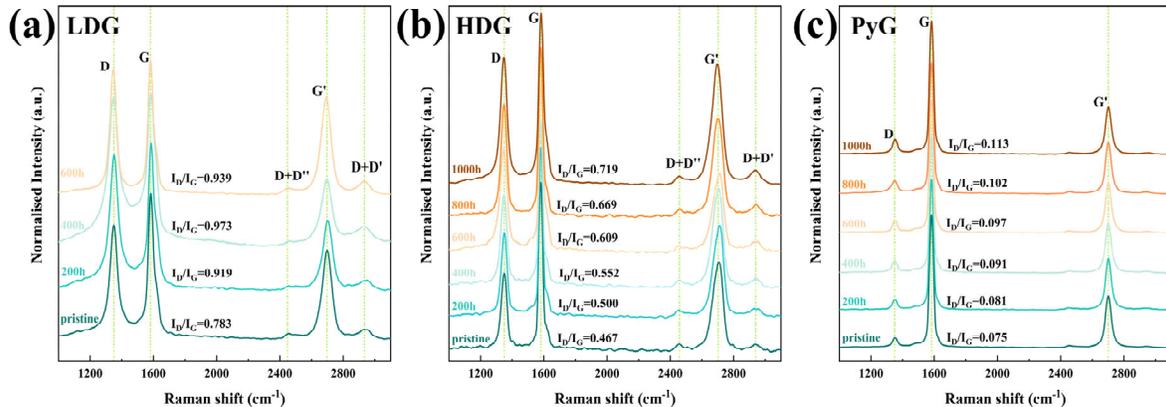
Figure 11. Raman spectra of graphite samples after exposure to molten CuSn alloy at 1100 °C for different durations. (a) LDG, (b) HDG, (c) PyG.

Laser Raman spectroscopy is an effective tool for characterizing the structural order of carbon materials. The Raman spectrum of defect-free graphite contains two sharp bands: the G band near 1580 cm^{-1} and the G' band near 2700 cm^{-1} . The appearance of the D band near 1350 cm^{-1} indicates structural defects in the material [40]. As structural defects in graphite increase, the intensity of the D peak also strengthens, while the G peak may undergo a slight shift or broadening. The intensity ratio of the D and G bands (I_D/I_G) is commonly used to represent the structural order of carbon materials. In this research, a 532 nm laser was used as the excitation source to test the graphite before and after corrosion. The intensity-normalized Raman spectra are shown in Figure 11, and the I_D/I_G values for each sample are directly marked in the figures. The Raman spectra show the three main bands, D, G, and G', indicating that the graphite structures contain defects. Additionally, two low-intensity bands, D + D' and D + D'', obviously appeared on either side of the G' band in the Raman spectra of LDG and HDG. Research indicates that these bands only appear when graphite has a high density of structural defects [41]. As the exposure time of graphite in molten CuSn alloy increased, the number of corrosion-induced defects increased, leading to a rise in the I_D/I_G ratio. After 1000 h of corrosion, the structure of all three graphite samples became more disordered due to the accumulation of defects. The D band intensity and I_D/I_G of LDG samples were generally higher than those of HDG and PyG, indicating that LDG materials have significantly higher degrees of structural disorder and defect content. PyG had the most ordered structure among the three graphite materials, and the results showed that it was also the least corroded. By Raman spectroscopy, the graphite samples with a more ordered structure suffered less corrosion in the molten CuSn alloy.

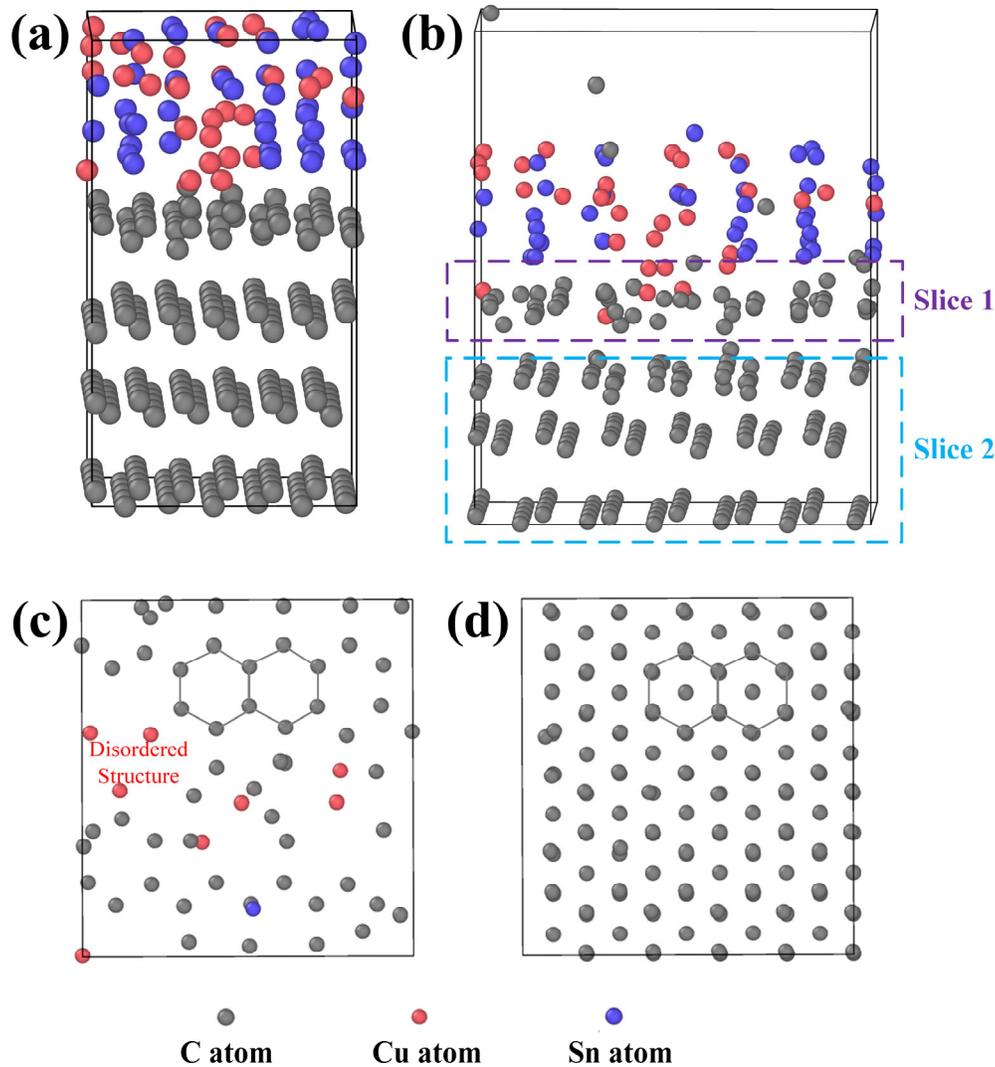
Figure 12. LAMMPS simulation images: (a) initial state of the CuSn–graphite solid–liquid interface, (b) state after 1 ps in a thermal bath, (c) cross-sectional image of slice 1, and (d) cross-sectional image of slice 2.

After 1.0 ps in the thermal bath, the equilibrated solid–liquid system is shown in Figure 12b, and the complete video of the atomic motion process is shown in the supplementary information. Surprisingly, the intact C atom lattice structure at the solid–liquid interface becomes defective due to interactions with Cu and Sn atoms. Some Cu atoms infiltrate the carbon lattice planes, displacing adjacent carbon atoms and disrupting the ordered arrangement. Additionally, carbon atoms diffuse into the molten CuSn alloy, suggesting

that the graphite structure transforms into amorphous carbon. The graphite structure was sliced for observation, as shown in Figure 12c,d. The damage to the graphite structure caused by Cu and Sn atoms occurs primarily at the contact interface. Carbon atoms deeper within the structure, which are unaffected by the metal atoms, retain their original arrangement. At the solid–liquid contact interface, atomic collisions cause some carbon atoms to displace, resulting in defect formation. Metal atoms occupy defect sites, causing the defects to propagate and ultimately leading to structural collapse. The MD simulation results confirmed the increased disorder in the graphite crystal structure, as detected by XRD and Raman spectroscopy and aligned with the formation of pores observed by SEM. Furthermore, the corrosion effect of metal atoms could be more pronounced for graphite materials with structural defects. Thus, the damage to the graphite atomic structure by metal atoms at high temperatures provides an explanation for graphite corrosion in molten CuSn alloy in addition to the stress effect.

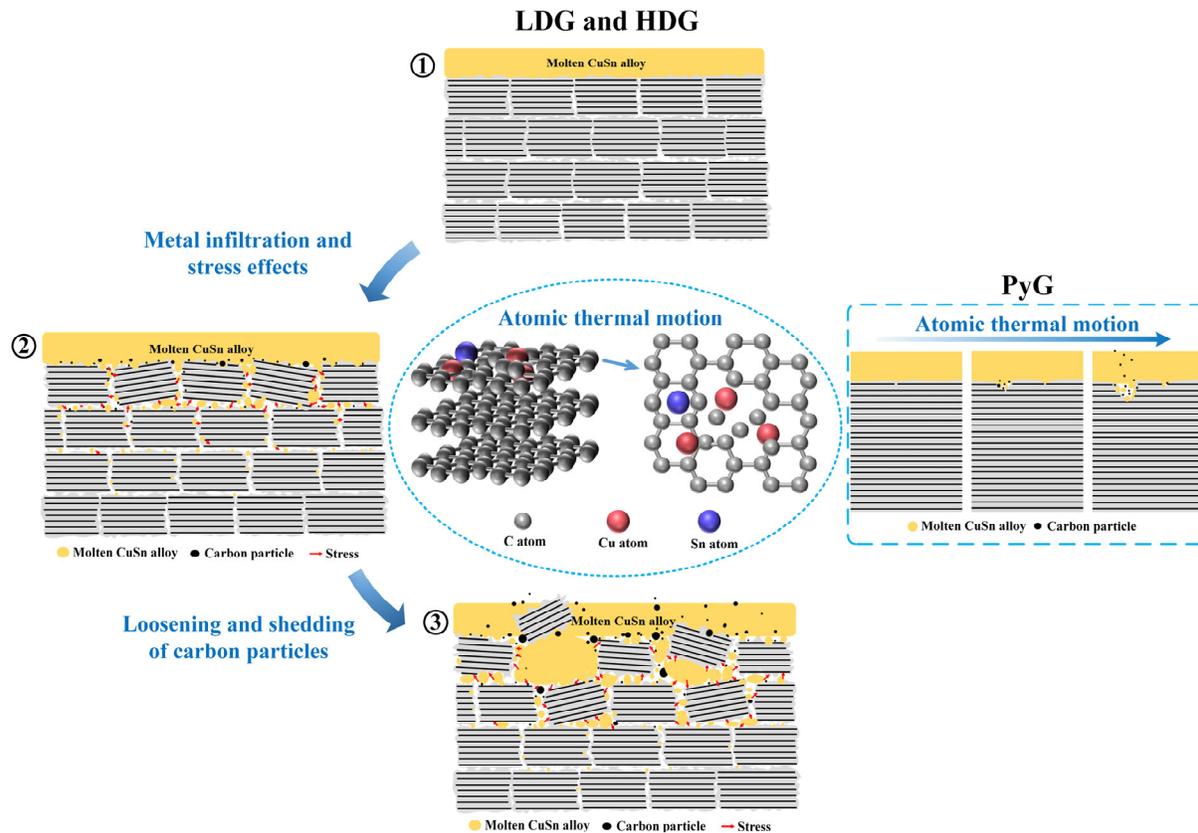
Figure 13. Schematic of the corrosion mechanism of graphite materials by molten CuSn alloy.

Experimental and simulation results demonstrate that atomic thermal motion and stress from metal penetration are the primary causes of graphite corrosion in molten CuSn alloy. At 1100 °C, the thermal motion of Cu and Sn atoms disrupts the ordered arrangement of carbon atoms, leading to a layer-by-layer disordering of the graphite structure. Throughout the experiment, atomic thermal motion continuously caused corrosion damage to the three graphite structures. The corrosion of this microstructure is typically slow but intensifies at graphite's inherent structural defects, forming local pores, resembling pitting corrosion. In contrast to the nearly non-porous layered graphite (e.g., PyG) produced by the CVD method, porous isostatically pressed graphite (e.g., LDG, HDG) also experiences stress due to molten CuSn alloy penetration during corrosion. The tightly packed graphite particles are damaged by stress within the pores, leading to loosening, deformation, and even fragmentation. The corrosion effect caused by this stress is highly significant and directly related to the density and porosity of graphite. Therefore, LDG suffered the most serious corrosion in the experiment, while PyG had relatively better corrosion resistance. Figure 13 illustrates the corrosion mechanism of molten CuSn alloy on graphite in detail. The process can be summarized as follows: (1) Molten metal wets the graphite surface at high temperatures, initiating material interaction at the interface and primarily causing atomic structural damage in graphite due to thermal motion. (2) The metal infiltrates and accumulates within the graphite, leading to localized stress concentration. (3) Stress generated by molten metal infiltration into graphite pores and defects accelerates pore expansion and material degradation, causing carbon particles to loosen and detach from the graphite matrix. Notably, the stress corrosion of PyG is minimal due to its non-porous structure. PyG could be considered to be corroded solely by atomic thermal motion.
