# Effect of HIP Treatment on Microstructure and Fatigue Strength of Selectively Laser Melted AlSi10Mg

**Abstract:** This study shows the effect of hot isostatic pressing (HIP) on the porosity and the microstructure, as well as the corresponding fatigue strength of selectively-laser-melted (SLM) AlSi10Mg structures. To eliminate the influence of the as-built surface, all specimens are machined and exhibit a polished surface. To highlight the effect of the HIP treatment, the HIP specimens are compared to a test series without any post-treatment. The fatigue characteristic is evaluated by tension-compression high cycle fatigue tests under a load stress ratio of  $R = -1$ . The influence of HIP on the microstructural characteristics is investigated by utilizing scanning electron microscopy of micrographs of selected samples. In order to study the failure mechanism and the fatigue crack origin, a fracture surface analysis is carried out. It is found that, due to the HIP process and subsequent annealing, there is a beneficial effect on the microstructure regarding the fatigue crack propagation, such as Fe-rich precipitates and silicon agglomerations. This leads, combined with a signific

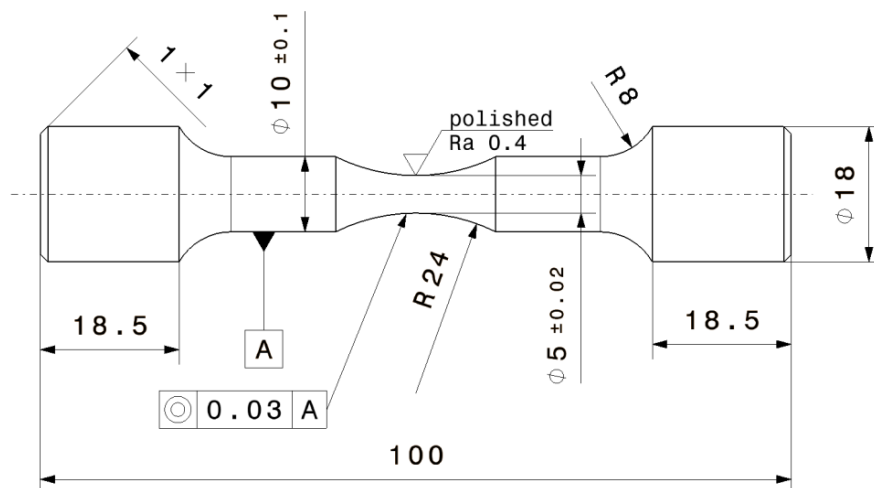
**Figure 1.** CAD drawing of the specimen geometry for the high cycle fatigue test.

Specimens were fabricated using an EOS M290 system with a Yb fiber laser, a power of 400 W, and a beam diameter of 100 μm. All specimens were built in the vertical direction with a certain machining allowance in order to remove subsequently the as-built surface and eliminate surface-related effects. The structures were manufactured according to the standard parameter set given by the system and powder manufacturer EOS. Following the built process, hot isostatic pressing was performed applying a temperature higher than 500 °C and a pressure of above 100 MPa with a holding time of at least two hours followed by quenching under constant pressure. Low temperature annealing over a certain time period was conducted afterwards. Subsequent to the heat treatment, the specimens were processed to the final geometry by turning and polishing. A CAD drawing with the detailed specimen geometry and dimensions is shown in Figure 1. The shape of the specimens was designed to show a homogeneous stress distribution over the cross-section with a stress concentration factor as low as possible due to the narrowing within the testing section, corresponding to no common standard.

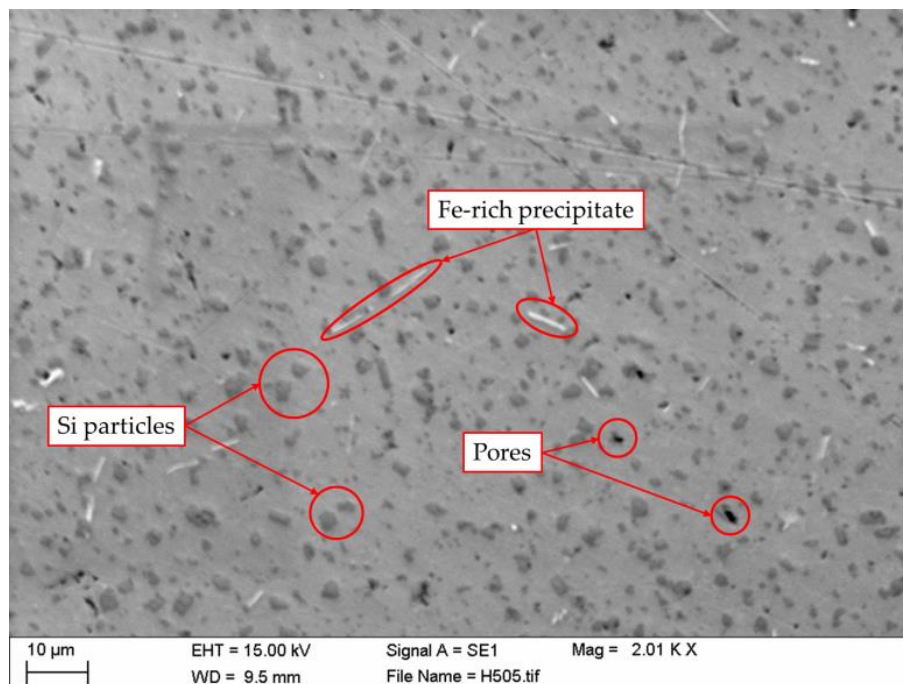
**Figure 2.** Microstructure after HIP and subsequent heat treatment.

HIP treatment at high temperature with considerably high pressure leads to significant microstructural differences compared to the as-built condition; hence, the effect on the material was investigated in detail. To characterize the microstructure after HIP and heat treatment, SEM images, taken with a Carl Zeiss EVO MA 15 microscope, of the post-processed condition were evaluated. In Figure 2, one can clearly see Fe-rich precipitates and Si particles, which were also detected in [21]. Silicon crystals were precipitated at the grain boundaries during the HIP treatment above the solubility temperature, and they grew to their respective size during low temperature annealing [22–25]. Microstructural features like silicon agglomerations and needle-shaped, Fe-rich precipitates obstructed a propagating fatigue crack and, therefore, generally improved the resistance against fatigue crack growth. Such microstructures favor crack deflection and energy dissipation at the crack tip. Hence, the long crack growth was decelerated, whereby the fatigue strength was enhanced [17,26].

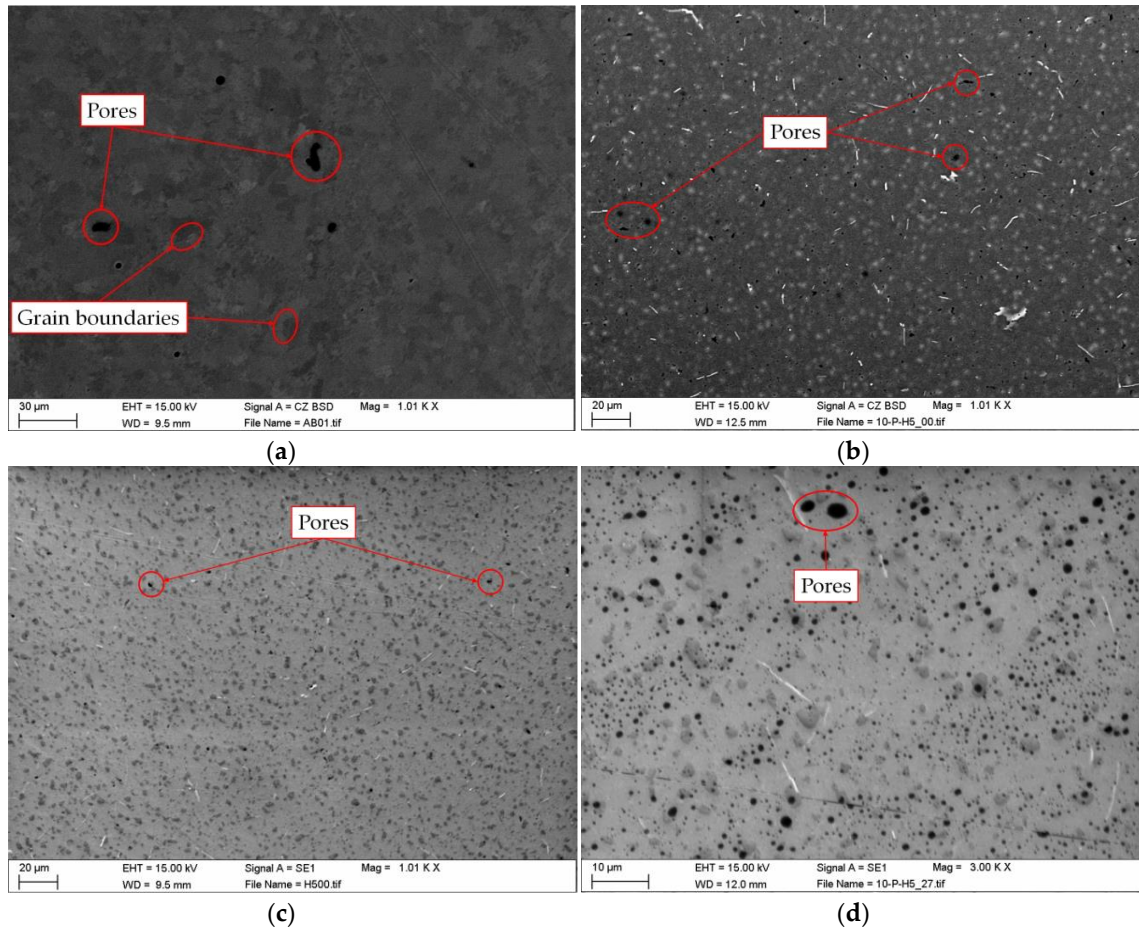
**Figure 3.** Microstructure (a) before and (b–d) after post-treatment.

Comparing the microstructure of the as-built condition (Figure 3a) to the microstructure after the post-treatment (Figure 3b,c), appreciable differences regarding the porosity we observed. For that reason, these figures have the same magnification and scale. A larger magnification image is depicted in Figure 3d, which reveals a circular shape of the observed micro-porosity. One can see that the amount of porosity and the maximum extension of pores have significantly decreased. Additionally, after the post-treatment, melt-pool boundaries completely vanished. The aforementioned Fe-rich precipitates

and Si-crystals were formed within the microstructure. Throughout the annealing, the Si-particles grew at Si-rich cellular boundaries, and finally, grain boundaries were no longer clearly visible at this stage due to the heat influence [23]. The comparison between backscatter images before (Figure 3a) and after (Figure 3b) HIP treatment highlights this microstructural change.

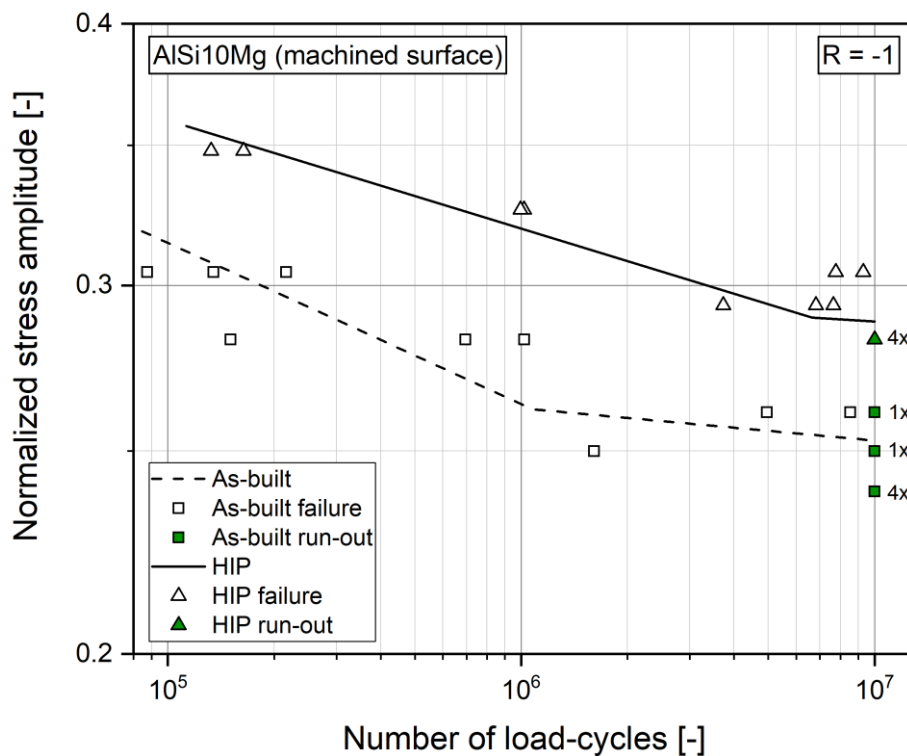
Figure 4. SN-curves for the as-built and HIP condition.

The fatigue test results are presented in Figure 4. The dashed line with square marks represents the data for the as-built series. The full line with triangle markings shows the data for the HIP condition. Within the finite life region, the specimen was tested at several load levels with a certain incrementation. The evaluation of the SN-curve in the finite life region is based on the ASTM E739 standard [27]. The high cycle fatigue strength at  $1 \times 10^7$  load-cycles was statistically evaluated by applying the  $\arcsin\sqrt{P}$ -transformation procedure given in [28]. Run-outs were reinserted at higher stress levels in order to obtain additional data within the finite life region. The results were normalized to the nominal ultimate tensile strength (UTS) of the additively-manufactured material without any post-treatment, given by the powder manufacturer [29]. The peak load level was set at about 35% of the UTS, which was well below the yield strength according to the powder manufacturer, to ensure testing within the linear-elastic region of the material and obtain reasonable results regarding endured load cycles. The results revealed that the HIP test series provided an increase of the high cycle fatigue strength of about 14% considering a survival probability of  $P_S = 50\%$ . The scatter band between 10% and 90% survival probability, referring to the stress amplitude, minorly decreased for the HIP condition compared to the as-built condition. Furthermore, the slope in the finite life region was less steep for the HIP condition. The fatigue test results are summarized in Table 2.

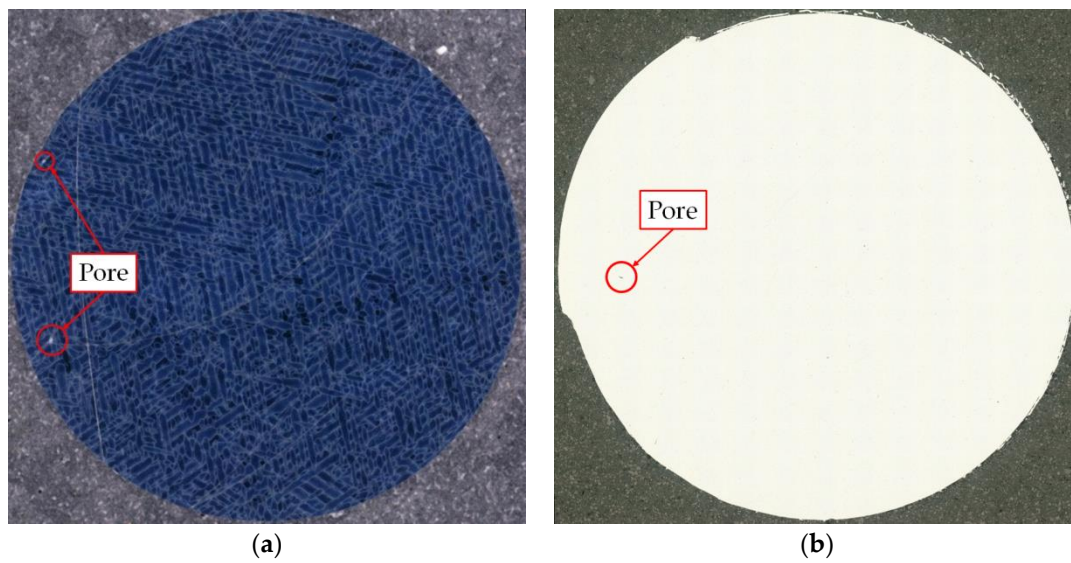
Figure 5. Micrograph of an (a) as-built and (b) HIP sample.

In order to evaluate the decrease in porosity, the average maximum pore extension, as well as the equivalent circle pore diameter, several micrographs of the two conditions were investigated. Figure 5a shows an example of the as-built condition, whereas Figure 5b is taken from the microsection of an HIP-treated specimen. All pictures of micrographs and fracture surfaces were recorded with a KEYENCE VHX-5000 light optical digital microscope. The microsections were prepared only by polishing and received no additional etching. Dependent on the polished surface and the image post-processing, different lighting options and angles were necessary. This was the reason why the as-built specimen in Figure 5a (ring-lighting) appears blue and shows a different texture, e.g., visible melting tracks and laser scanning strategy, than the HIP sample in Figure 5b (coaxial lighting). In order to determine the amount of porosity, image processing tools were utilized. At first, the images were converted to binary pictures with a certain threshold to ensure that the microsection of the specimen area appeared white while pores appeared black. Secondly, the embedding material was subtracted from the image. In the end, the separated pores, as well as the porosity, which is the ratio of specimen area to pore area, could easily be evaluated. The outcome is presented in Figure 6a–c and summarized in Table 3. The results were again normalized to the as-built condition to highlight the differences between the two test series. The results maintained that the HIP samples possessed a significant lower level of porosity (−64%), a decreased maximum pore extension (−22%), as well as an equivalent circle diameter (−11%).

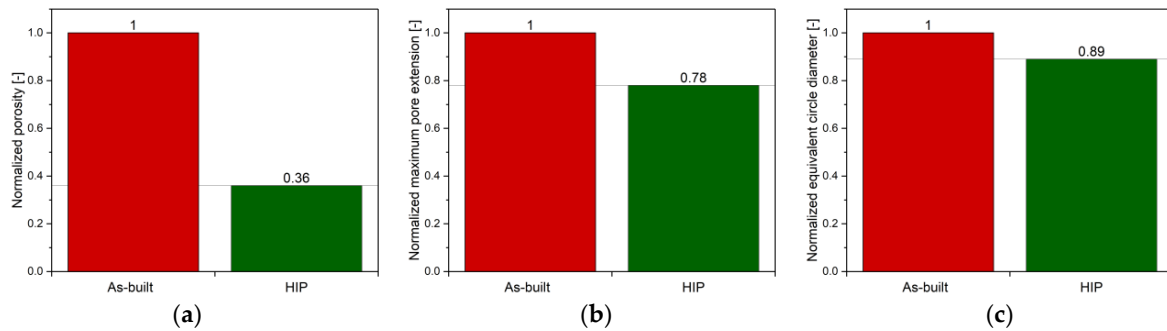
Figure 6. Difference in (a) porosity, (b) maximum pore extension, and (c) equivalent circle pore diameter between the as-built and HIP series.

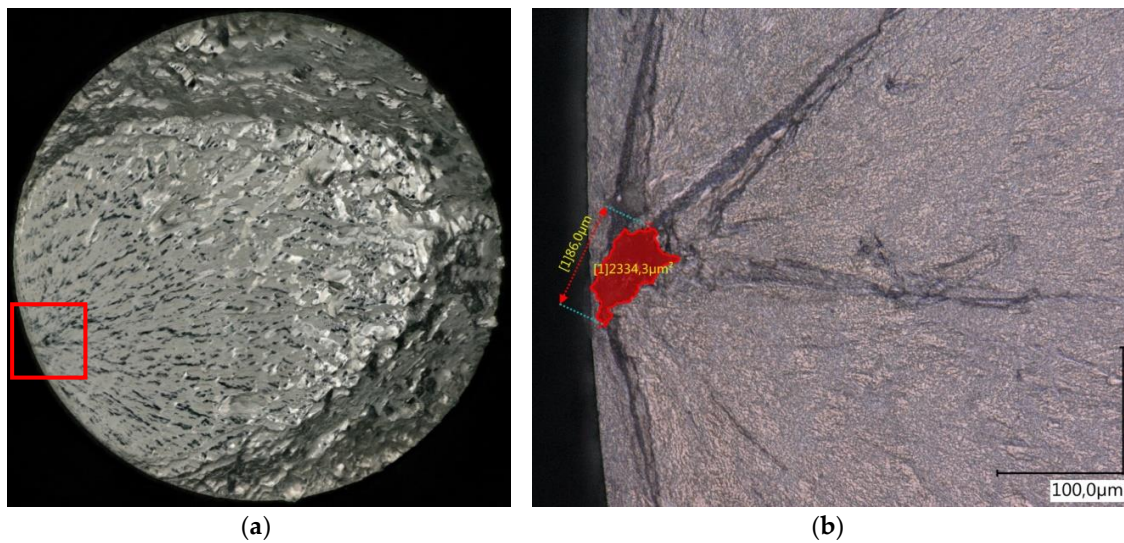
Figure 7. (a) Fracture surface of an as-built specimen; (b) size measurement of failure-critical defect.

To characterize the crack-initiating defect, a fracture surface analysis for each tested specimen was carried out. A fractured surface of the as-built specimen is presented in Figure 7a. The surface is visually differentiated into two sections, the oscillating crack growth regime and the burst fractured area. The defect, which was responsible for the failure, can be easily identified and evaluated. In every investigated fractured surface for the as-built condition, a pore was failure critical. An example with a marked and measured pore is given in Figure 7b. The size and location of the failure causing imperfection was one determining factor for the fatigue strength of the material; see also [30,31]. Therefore, an evaluation of the defect size was necessary to compare and to assess the fatigue strength of the two investigated conditions.

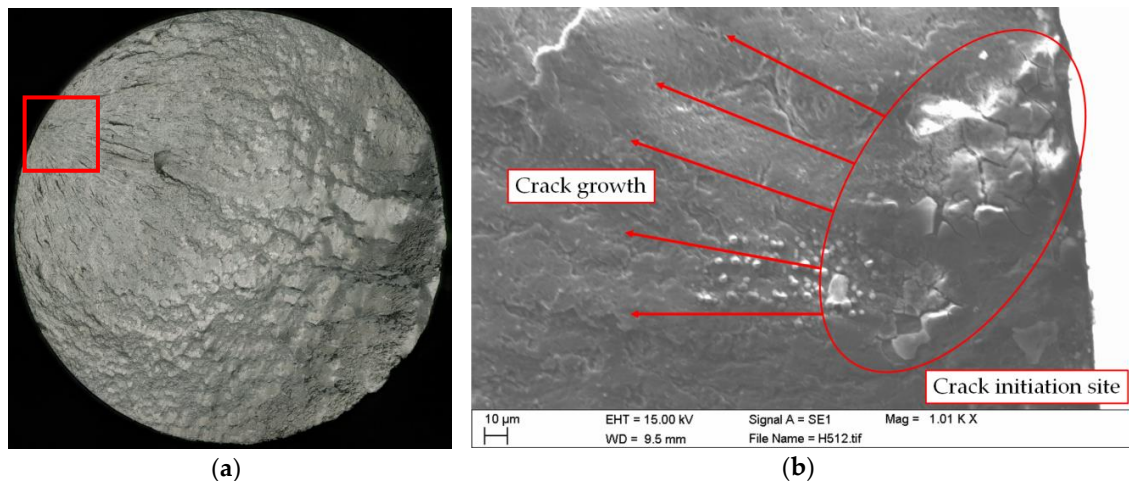
Figure 8. (a) Fracture surface of an HIP specimen; (b) failure-critical, microstructural inhomogeneity.

A fracture surface for the post-processed condition (two-dimensional image with in depth focus) is displayed in Figure 8a. As pointed out for the as-built condition, the fracture surface is again separated into two different zones. The crack origin can be found within the fatigue fracture area, since the fine structured area points towards the crack initiation site. The fracture surface analysis for the HIP specimens revealed a different failure mechanism compared to the as-built ones. Due to the remarkable decrease in porosity, cavities were no longer responsible for fatigue crack initiation, but rather microstructural features such as silicon-rich phases. In Figure 8b, one can identify the debonding of Si-crystals as the failure origin; see also [26]. The crack initiated near the subsurface at all tested samples, for the HIP condition, as well as for the as-built condition. In almost every case, no evidence of pores could be found near the crack origin.
