# Impact Damage Ascertainment in Composite Plates Using In-Situ Acoustic Emission Signal Signature Identification

**Abstract:** Barely visible impact damage (BVID) due to low velocity impact events in composite aircraft structures are becoming prevalent. BVID can have an adverse effect on the strength and safety of the structure. During aircraft inspections it can be extremely difficult to visually detect BVID. Moreover, it is also a challenge to ascertain if the BVID has in-fact caused internal damage to the structure or not. This paper describes a method to ascertain whether or not internal damage happened during the impact event by analyzing the high-frequency information contained in the recorded acoustic emission signal signature. Multiple 2 mm quasi-isotropic carbon fiber reinforced polymer (CFRP) composite coupons were impacted using the ASTM D7136 standard in a drop weight impact testing machine to determine the mass, height and energy parameters to obtain approximately 1" impact damage size in the coupons iteratively. For subsequent impact tests, four piezoelectric wafer active sensors (PWAS) were bonded at specific locations on each coupon to record the acoustic emission

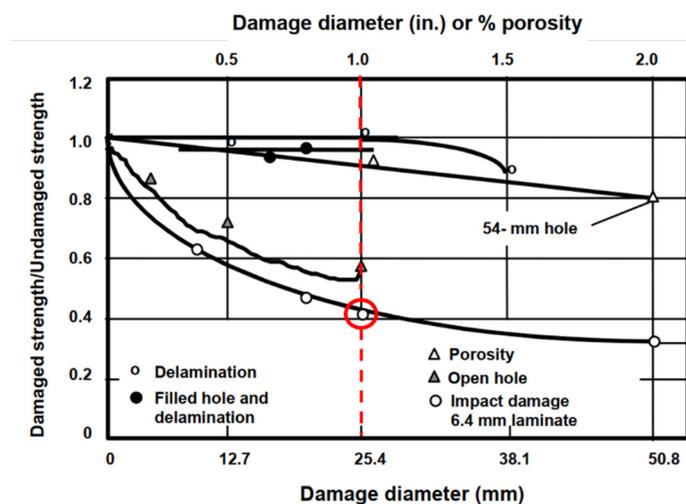
Figure 1. Remaining composite strength as a function of impact damage diameter [3].

The damage tolerance concepts introduced around 20–30 years ago paved the way for understanding BVID and how it led to complicated damage in composites [1,2]. Following these developments, inspection standards needed to be developed for the inspection of composite structures where BVID became an important aspect and needed to be distinguished from visible impact damage (VID). A damage is characterized as BVID if it is visible at a distance of less than 1.5 m using regular vision. Similarly, a damage is characterized as VID if it is visible at a distance of 1.5 m or greater [3]. Depending on how a damage is characterized (as BVID or VID), important decisions regarding repairs to be conducted on composite in the areas where impact events occur, are taken. VID's need to be repaired immediately based on this understanding. However, there may be a situation when the damage is characterized as BVID based on visually conducted inspections but may in fact have an impact damage size of 1" (25 mm) or greater which could significantly aggravate the strength of the composite part (see Figure 1). Since this damage is now characterized as BVID, it may get ignored from being repaired. Figure 1 clearly demonstrates that 1" impact damage diameter can seriously reduce the strength of a composite structure compared to any other damage type (delamination, porosity, open hole), having the same size. This clearly demonstrates the seriousness and significance detecting and monitoring impact damage having a diameter of 1" or greater [4,5].

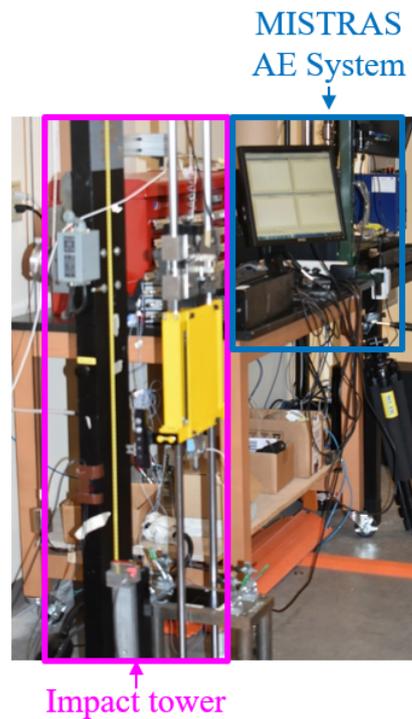
Figure 2. Drop weight impact testing with AE signal capture.

After estimating the mass, height and energy combination for creating approximately 1" impact damage diameter in a 2 mm thick composite coupon, subsequent impact tests were conducted on AE instrumented composite coupons on which four PWAS were bonded at specific locations based on the fiber orientation angles in the composite coupons. The drop weight impact testing system along with the AE signal capture using the MISTRAS AE system is displayed in Figure 2. Two sets of experiments were conducted—one experiment with low energy (1 J) impact that created no damage in an instrumented composite coupon and the second test with a higher energy (16 J) impact which created approximately 1" impact damage size. AE signal analysis and mode separation study were performed to understand both the impact events and clearly differentiate between a catastrophic impact that creates sizable damage and a benign impact that creates no damage.

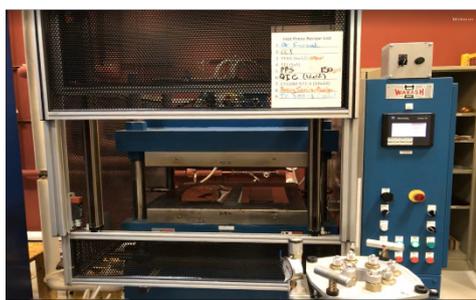
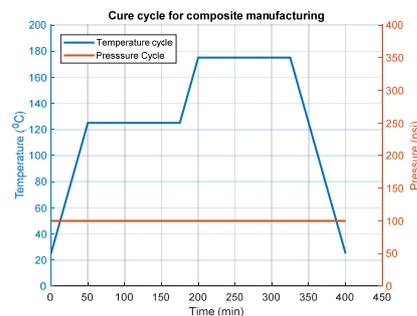
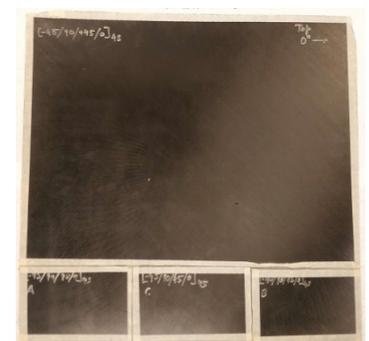
Figure 3. Manufacturing of composite coupons for impact testing: (a) Wabash hot press machine; (b) Manufacturing cure-cycle; (c) Cured composite laminate with 6" × 4" cut-outs.

CFRP Composite laminates were fabricated using the CYCOM<sup>®</sup> 5320-1 epoxy resin system with the Hexcel IM7 12K fiber in a Wabash hot press using the cure cycle provided by the manufacturer of the prepreg. To manufacture quasi-isotropic composite plates with the correct thicknesses, a stacking sequence with the appropriate number of layers had to be chosen [36–38]. A  $[-45/90/+45/0]_{25}$  stack up was chosen for fabricating the composite laminate with 16 layers having a nominal thickness of approximately 2 mm. From the cured composite laminate, 6" × 4" coupons were cut out for conducting standardized impact tests [35]. The Wabash hot press machine, cure cycle and the cured composite plate with the 6" × 4" cut-outs is displayed in Figure 3.

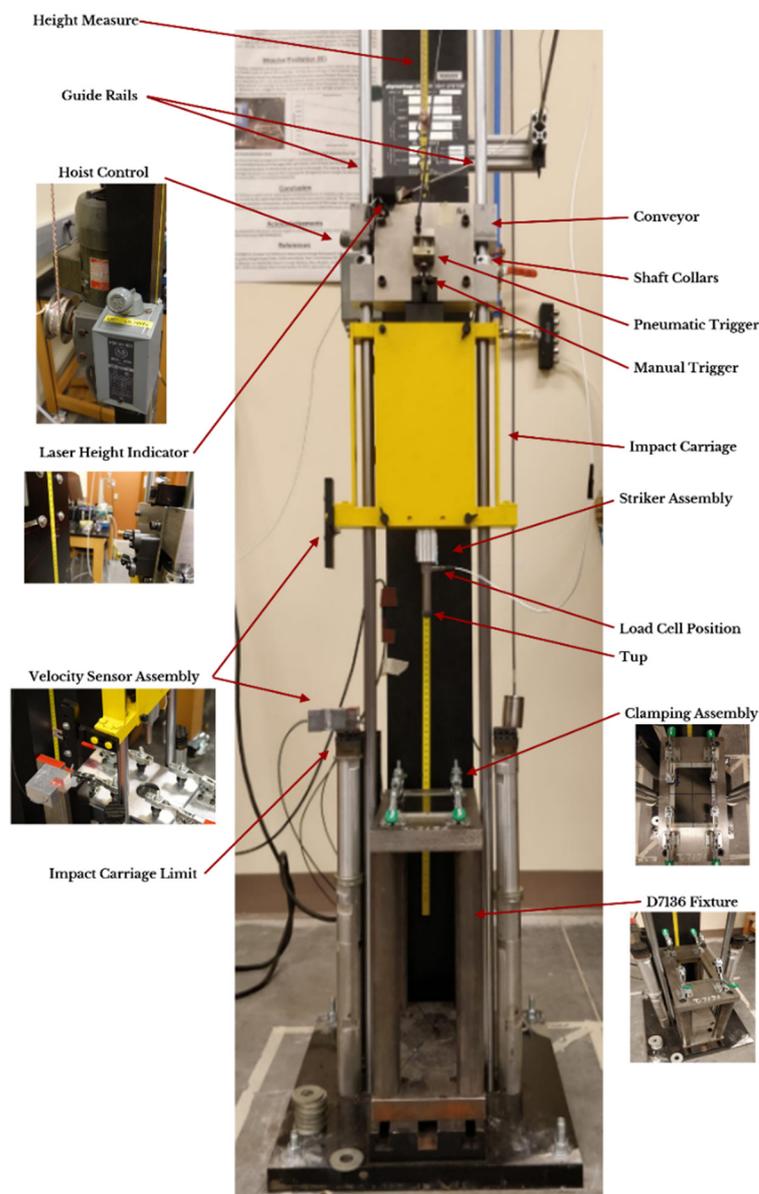
Figure 4. Dynatup 8200 drop weight impact testing machine instrumented with load cell and velocity sensor.

energy combination to obtain a certain size of impact damage. These impact tests were conducted on a drop weight impact tower conforming to the ASTM D7136 standard as displayed in Figure 4. After this, real-time acoustic emission experiments were supposed to be carried out on more 2 mm 6" × 4" quasi-isotropic CFRP composite coupons. In order to do this, four piezoelectric wafer active sensors (PWAS), 7-mm in diameter and 0.5-mm in thickness, were bonded on each composite coupon at different locations corresponding to fiber orientation angles in the stacking sequence of the composite. PWAS 1 was bonded 45-mm from the impact location in the 90-degree fiber direction. PWAS 2 was bonded 75-mm away from the impact location in the -45-degree fiber direction. PWAS 3 was bonded 75-mm away from the impact location in the 0-degree fiber direction. PWAS 4 was bonded 75-mm away from the impact location in the 45-degree fiber direction as can be observed in Figure 5. In this way the impact coupons were instrumented to carry out real-time acoustic emission recording of impact tests to be conducted on them.

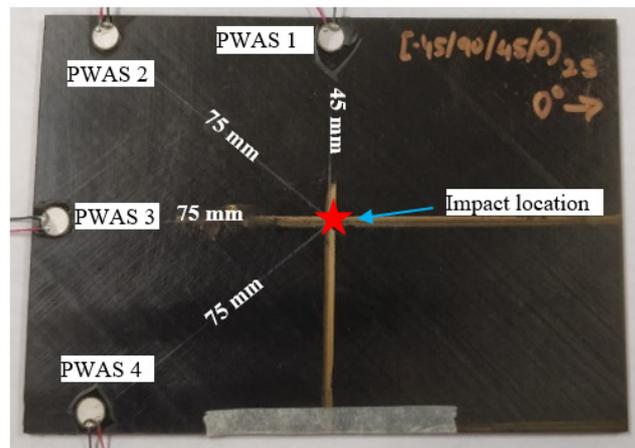
Figure 5. Location of four PWAS with respect to impact location on composite coupon.

The first instrumented impact test conducted on a 2 mm composite coupon is a low energy impact i.e., about 1 J impact that produces no damage in the composite coupon. To conduct this impact test, the instrumented coupon displayed in Figure 5 was clamped on the ASTM D7136 fixture and the real-time AE signal hit were acquired by all the four PWAS using the MISTRAS AE system as displayed in the experimental setup given in Figure 6. Since the impact energy is only 1 J, the height from which the impactor is dropped on the composite coupon is only a few centimeters. In such a scenario, it becomes very difficult to avoid a rebounding or secondary impact on the composite coupon after the first impact. The AE hits acquired at all the four PWAS for this 1 J impact event is displayed in Figure 7.

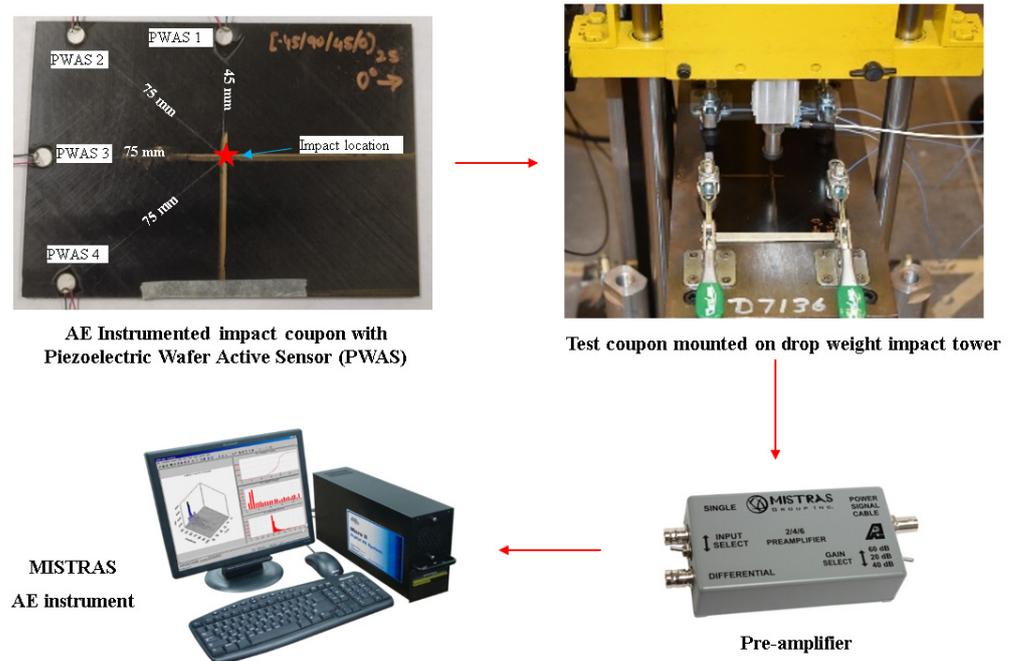
Figure 6. Experimental setup of ASTM drop weight impact test on AE instrumented coupon.

To conduct the real-time acoustic emission experiment, the instrumented coupon with the four PWAS was clamped on the ASTM D7136 fixture on the drop weight impact testing machine. The wires from the four PWAS were connected to a pre-amplifier and the connections from the pre-amplifier were connected to the MISTRAS AE system for capturing the AE signals during the drop weight impact testing experiment so that all the signals associated with the impact event using the four PWAS bonded in the different fiber orientation angles could be analyzed. The acoustic preamplifier is a bandpass filter, which can filter out signals between 30 kHz to 700 kHz. Provided with 20/40/60 dB gain (can be selected using a switch), this preamplifier operates with either a single-ended or differential sensor. In the present experiment, 40 dB gain was selected. The preamplifier was connected to the MISTRAS AE system. A sampling frequency of 10 MHz was chosen to capture any high-frequency AE signals. The timing parameters set for the MISTRAS system were: peak definition time (PDT) = 200  $\mu$ s, hit definition time (HDT) = 800  $\mu$ s, and hit lockout time (HLT) = 1000  $\mu$ s. This complete experimental setup with the AE instrumentation used is displayed in Figure 6.

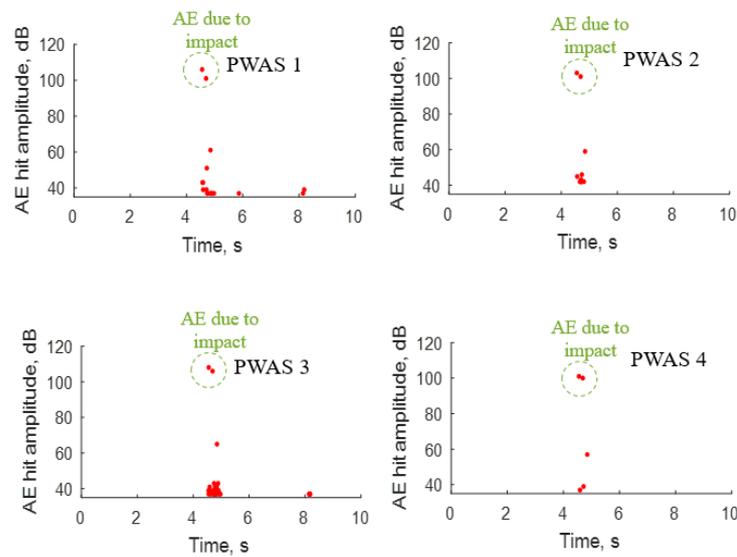
Figure 7. AE hits observed at the four PWAS due to 1 J impact event.

In Figure 7 there are two successive AE impact hits due to the rebound of the impactor on the composite coupon. These two hits are obtained by all the four PWAS and are clearly separated from other low amplitude hits which could consist of background noise or boundary reflections from the edges of the composite coupon, since we are assuming that this low energy of approximately 1 J did not create any damage in the composite coupon.

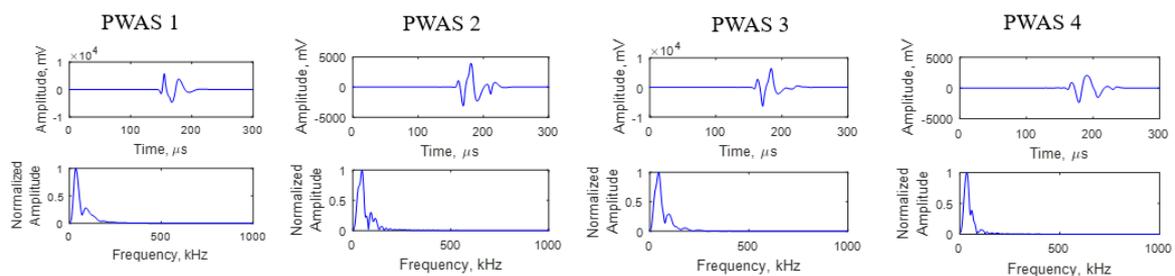
Figure 8. Signal correspondence at all four PWAS due to the 1st impact hit.

After this, the waveforms of the impact hits were extracted from the MISTRAS AE system. The waveforms of the 1st and 2nd impact hits and their FFT’s are presented in Figures 8 and 9. We can clearly observe that the signals from these two successive impact hits had a major frequency content in the low-frequency range below 200 kHz which indicates low-frequency flexural modes in the composite coupon. We can also observe that the signal amplitude for the 1st impact hit was higher at PWAS 1 which was in the 90-degree direction and PWAS 3, which was in the 0-degree direction.

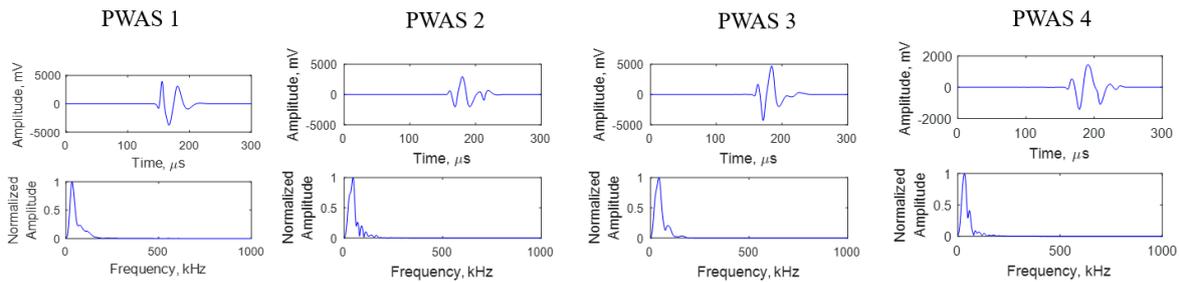
Figure 9. Signal correspondence at all four PWAS due to the 2nd impact hit.

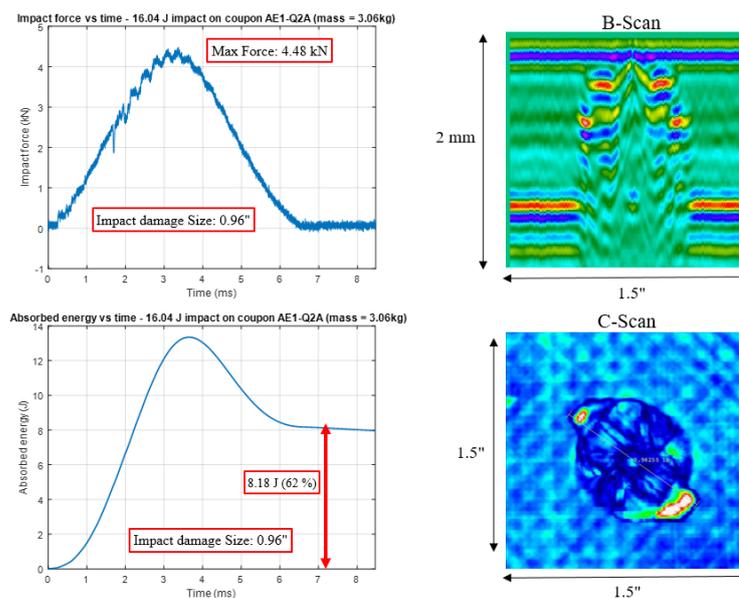
Figure 10. Impact results of 2 mm coupon AE1-Q2A consisting of force-time plot, energy-time plot, B-scan and C-scan from UT.

Figure 10 shows four plots related to coupon AE1-Q2A, displaying the force-time plot, the energy-time plot, the B-scan and C-scan from ultrasonic testing (UT). The force-time plot is parabolic in shape and shows a peak at a certain maximum load of approximately 4.48 kN. Anomalies in the parabolic shape of the force-time plot indicate that the coupon has undergone extensive damage when undergoing impact.

The energy-time plot clearly demonstrates the energy absorbed (62%) by the coupon during the impact event to create the irreversible process of a 1" impact damage diameter in coupon AE1-Q2A. From the B-scan, it can be seen, that although the center of the damaged area undergoes permanent deformation similar to a dent, it does not have a delamination, since a clear back wall reflection from the center of the damage can be seen in the B-scan. From the C-scan, we can clearly see the fiber break and push out in the  $-45^\circ$  fiber direction and this can be physically seen by looking at the rear surface of the impacted coupon as well. It can be observed that bonding the four PWAS on the AE1-Q2A composite coupon had little to no change in its impact characteristics.

As observed from the C-scan in the quad plot displayed in Figure 10, we can clearly see that the maximum extent of damage due to the impact event occurs at the  $-45$  degree direction. Therefore, we take a closer look at the signals obtained from some of the hits at PWAS 2 which is bonded in the  $-45$ -degree direction in Figure 14. We can clearly separate the high amplitude, low-frequency impact hit and its signal from some other hits and their signals that correspond to damage propagation. Within the class of hits and their signals that correspond to damage, there are subtle differences in the signals because they may represent different types of damage such as matrix cracking, fiber break, and delamination growth. One of the goals in future experiments will be to separate the damage signals from different types of damage experienced by the composite coupon upon impact.

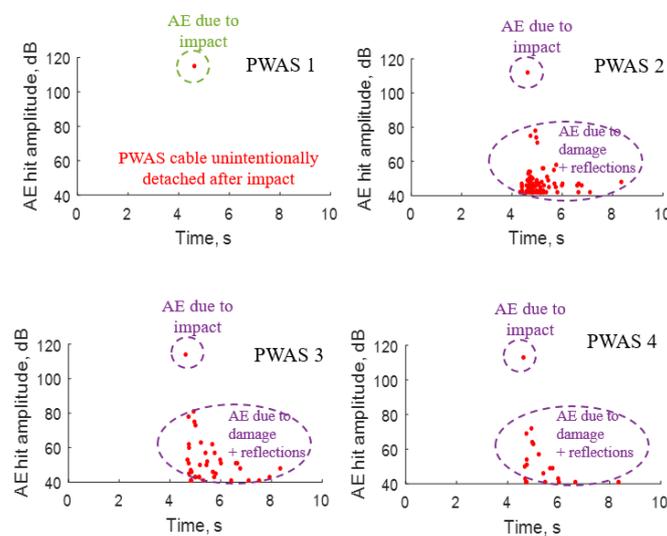
**Figure 11.** AE hits observed at the four PWAS due to 16 J impact event.

Next, we analyze the AE signals received at all four PWAS. We can clearly observe in Figure 11 that the impact hit i.e., the hit which is received at the four PWAS when the first contact is made between the impactor and the composite coupon, can be clearly separated from the remaining hits received by the four PWAS. The other low amplitude hits consist of hits obtained due to the damage propagation within the composite coupon mixed with background noise and boundary reflections from the edges of the composite coupon. It is also important to note that at the PWAS 1, only the impact hit was received and after that no more hits were received by PWAS 1. This issue occurred at PWAS 1 because at the moment of impact, one of the cables connected to the PWAS 1 got unintentionally or accidentally detached from the PWAS 1 after the high amplitude flexural wave was experienced at the location where PWAS 1 was bonded to the composite coupon. Due to the detachment of the cable from PWAS 1 it was only able to capture the impact hit and was not able to capture any of the other low amplitude hits which could have valuable information about the impact damage propagation. In future experiments, all the cables will be properly reinforced so that signals at all PWAS can be received in an uninterrupted manner.

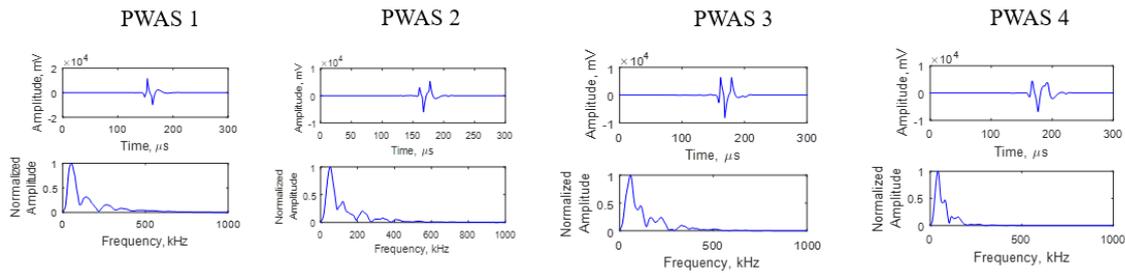
Figure 12. Signal correspondence at all four PWAS due to the 1st impact hit.

If we separate the time domain signals and their FFT's, received at all four PWAS from the impact hit as observed in Figure 12, we can clearly observe that the signals from the impact hit has a major frequency content in the low-frequency range below 200 kHz with a large amplitude which indicates low-frequency flexural modes in the composite coupon.

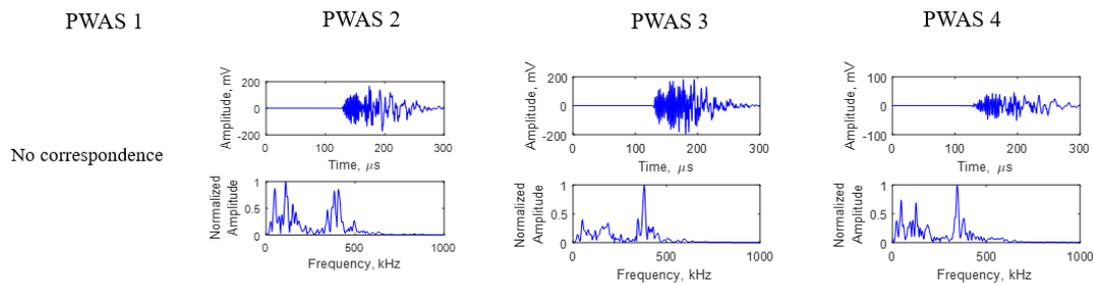
Figure 13. Signal correspondence at all four PWAS due to a hit corresponding to damage formation.

If we separate the time domain signals and their FFT's, received at all four PWAS from a hit that corresponds to damage propagation in the composite as observed in Figure 13, we can clearly observe that the signals from this hit at all the PWAS has a major frequency content in the frequency range between 300 and 500 kHz with a much lower amplitude in comparison to the impact hit. It is also important to note that there is no signal correspondence at PWAS 1 for a hit that corresponds to damage growth since no AE hits were received by PWAS 1 other than the impact hit, as stated earlier.

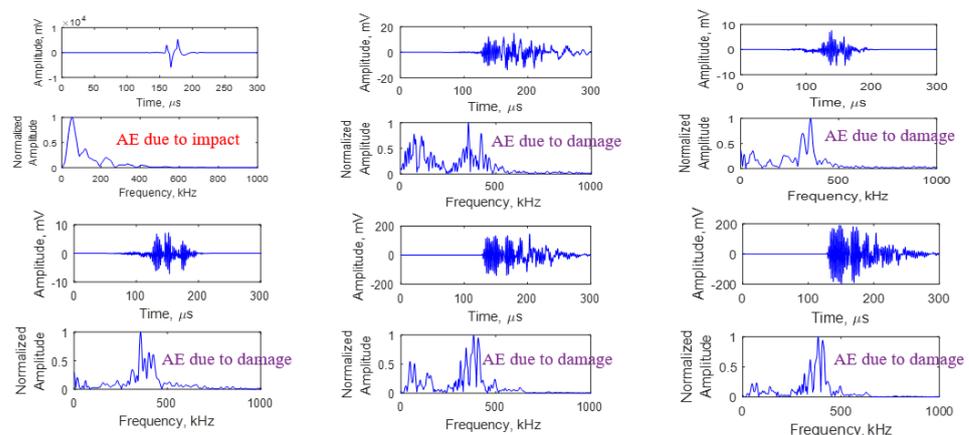
Figure 14. Various signals observed at PWAS2 due to the 16 J impact event.

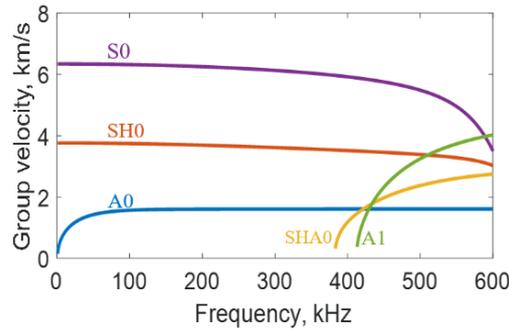
**Figure 15.** Group velocity dispersion curve for 2 mm composite coupon having a stacking sequence of  $[-45/90/+45/0]_{2S}$ .

After acquiring all the AE hits and performing the signal analysis from the AE hits, time-frequency analysis of the AE signals was also performed. The analysis aimed to study the Lamb wave mode content in the AE signals recorded. To do this, we first use the Semi-Analytical Finite Element (SAFE) method to obtain the group velocity dispersion

curve for the 2 mm composite coupon with a stacking sequence of  $[-45/90/+45/0]_{2S}$  as displayed in Figure 15.

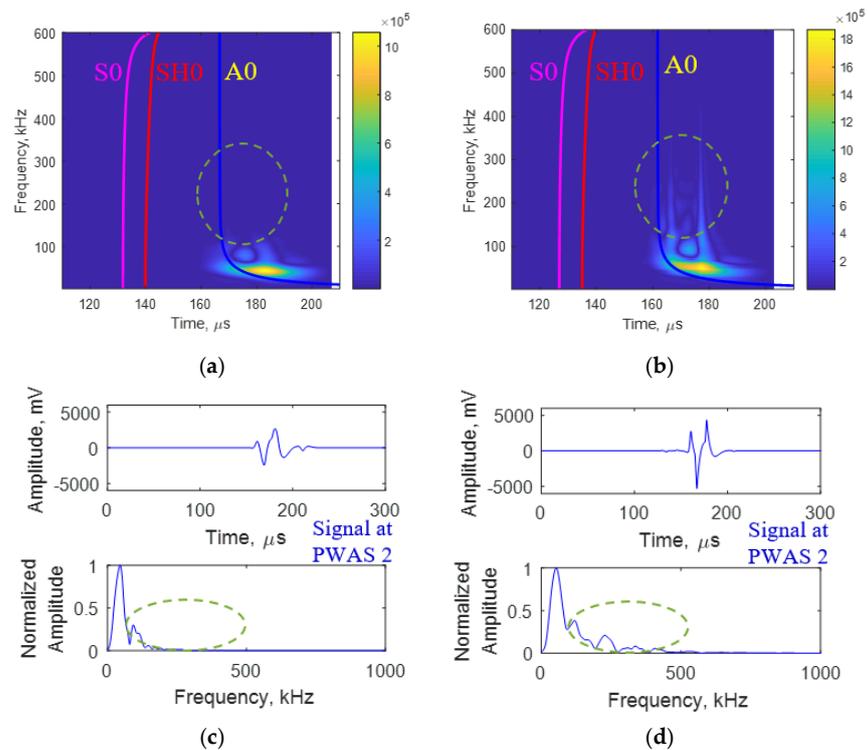
**Figure 16.** (a) Time-frequency plot from 1 J impact hit signal (b) Time-frequency plot from 16 J impact hit signal (c) AE signal at PWAS 2 due to 1 J impact hit and frequency spectrum (d) AE signal at PWAS 2 due to 16 J impact hit and frequency spectrum.

To perform the mode separation study for the AE due to the impact event, we first analyze the impact hits from the 1 J impact hit that caused no damage in a 2 mm composite coupon, and the 16 J impact hit that caused a 1'' impact damage in a composite coupon. We conduct the time-frequency analysis for both the impact hits and superimpose it with the group velocity dispersion curve of the 2 mm composite coupon. These plots can be observed in Figure 16a,b. If we compare these two plots, we can clearly observe that the strong A0 mode can be observed due to the impact hit in both the plots. We can also observe that 16 J impact hit has a stronger A0 content. We can also see the signals obtained at PWAS 2 for both impact hits in Figure 16c,d. Upon comparing these two plots we can observe that the 16 J impact hit has an additional higher frequency content between 200 kHz and 400 kHz due to a higher energy impact of 16 J compared to a lower energy impact of 1 J.

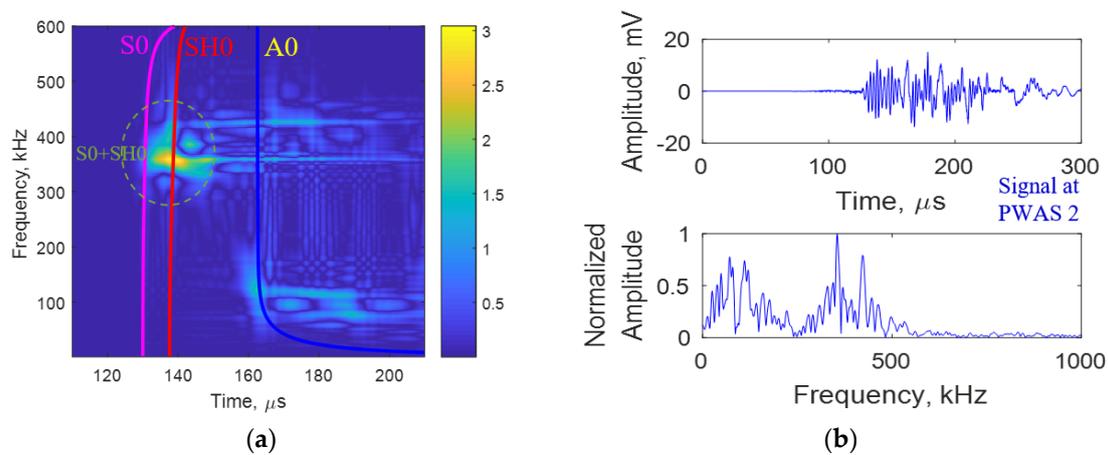
**Figure 17.** (a) Time-frequency plot from 16 J damage hit (b) Signal at PWAS 2 and the frequency spectrum due to 16 J damage hit.

To perform the mode separation study for the AE due to damage growth, we analyze an AE hit that corresponds to damage growth from the 16 J impact event that caused a 1" impact damage in the composite coupon. We conduct the time-frequency analysis of the signal and superimpose it with the group velocity dispersion curve of the 2 mm composite coupon. This plot can be observed in Figure 17a. We can also observe the signal due to the damage growth obtained at PWAS 2 displayed in Figure 17b. From these plots we can clearly observe that the damage growth has a strong S0 and SH0 mode between 300 kHz and 500 kHz. We can also see that the damage growth has weak A0 mode along with many boundary reflections. If we were to conduct a preliminary inspection, we can see that SH0 mode is found stronger than the S0 mode. Previous work [25–28] has also indicated that SH0 mode is very sensitive to impact damage and can be used to detect impact damage.
