Article

Surface Damage in Woven Carbon Composite Panels under Orthogonal and Inclined High-Velocity Impacts

Abstract: The present research is aimed at the study of the failure analysis of composite panels impacted orthogonally at a high velocity and with an angle. Woven carbon-fibre panels with and without external Kevlar layers were impacted at different energy levels between 1.2 and 39.9 J. Sharp and smooth gravels with a mass from 3.1 to 6.7 g were used to investigate the effects of the mass and the contact area on the damage. Optical microscopy and thermography analyses were carried out to identify internal and surface damage. It was identified that sharp impactors created more damage on the impacted face of the panels, while the presence of a Kevlar layer increased the penetration limit and reduced the damage level in the panel at a higher energy.

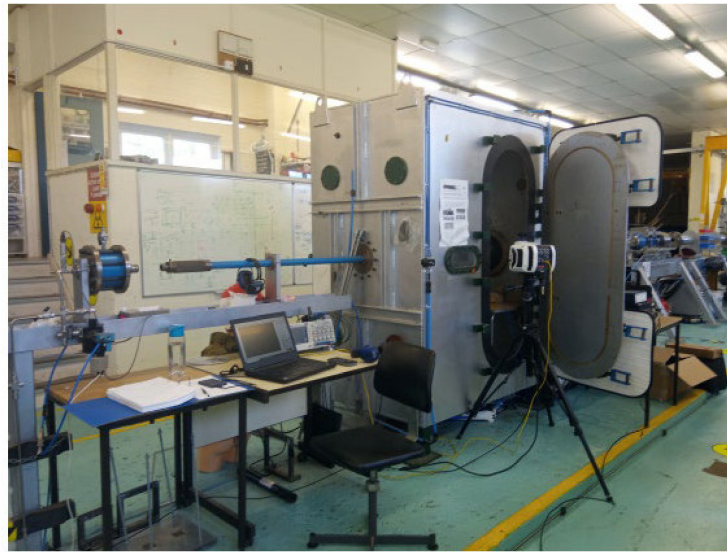
Figure 2. Picture of the setup for the gas gun and chamber.

The impact testing was conducted using a single-stage light gas gun (Figure 2), which used compressed air to propel the projectiles. The gas gun consisted of a 1.75-m-long smooth-bore barrel with a calibre of 22 mm. Gravel was used as a projectile; this was sabotaged to enable the firing of sub-calibre sizes and loaded into the gun at the breech end. The breech was then sealed and the was gun charged with the correct pressure to produce the velocity required. The velocity was measured via a set of infrared LEDs and receivers, and the time between them was recorded on an oscilloscope. The gun was fired remotely via an electronic solenoid. A Phantom V1212 high-speed camera operating at 10,000 frames per second was used to record the impact and assess the residual velocity.

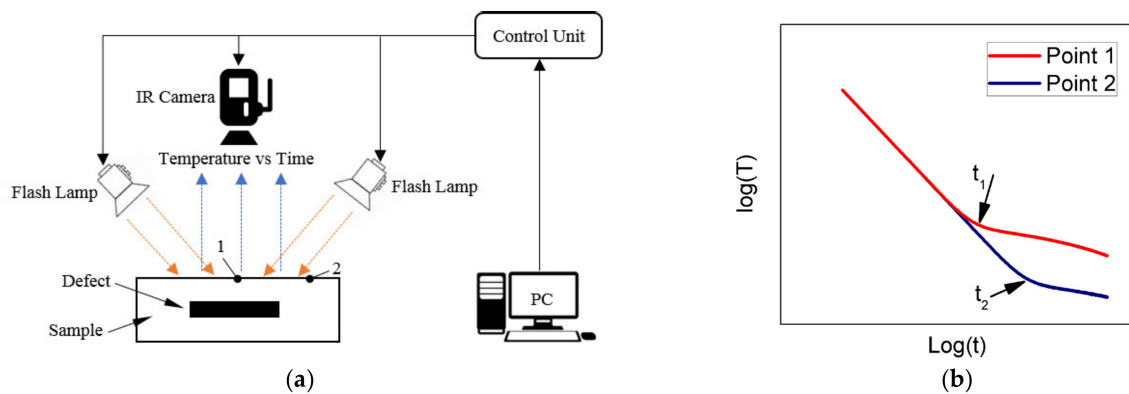
Figure 4. (a) Experimental configuration of the pulsed thermographic inspection under the reflection mode, where Point 1 denotes a surface location with a defect underneath and Point 2 denotes a location on the sample surface with no defect underneath. (b) Typical observed time–temperature decay curves in the logarithmic domain for Points 1 and 2, respectively, where the times of t_1 and t_2 are the key for measuring the thickness of the local materials.

Pulsed thermography is a reliable non-destructive testing technique for detecting near- and sub-surface damage. It is a more robust and faster method compared to ultrasonic testing and X-radiography [26]. The typical thermographic setup is illustrated in Figure 4. A pulse was emitted by a flash lamp onto the specimen's surface. Heat conduction took place on the sample and led to a decrease from the surface to the interior. An infrared (IR) camera measured the temperature of the sample surface against time. Point 1 in Figure 4 represents an undamaged area of the sample, while Point 2 represents a damaged one. In the presence of a defect, a temperature deviation occurred, and the time when it occurred (t_1 in Figure 4) allowed the estimation of the defect's depth. Initially, thermographic analysis was based on contrasts in the post-heating images. Most modern systems analyse each pixel individually and independently. This allows to not be dependent of a reference standard. Thermographic signal reconstruction (TSR) allows noise reduction, and its first and second derivatives are invariant to ambient conditions, surface preparation, and input energy, thus allowing the analysis of the sub-surface of a specimen. TSR is, then, a polynomial fitting, and its first and second derivatives allow the visualisation of heat flow and heat flow variation. In this study, the model order was chosen as 7. Considering the thickness of the samples and the low thermal diffusivity of the composites, a sampling rate of 20 Hz was used, and a total of 1000 frames (equivalent to 50 s) were captured after the flash.
