# Investigation of Injection Repair Technique for Non-Visible Damages in Automotive Composites

**Abstract:** In recent decades, composite materials have been widely used in several fields. The challenge in recent years has been to find an effective and automatable repair technique for these materials. Low-speed impact tests were carried out on panels made from prepregs in carbon fibre and epoxy resin. An innovative repair technique has been tested by injecting resin into the delamination due to the impact event. After the first impact, some panels were repaired and re-impacted, while others were impacted twice consecutively. The data analysis and damage detection by an ultrasound technique demonstrate that the absorbed energy of the twice-impacted panels is lower than that of the repaired ones, demonstrating a configuration similar to that of the panels impacted only once. The results of this research have demonstrated the effectiveness of the repairs.

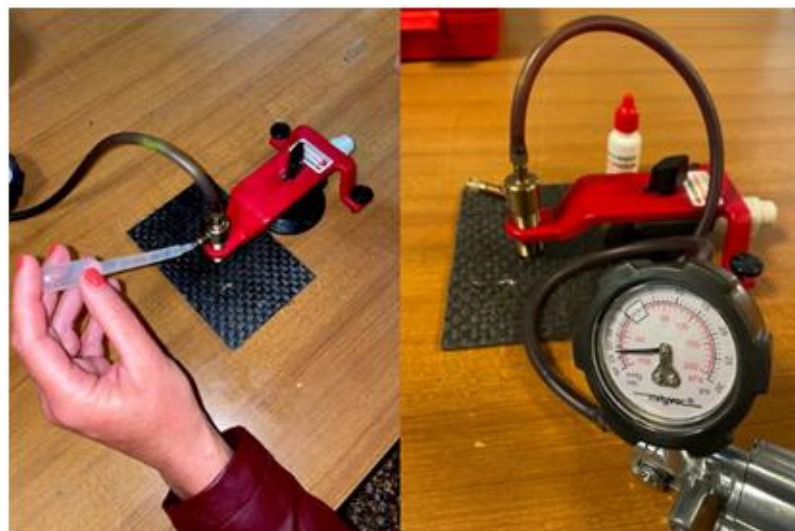
The proposed injection repair process, illustrated schematically in Figure 1, offers several advantages over traditional techniques. Initially, the specimens are prepared by securing them onto a work surface using a specially designed frame. This ensures stability during the repair process. The central part of the work focuses on the impact point, where a circular pattern of holes is drilled (Figure 2). These holes serve two primary purposes: cleaning the delaminated area and providing vents for the injected resin (Figure 1). Traditional injection methods often lack this venting mechanism, leading to air becoming trapped and incomplete resin infiltration. By incorporating vent holes, the proposed method effectively eliminates air entrapment, which could otherwise obstruct resin flow within the delaminated layers. Before injecting the resin, any residual debris from the impact is removed using acetone and compressed air to ensure a clean bonding surface.

**Figure 1.** Repair of impact damages by direct injection.

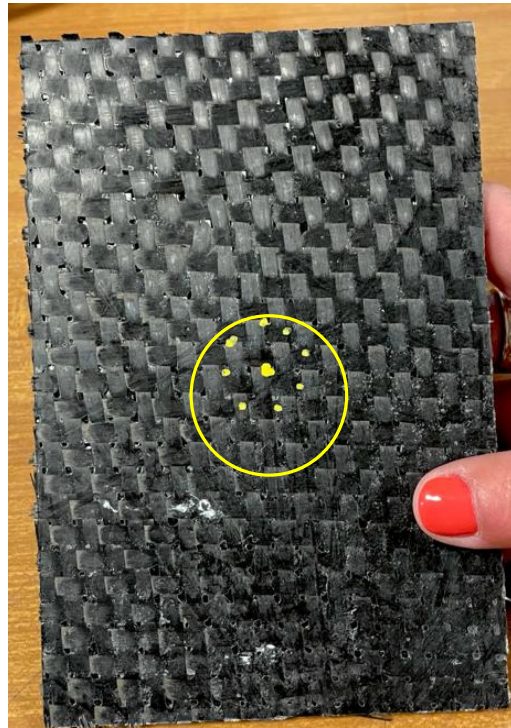
**Figure 2.** Vent holes and resin injection point on the composite panel.

The proposed injection repair process, as illustrated in Figure 2, represents a significant advancement over traditional methods by incorporating several innovative features designed to enhance repair effectiveness. Unlike conventional techniques, which often face challenges such as incomplete resin infiltration due to trapped air, this process inte-

grates venting holes to ensure thorough resin distribution and minimize air entrapment. Lai et al. (2020) underscore the critical role of effective resin infiltration in restoring mechanical properties after impact damage, and this method addresses this need by employing targeted venting strategies to optimize resin flow and penetration [19].

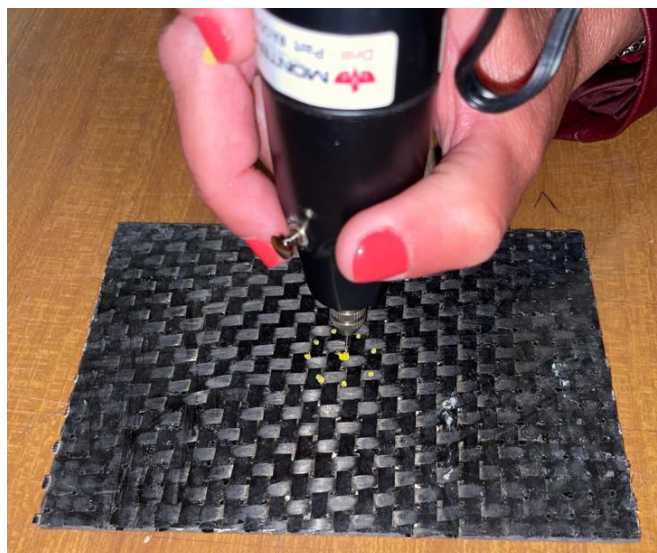
The injection apparatus is then precisely positioned over the impact point and secured to create a perfect seal. This step is critical to prevent resin leakage and ensure that the resin is directed into the delaminated areas. Once the pump is attached, the resin is injected through a secondary nozzle, ensuring thorough penetration and distribution of the resin within the damaged area (Figures 2 and 3). The repaired panels are subsequently placed in an oven for curing at 40 °C for 16 h. This controlled curing process allows for optimal resin performance and adheres to the composite's service requirements.

**Figure 3.** Resin injection.

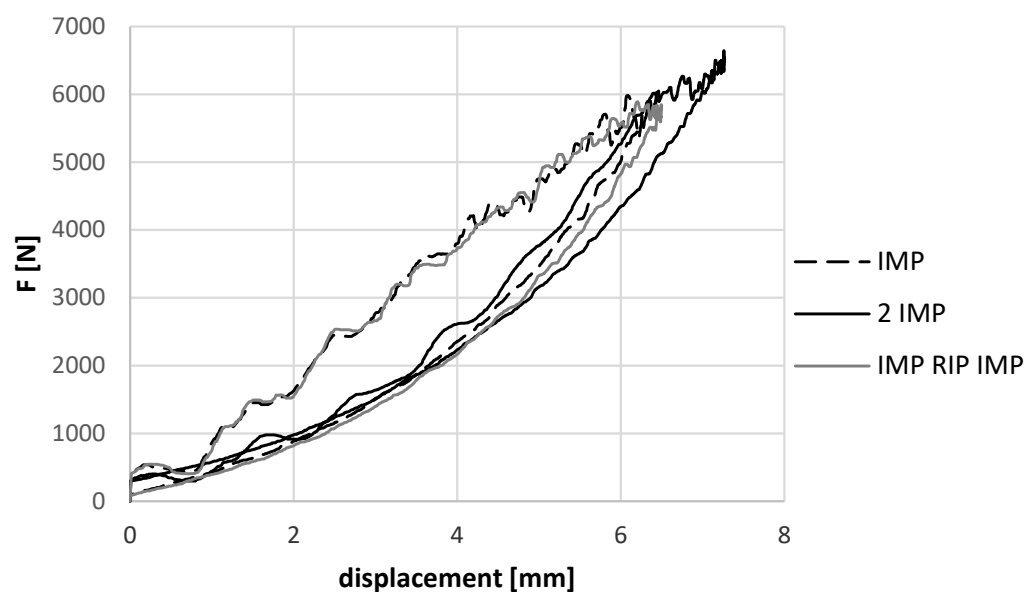
In Figure 4, closed load–displacement curves obtained with the three selected procedures are compared. The closed curves indicate the start of damage without perforation. The impact strength grows from zero to the maximum load, where the impactor returns and the force decreases. The area enclosed in the curves is equal to the absorbed energy,  $U_a$ , used by the material to create damage. So, as the area increases, the absorbed energy and global damage increase. In particular, the panels repaired before the second impact (IMP-RIP-IMP) return to their previous state, displaying properties like those of the panel that was subjected to only one impact. Also, the recorded maximum deformation ( $d_{max}$ ) and maximum impact strength ( $F_{max}$ ) values are similar for the IMP and IMP-RIP-IMP cases but lower than that observed for the panel that suffered two consecutive damages, 2IMP (Table 2).

Figure 4. Load–displacement curves for all tested samples at  $U = 20$  J.

The enclosed area under the curve represents the absorbed energy,  $U_a$ , and the global damage index grows higher as the damage increases. For example, Table 2 shows that the  $U_a$  from a single impact case (IMP) is lower than of an impacted-repaired-impacted panel (IMP-RIP-IMP), since the intermediate repair has restored its initial properties, considering that the composite behaves elastically. On the contrary, the energy absorbed by the double-impact panel (2IMP) is shallow compared to the  $U_a$  entity absorbed after the first impact, since the consequential damage causes the panel to behave like two glued thin laminates. Thin panels [27] exhibit elastic behaviour, so most energy is elastically dissipated. At the same time, the extension of the damaged area propagates further.

The analysis of load–displacement curves (Figure 3) and subsequent measurements of absorbed energy ( $U_a$ ), delamination area (A), and indentation depth (I) reveal that the repair process significantly mitigates the impact of damage. Panels that are repaired before undergoing a second impact (IMP-RIP-IMP) exhibit performance characteristics similar

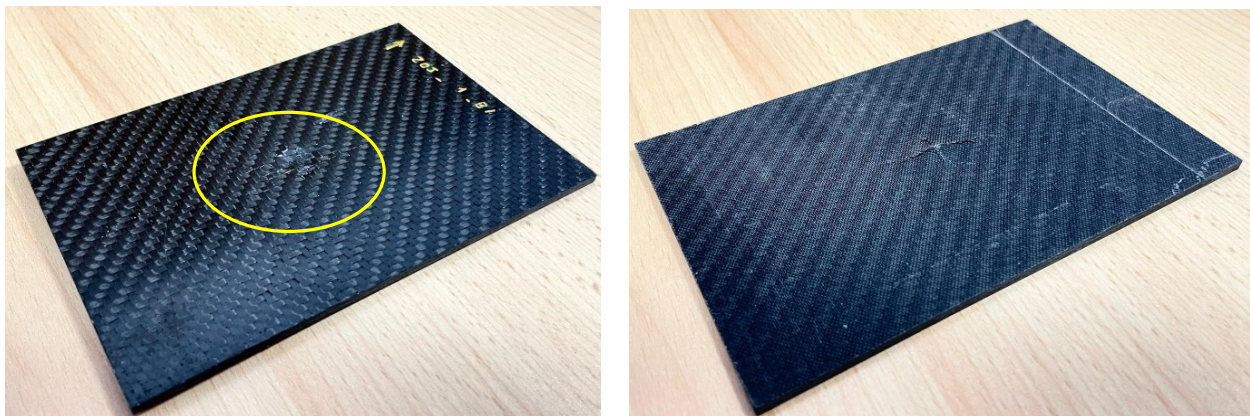
Figures 5–9 show images of the samples after impact. The damaged area consistently appears diamond-shaped, with the principal axes aligned with the warp–weft directions of the surface fabric layers (the horizontal and vertical directions in the pictures), where fibre fractures are observed. For the sample that was impacted only once (IMP) (Figure 5), more significant damage is visible on the side that was in contact with the penetrator. In contrast, the other panels, including those that were impacted twice (2IMP) (Figures 8 and 9) or impacted–repaired–impacted (IMP-RIP-IMP) (Figures 6 and 7), exhibit more extensive damage on the back side of the panel. This pattern suggests that the single-impact sample (IMP) absorbed the impact energy in a way that concentrated damage near the point of impact, whereas the panels subjected to multiple impacts, including the repaired panel, showed damage that extended more towards the back side. The measurements taken after deployment confirm these observations, revealing fibre fractures along the warp–weft directions in the internal layers. The greater deformation on the lower surface of the twice-impacted (2IMP) samples and the IMP-RIP-IMP samples indicates that the energy distribution during the impact event differed, leading to distinct damage patterns.

**Figure 5.** Front and back pictures of the impacted panel (IMP).

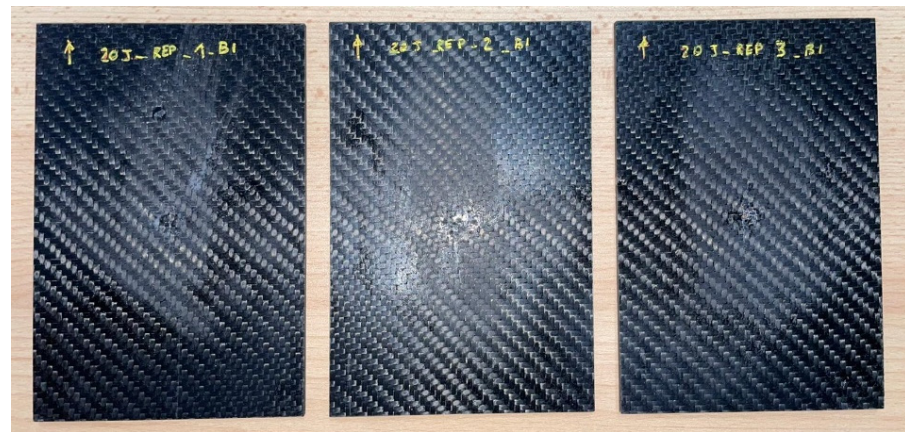
**Figure 6.** Front pictures of the impacted–repaired–impacted panels (IMP-RIP-IMP).

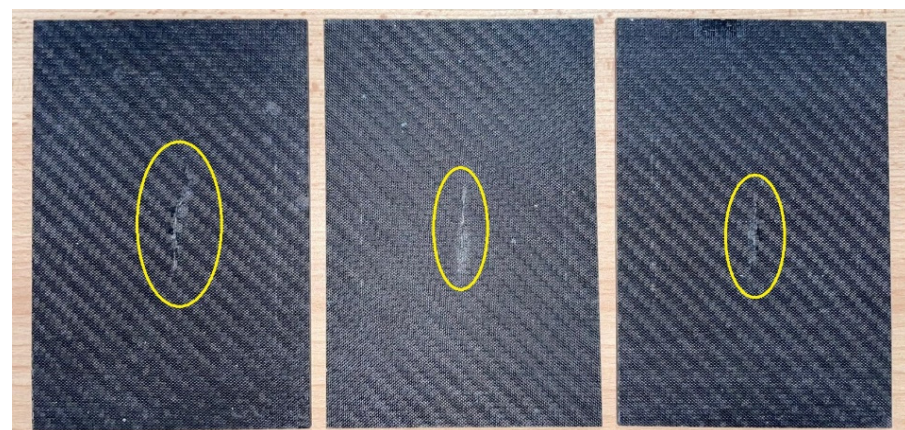
**Figure 7.** Back side pictures of the impacted–repaired impacted panels (IMP-RIP-IMP).

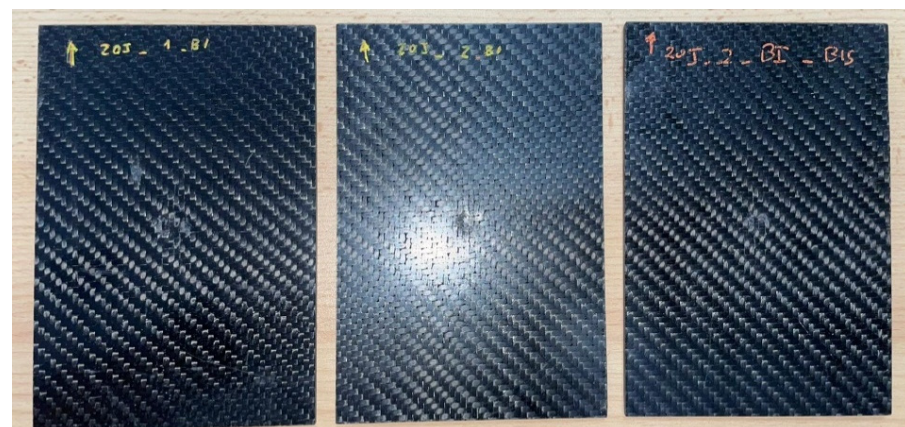
**Figure 8.** Front pictures of the impacted twice panels (2IMP).

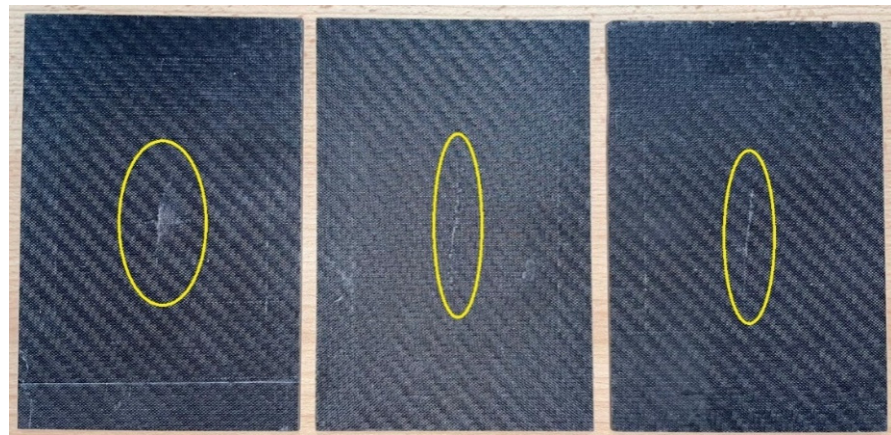
**Figure 9.** Back side pictures of the impacted twice panels (2IMP).

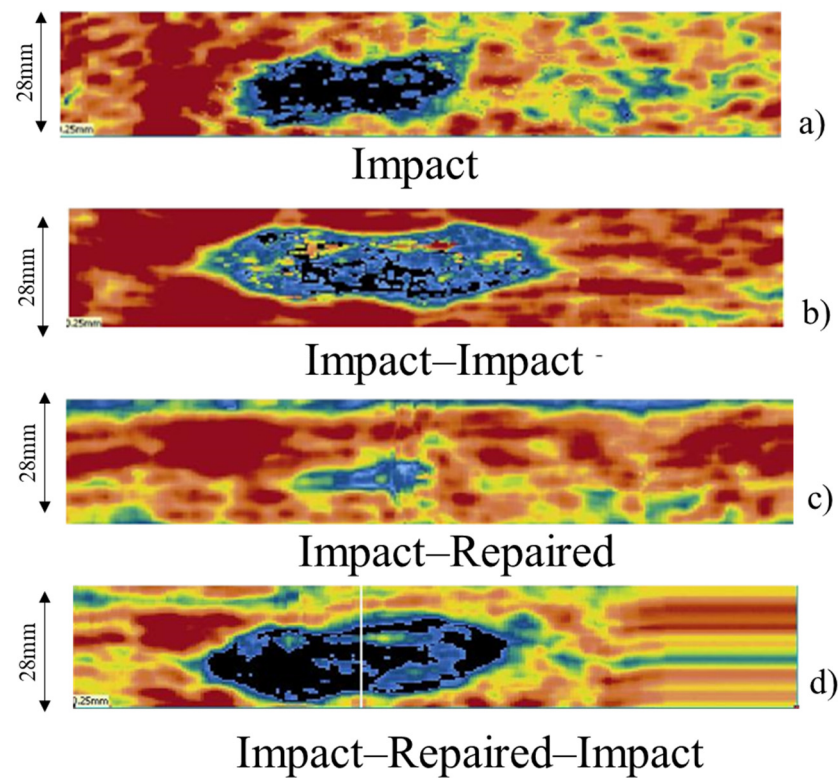
One of the most potentially dangerous aspects of the impact response of composite structures is the difficulty of detecting damage via visual inspection, even in the presence of considerable strength and rigidity losses. The specimen was scanned along the thickness ply by ply, and the result is reported in one plan as a C-scan image of the impacted, twice impacted, impacted-repaired, and impacted-repaired-impacted specimens (Figure 10). C-scan inspections were applied to provide a plane view of specimens subjected to ultrasound analysis, and they were captured using ultrasonic evaluation before and after impact, providing a baseline for damage and identifying fabrication flaws. In particular, the C-scan shows a reconstruction of the damage, ply by ply, in one plane, so that all of the damage can be seen and measured. A more transparent image of the internal delamination was obtained by appropriately setting the gate. Using this image and the known dimensions of the scanned area and specimen, the size of the defect can be properly quantified. Echo Max (abs) was the detection mode used. Once the gate has been set, only the maximum peak that exceeded it was recorded in the scan. Based on the exceeding threshold of the gate (and therefore the signal amplitude), the C-scan had a different colour, which turned black if the signal could not exceed the established threshold. Each delaminated area was then imported into CAD software (Image J Wayne Rasband (NIH) version 1.54J), where it was bordered and measured. The damaged areas are represented in different colours and can be easily identified and measured. Table 3 summarizes the absorbed energy ( $U_a$ ), delamination area ( $A$ ), and indentation depth ( $I$ ) of the samples. The indentation depth, which measures the plastic deformation caused by the impactor, is the lowest for the IMP sample and the highest for the IMP-RIP-IMP sample.

Notably, the IMP-RIP test results show the smallest delaminated area, with only  $129.876 \text{ mm}^2$  of damage detected. This minimal damage underscores the effectiveness of the repair process in restoring the composite's structural integrity. The reduced delamination indicates that the composite regained much of its original strength and stiffness, allowing it to better resist subsequent impacts. When the repaired sample was subjected to a second impact (IMP-RIP-IMP), it exhibited a delaminated area comparable to that of the panel that was impacted twice (2IMP). However, it absorbed energy similar to that of the panel that was impacted only once (IMP). This comparison highlights the high efficiency of the repair process, which effectively minimizes damage while preserving the composite's durability and performance. Additionally, the greater indentation observed in the IMP-RIP-IMP panel further demonstrates the successful restoration of the material's impact resistance after repair.

**Figure 10.** C-scan images of samples impacted (a), impact–impact (b), impact–repaired (c) and impact–repaired–impact (d).

An ultrasound C-Scan inspection was carried out along the plate in a strip containing the delaminated area to evaluate the repair technique's suitability. In any case, as reported in the literature, the different kinds of damage can be collected in two big groups [2–5]: (a) external damage, which is characterized by different depths of the plastic deformation left by the impactor on the impacted surface, labelled as indentation; (b) internal damage, which is characterized by interlaminar fractures, delaminations produced by interlaminar stresses, fibre cracks (in-tension fibre breakage and in-compression fibre buckling) and
