Fatigue Crack Propagation Monitoring Using Fibre Bragg Grating Sensors

Abstract: The paper presents the analysis of the possibility of fatigue crack detection and monitoring its propagation process using fibre Bragg grating (FBG) sensors. The investigations were carried out on an aluminium alloy sample (a part of the Mi-2 helicopter rotor blade). During the fatigue test, the sample was equipped with FBG sensors applied for strain measurement and the vibration-based strain monitoring. It was observed that the strain curves determined by the FBG sensors agreed well with the fatigue force profile. However, the strain curves were almost insensitive to the crack propagation process, except in the last stage of the test, when the crack length was equal to 25 mm. The strain values and the natural frequencies of the sample that were determined experimentally were compared with the values achieved from the finite element method model, with both methods showing good agreement. Additionally, spectrogram-based analyses were performed, focused on the acoustic waves phenomena related to a crack propagation process. It was confirmed that the proposed signal processing method, based on spectrogra

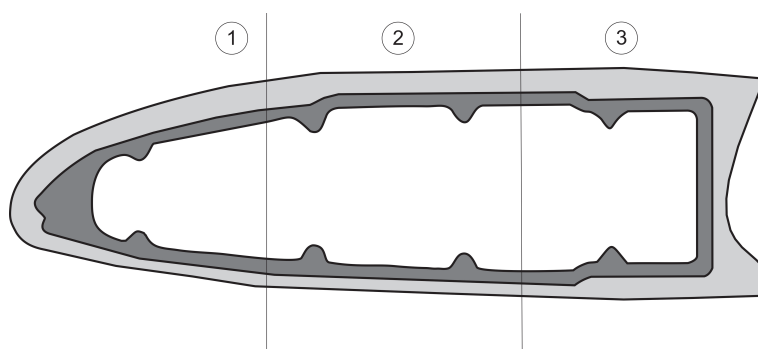
A helicopter's main rotor blades are complex structures. In helicopter Mi-2, this element is made of aluminium alloy (duraluminium 2024-T3). The honeycomb filler has regular hexagonal cells of 5 mm size. The scheme of a main rotor blade part is presented in Figure 1. In the scheme, three regions are marked according to their structural features. They are as follows:

- (1) A leading edge part including corrosion protection elements and heating parts;
- (2) A middle part including upper and lower D-spar walls;
- (3) A back part containing a D-spar back wall as well as additional sections with honeycomb filler (do not present in the scheme).

Figure 1. Scheme of the helicopter Mi-2 main rotor blade cross-section focused on D-spar element.

Investigations performed on rotor blades of helicopters Mi-2, Mi-4, Mi-8 and Mi-24 suggest that the origin of many fatigue cracks is located on the back wall of the main rotor blade D-spar (73% cases) (region (3)—Figure 1). Then, the cracks propagate on upper or lower walls of a D-spar (region (2)—Figure 1). The dimension of typical fatigue damage ranges from 35% to 40% of an area of a blade cross-section. Usually, damaged areas are detected during typical scheduled NDT inspections, and blades are repaired [41].

As mentioned previously, fatigue cracks propagate in the upper or the lower wall of D-spar (a part denoted as (2)—see Figure 1). Therefore, the experimental investigation was performed on a sample of a dimension of $0.3 \text{ m} \times 0.1 \text{ m}$ that had been mechanically extracted from the upper wall of Mi-2 main rotor blade. During the extraction process, attention was paid to not overheat the sample, resulting in changes in its structural properties. The sample thickness was almost stable and its mean value was equal to 0.005 m. The geometry of the sample instrumented with FBG sensors array is presented in Figure 2.

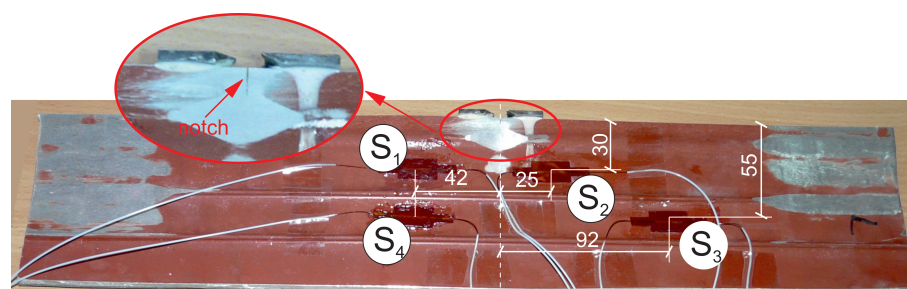
Figure 2. Geometry of the investigated sample with FBG sensors array (FBG are denoted as S_1 – S_4).

The FBG sensors were placed in locations denoted from S_1 to S_4 —see Figure 2. Each sensor location along the sample was determined as a distance between the notch axis (dotted line) and the centre of the sensor. Analogically, a similar distance along the sample was determined from the edge (with the notch) of the sample to the centre of each sensor. Three FBG sensors (S_1 , S_2 and S_4) were mounted close to the notch tip, while one FBG sensor (S_3) was mounted far from the notch, close to one end of the working area of the sample. Sensors S_1 and S_2 were not located symmetrically due to the dimension of the FBG sensors' protective coat. The FBG sensor S_4 was mounted at the same distance from the notch tip axis as sensor S_1 , but after a stiffener.

The spectrograms presented in Figures 11–14 showed that a crack propagation influence is not visible on any of the spectrograms determined for sensor S_3 . As mentioned previously, sensor S_3 was close to the machine clamps to determine frequency responses that originated from the fatigue test (Figure 2). Therefore, it can be assumed that sensor S_3 is only influenced by the fatigue test loading spectrum. The phenomena related to the fatigue test loading are visible in all spectrograms for all FBG sensors. Therefore, it can be assumed that the influence of the fatigue test is similar for all FBG sensors mounted on the sample.

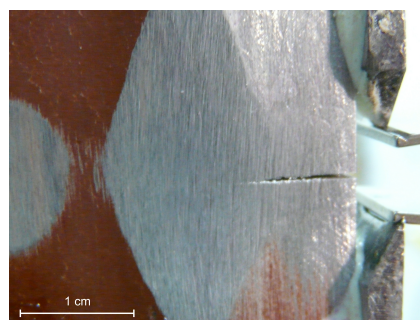
In the middle of the longer side of the sample, a notch was cut to serve as a fatigue crack origin (Figure 3). The notch tip location was chosen based on investigations performed in the Air Force Institute of Technology (AFIT) related to fatigue crack propagation and its origin in the main rotor blade D-spar. Then, the sample was ground on both sides to prepare for clamping in a fatigue machine.

Figure 3. The notch in the sample—the fatigue crack origin.

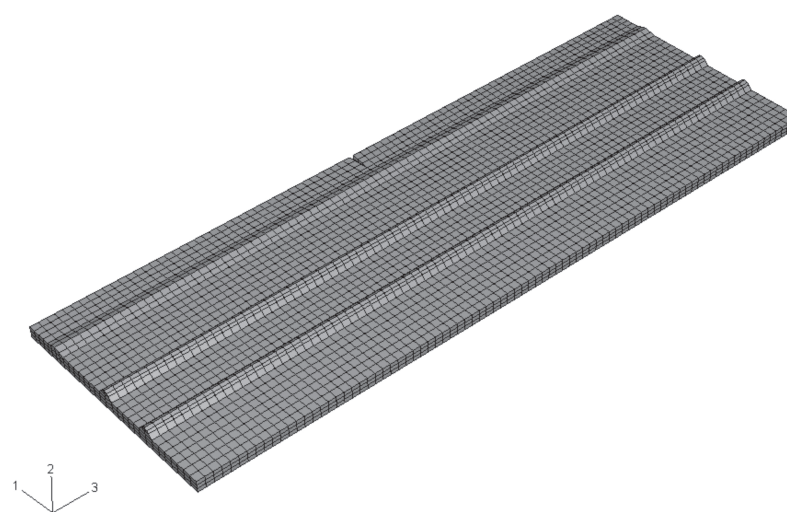
In order to predict the behaviour of the sample during the fatigue test and to determine the FBG sensors' locations, a finite-element model of the investigated part of the main rotor blade was prepared. The finite-element method (FEM) model with mesh is presented in Figure 4. The model was based on the blade geometry presented in Figure 2 and as a modelling tool, the finite-element package ABAQUS® was used. By using the commercial code strain/stress fields during the crack propagation process, the chosen crack propagation path can be determined.

Figure 4. A finite element mesh.

For the finite-element model of the sample, 8600 elements were used in total, while the number of model degrees of freedom was 133,578. Three-dimensional finite elements (brick of C3D20 type) were employed to model the blade.

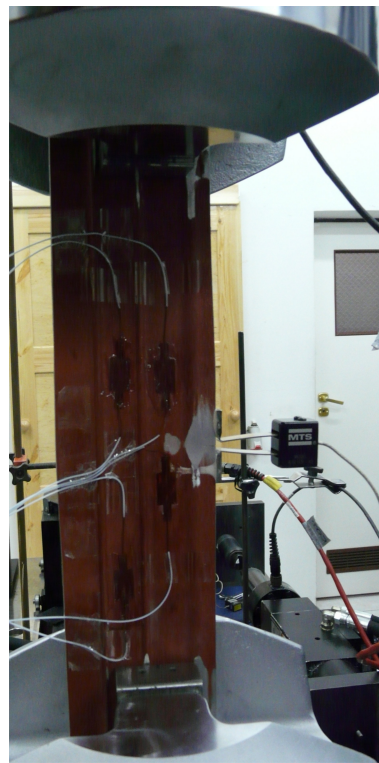
The instrumented sample was mounted in fatigue machine (MTS 810.23) clamps (Figure 5). Additionally, during the test, extensometer MTS 632.03F-30 was used. The FBG sensor array was equipped using interrogator FS2500 Industrial BraggSCOPE (Fiber Sensing) with a sampling frequency equal to 1 kHz. The test was performed at constant temperature, so the temperature compensation was not needed, although the temperature was monitored during the test.

Figure 5. The sample clamped in fatigue machine.

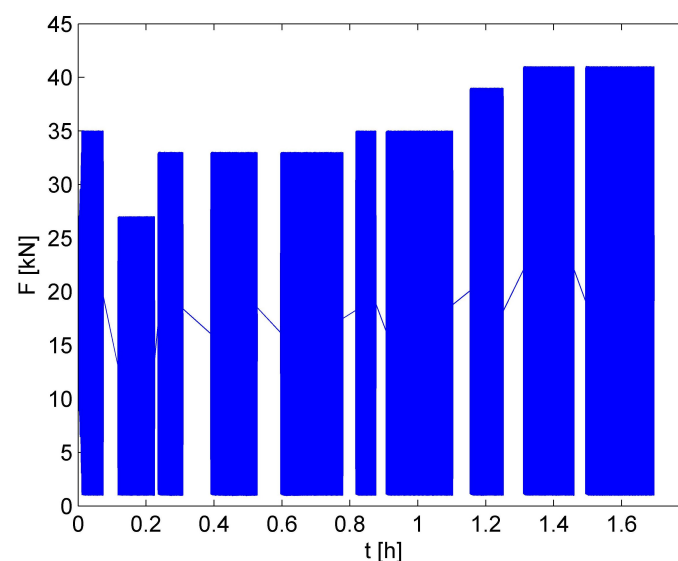
During the test, the sample was loaded cyclically according to the force characteristic presented in Figure 6. The fatigue test consisted of tension cycles from 1 N to maximum load values under stable frequency 2 Hz. The fatigue test is not strictly based on the Mi-2 main rotor blade loads that occur during its normal exploitation. In contrast with an aircraft wing, a helicopter rotor blade has both its upper and lower surfaces in tension because the centrifugal (tensile) loads exceed the compressive blade-bending loads [42]. The maximum load values were selected for the purpose of moderate fatigue crack propagation velocity—mostly achieving stable fatigue crack propagation velocity. The fatigue test parameters were assumed based on the AFIT experience.

Figure 6. A fatigue force values during the test.

The breaks between the consecutive stages of the test, presented in Figure 10 are minimised for the purpose of presenting the real duration of the fatigue test, which took about 80 min. The strain curves remained the shape of the load signal registered by the fatigue test machine—see Figure 6. A small exception is presented in the graph determined for sensor S_2 (Figure 10). The sensor was likely prestrained during the gluing process, so it also showed negative strain values (suggesting the compression behaviour of the sample). Additionally, the strain amplitudes are about half the value of those registered for the other FBG sensors. It is worth noting that the crack propagation process is visible on all strain curves, but only during the two last stages of the fatigue test when the crack was no shorter than 20 mm. For two sensors, denoted as S_1 and S_2 (located before the stiffener), the strain values were decreasing, showing a local small compression. For the other two sensors (S_3 and S_4), mounted after the first stiffener, the registered strain values increased at the end of the fatigue test. The differences are due to the fatigue crack propagation process and the different behaviour of the material when close to the crack tip, as well as the change in the dimension of the effective cross-section of the sample.

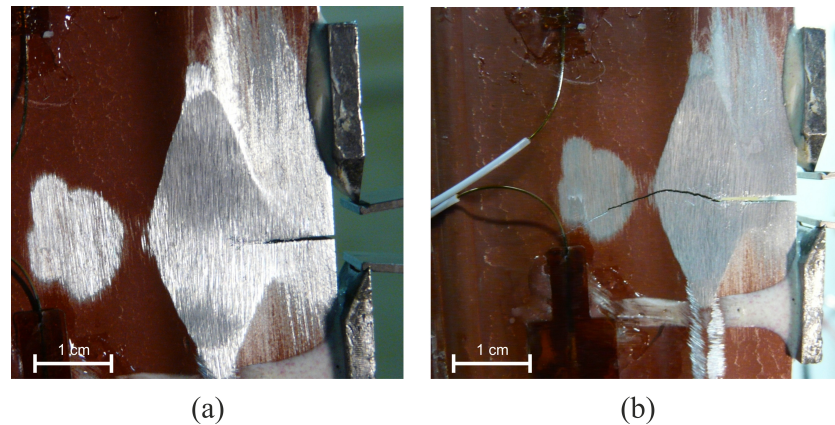
The test was divided into ten stages, lasting between 300 and 450 s. After every stage, the fatigue machine was stopped and the total length of the crack was measured. Two stages of crack evolution are presented in Figure 7. The length of the crack was measured from the end of the notch tip. The fatigue test was finished when the total length of the fatigue crack exceeded of 25 mm in length (Figure 7b).

Figure 7. Photographs of the fatigue crack growth: (a) with a length of 3.6 mm, (b) after the end of the fatigue test.

Spectrograms for FBG sensors for the fifth stage of the fatigue test are presented in Figure 13. The phenomenon of system responses in a wide range of frequencies is visible on spectrograms for sensors S_2 and S_4 , especially in a range between 180 s and 200 s from the beginning of the stage. The total length of the crack after the stage was equal to 3.6 mm (Figure 7a). In this case, the phenomenon can also be connected with the crack evolution.

In Figure 14 spectrograms for the last stage of the fatigue test are presented. The phenomenon of the response of the system in a wide range of frequencies is visible on the spectrograms for sensors S_2 and S_4 , about 400 s and 650 s from the beginning of the stage. The total length of the crack after the end of the fatigue test was equal to 27 mm, and is presented in Figure 7b.

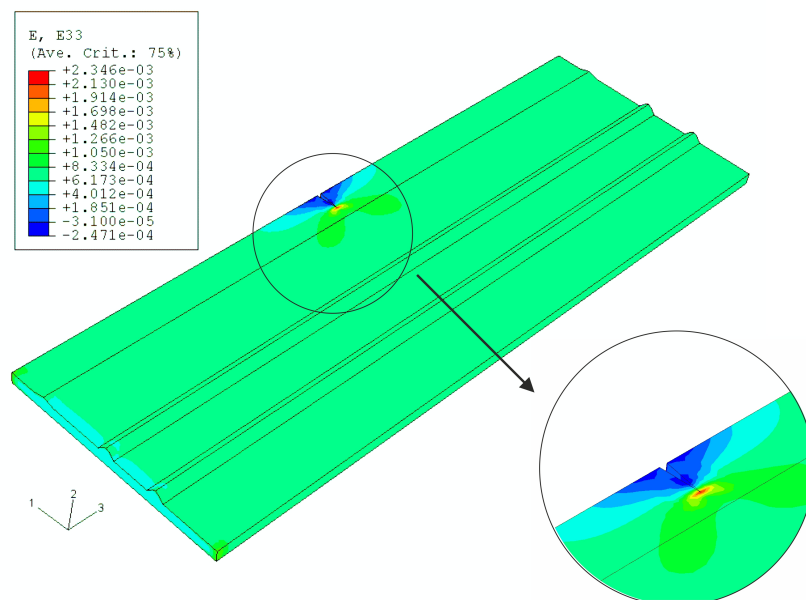
To determine longitudinal strain distribution over the sample surface, the FEM model was used. This parameter was measured by the FBG sensors in the experimental part of this analysis. The FEM results for two stages are presented: for the fatigue test, beginning with a notch in the sample (Figure 8), and for the end of the fatigue test, when the crack length was equal to 25 mm (Figure 9).

Figure 8. Distribution of the longitudinal strain over a sample surface at the beginning of the fatigue test.

As visible in Figures 8 and 9, the maximum strain values are in the notch tip. The strain values determined for the FBG sensor locations are collected in Table 2. In the first stage (Figure 8), strain values are similar in all FBG sensors locations, because the FBG sensors (S_1) and (S_2) located closest to the notch were used after the first stiffener. Due to this, the notch tip influence on the strain values was neglected. The situation changes due to fatigue crack evolution. For the last stage (Figure 9), the maximum strain values in all FBG sensors locations were higher than they previously were. The lower values determined for FBG S_1 and S_2 are because of the decrease in the sample's effective cross-section.

where indexes m and a refer to the strain values measured and calculated using FEM, respectively. The average percentage error for all cases was 10.8%. It can clearly be seen that the obtained results of experimental measurements (Figure 10) are in good agreement with the results of FEM calculations (Figures 8 and 9).

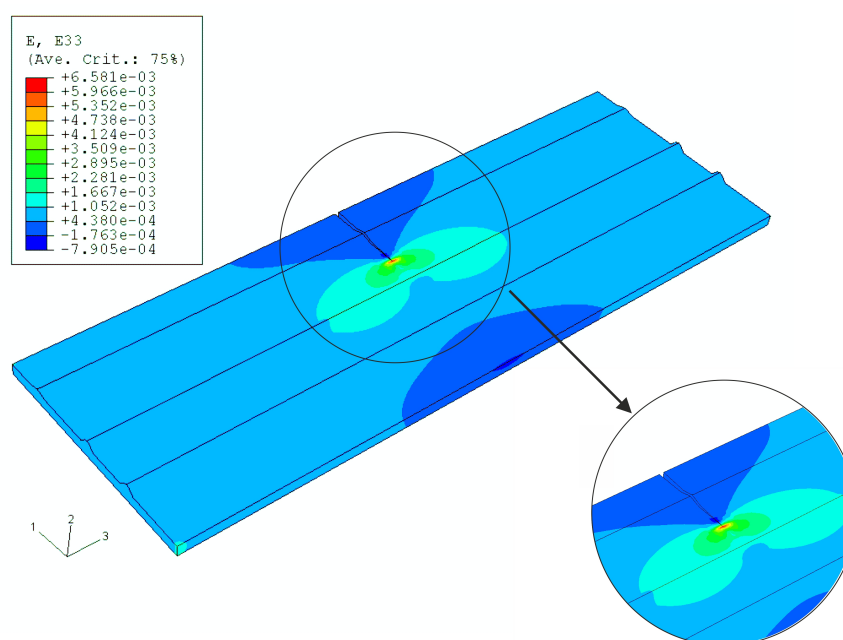
Figure 9. Distribution of the longitudinal strain over a sample surface at the end of the fatigue test.

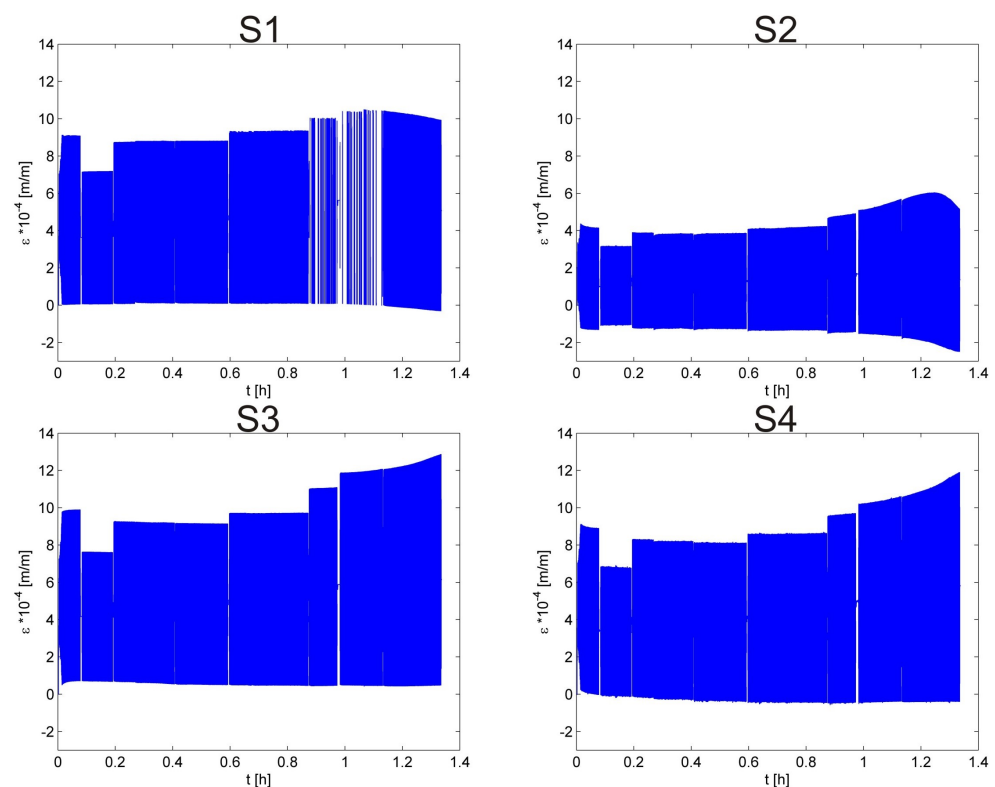
In Figure 10, the strain values measured by FBG sensors during the fatigue test are presented. The strain values were determined using the following relationship:

Figure 10. Strain values measured by FBG sensors during fatigue test.

The strain curves determined experimentally using the FBG sensors (Figure 10) contain an influence originating from both fatigue loading and the blade material degradation process. To obtain strain values trends in the blade, the measured strain signals were filtered and all frequencies higher than 1.5 Hz were removed, as they were related to the fatigue test-loading characteristics.

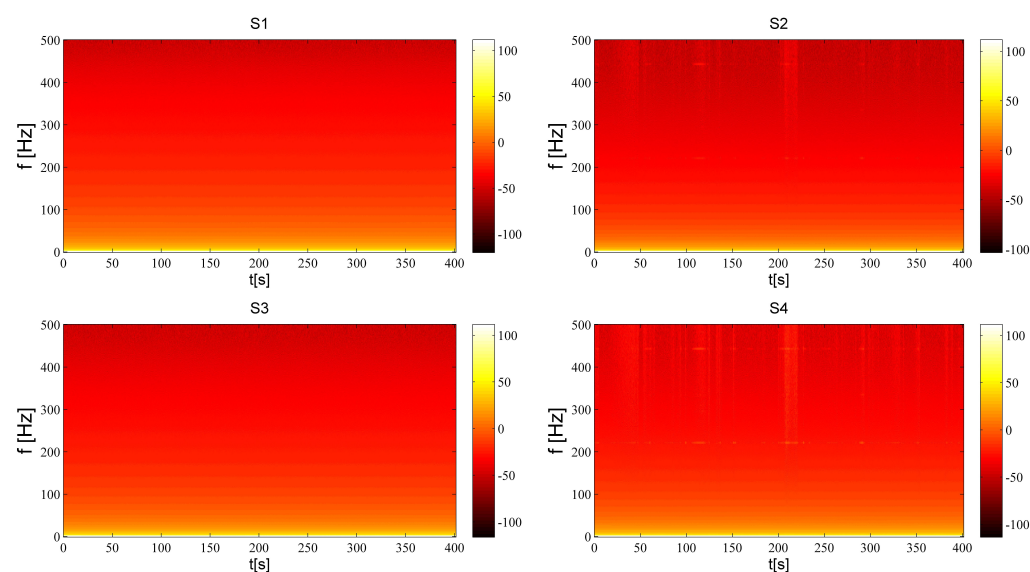
Figure 12. Spectrograms from the second stage of the fatigue test.

Spectrograms for the second stage of the fatigue test are presented in the Figure 12. The maximum loading value, in this case, was smaller than in the previous stage. It was changed to reduce the crack propagation velocity. During this stage, the crack was not propagating, so the length of the crack after this stage was the same as after the previous one. The spectrograms for all FBG sensors were similar, showing only the loading from the fatigue machine. The phenomena referred to as the crack evolution were not observed during this stage.

The differences in spectrograms for the second stage of the fatigue test are presented in Figure 20. The crack propagation process was not observed using the magnifying glass or during the first spectrogram analysis (Figure 12). The response of the spectrum in a wide range of frequencies is visible in spectrogram differences about 210 s from the beginning of the stage of the fatigue test for sensors S_2 and S_4 . The amplitude values of the phenomenon were too small to observe during the previous analysis. Therefore, the crack evolution also occurred during this stage, but the crack propagation velocity was too small to noticeably elongate the fatigue crack using the magnifying glass, even after the end of the stage. The frequency equal to 222 Hz is also excited during the fatigue test stage.

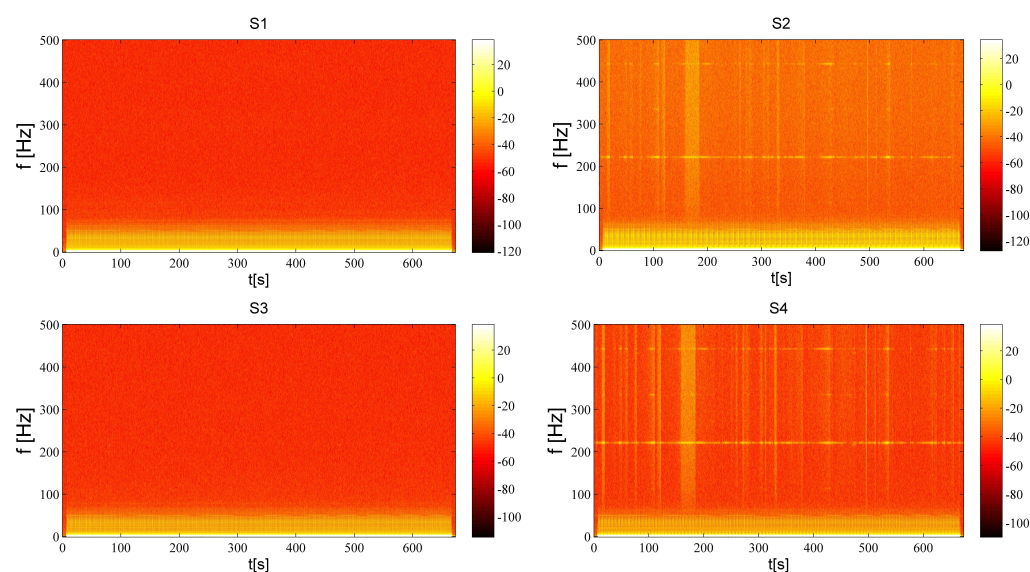
Figure 13. Spectrograms from the fifth stage of the fatigue test.

The strain trends received for the fifth stage of the fatigue test are presented in Figure 17. About 200 s from the beginning of the test, a small peak (2×10^{-6} m/m) is observed for the FBG sensor S_2 . It is worth noting that the change level is close to the sensitivity of the used interrogator, which is equal to 1×10^{-6} m/m. The peak is observed at the same time as the response of the investigated sample in a wide range of frequencies in the spectrogram analysis (Figure 13).

The differences in spectrograms for FBG sensors for the fifth stage of the fatigue test are presented in Figure 21. The phenomenon of the system responses in a wide range of frequencies is visible on both graphs (for sensors S_2 and S_4) in a range between 180 s and 200 s, as well as about 350 s and 480 s from the beginning of the stage. The first range is easily determined for the spectrogram analyses—see Figure 13. The frequency 222 Hz, excited during the fatigue test, has a high amplitude over the whole stage.

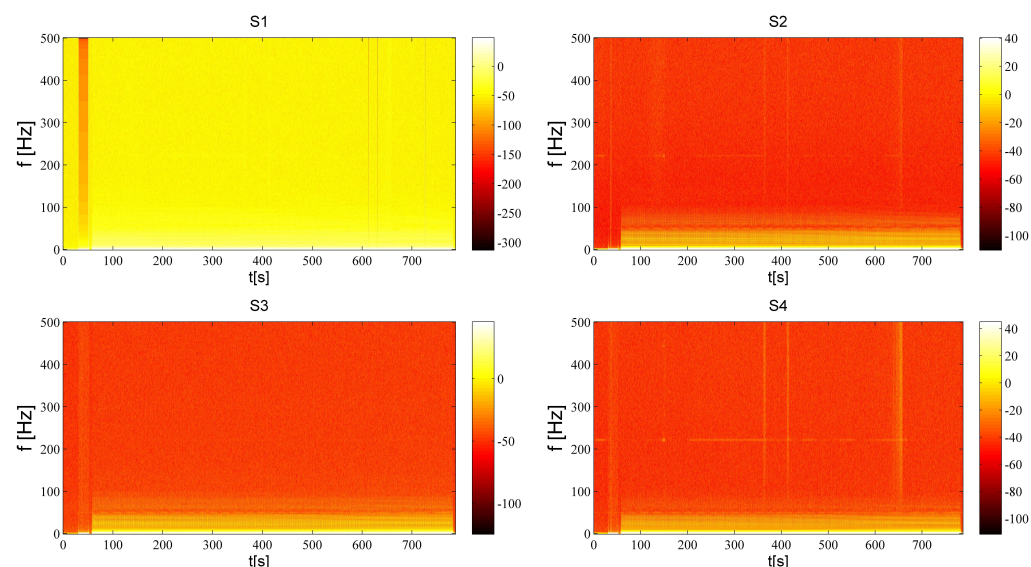
Figure 14. Spectrograms from the tenth stage of the fatigue test.

The strain trends for the tenth stage of the fatigue test are presented in Figure 18. A strong decrease in the strain is observed for the FBG sensor S_2 , while, at the same time, a strong increase in the strain values is registered by sensor S_4 . In the graph for the FBG sensor S_2 , two peaks are observed at 400 s and 650 s from the beginning of the stage. They are observed at the same time as the response of the investigated sample, in a wide range of frequencies, in the spectrogram analysis (Figure 14). The peak amplitude is similar, as it was observed during the fifth stage of the test.

In Figure 22 differences of spectrograms for the last stage of the fatigue test are presented. The phenomenon of the system response in a wide range of frequencies related to crack propagation is visible in the differences for sensor S_4). The phenomenon occurs in a range from 380 s to 400 s as well as about 650 s from the beginning of the tenth stage of the fatigue test. The second range can be also easily determined for the spectrogram analyses—see Figure 14.

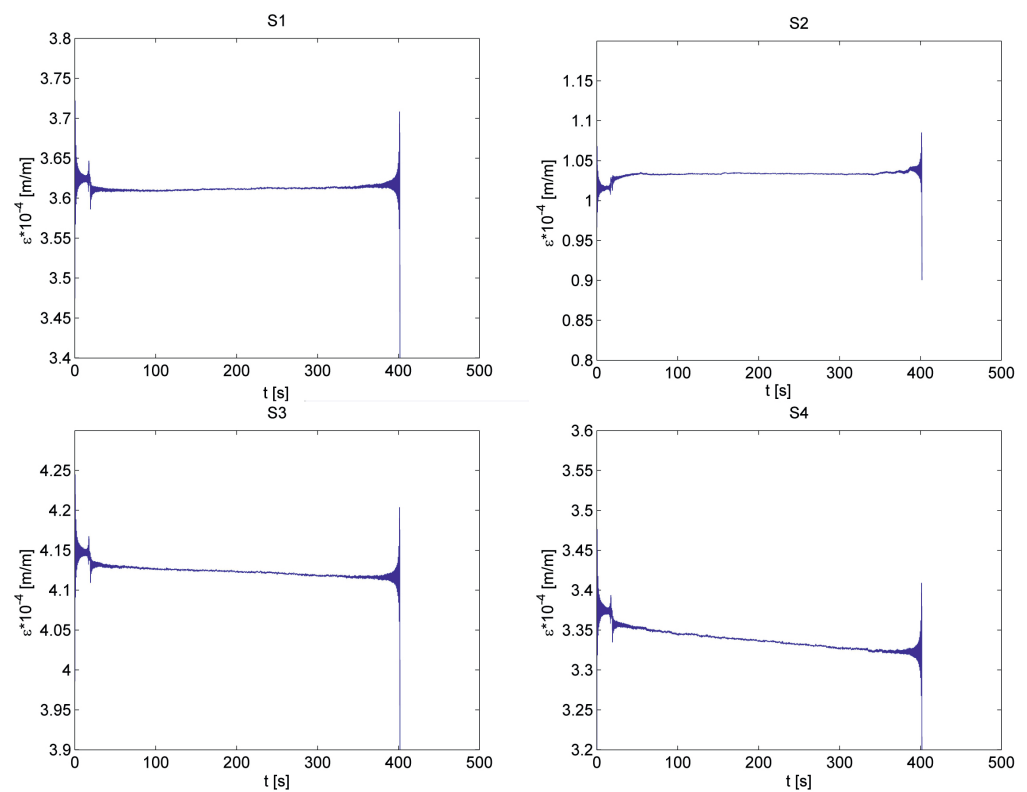
The strain trends received for the second stage of the fatigue test are presented in Figure 16. As in the previous stage, there is no indication of the fatigue crack propagation. Strain changes close to 20 s from the beginning of the stage are related to an unexpected change in the force level.

Figure 16. Strain trends for the second stage of the fatigue test.

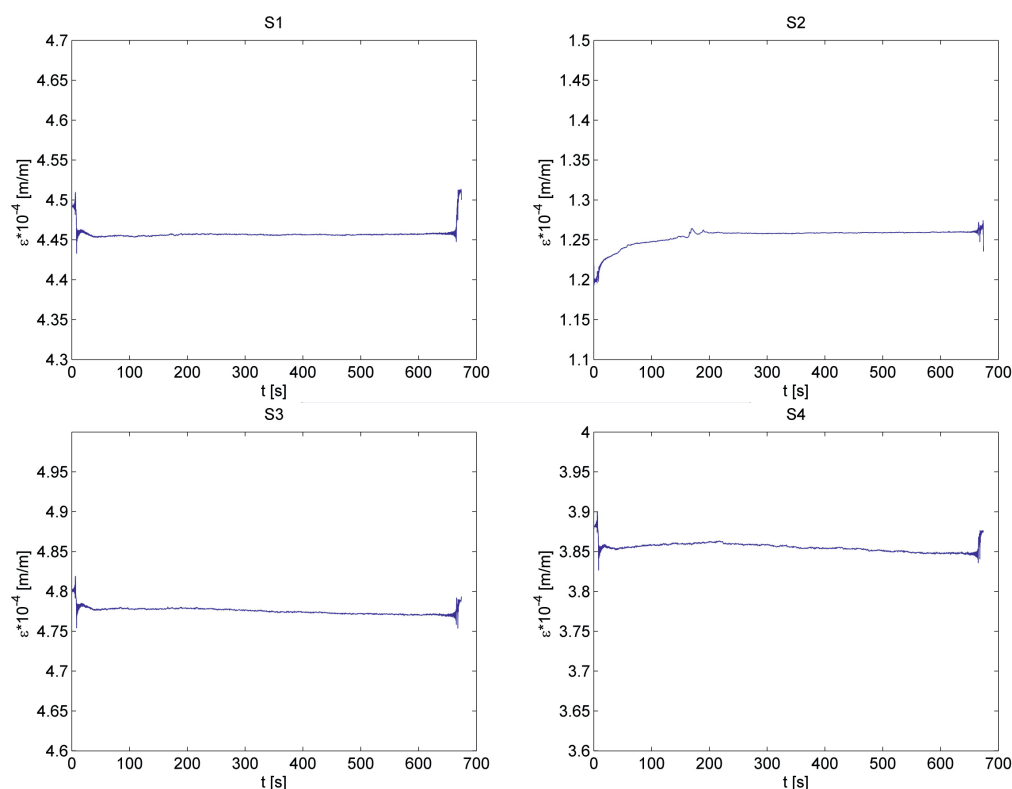
Figure 17. Strain trends for the fifth stage of the fatigue test.

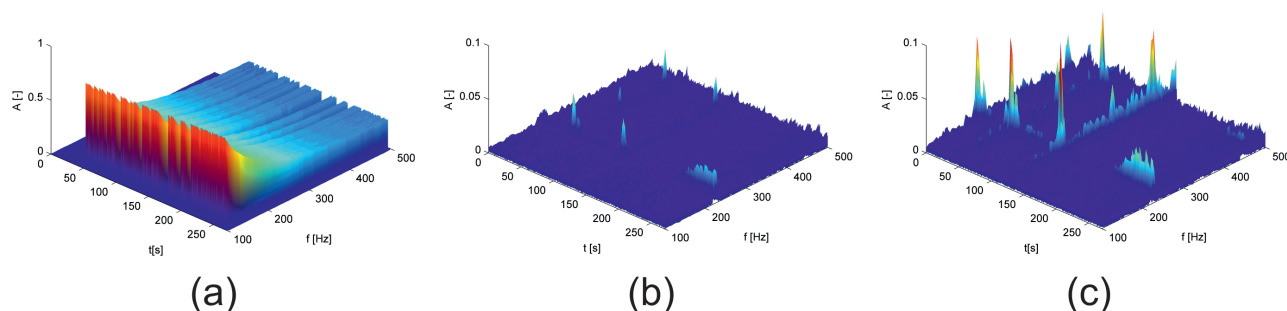
Figure 19. Differences for spectrograms, for the first stage of the fatigue test, for sensor: (a) S_1 , (b) S_2 , (c) S_4 .

Figure 19 presents the differences between spectrograms determined for the first stage of the fatigue test. The phenomenon of the system response in a wide range of frequencies observed in Figure 11 in spectrograms for FBG sensors was S_2 and S_4 about 50 s and 120 s, and is also visible in Figure 19. There are additional high peaks for a frequency equal to 222 Hz. Such a frequency is usually excited in the fatigue test stage. The maximum amplitude values are higher for sensor differences of S_4 than they are for sensor differences of S_2 , because sensor S_4 was located closer to the crack tip than sensor S_2 .

The differences among the spectrograms presented in Figures 19–22 indicate two types of areas with high amplitudes. The first is related to the natural frequencies of the sample (especially the first mode) and are observed for stable frequencies. While the second is related to the fatigue crack propagation and is observed for stable time values. For the purpose of determining the crack propagation process and distinguishing the amplitude changes related to the crack from those linked with the natural frequencies, the following calculations were proposed. Based on the observations presented above, two indicators (F_{Sk} and C_{Sk}) were determined. They are related to frequency and crack influences on the amplitude values, respectively. The indexes are described by the following relationships

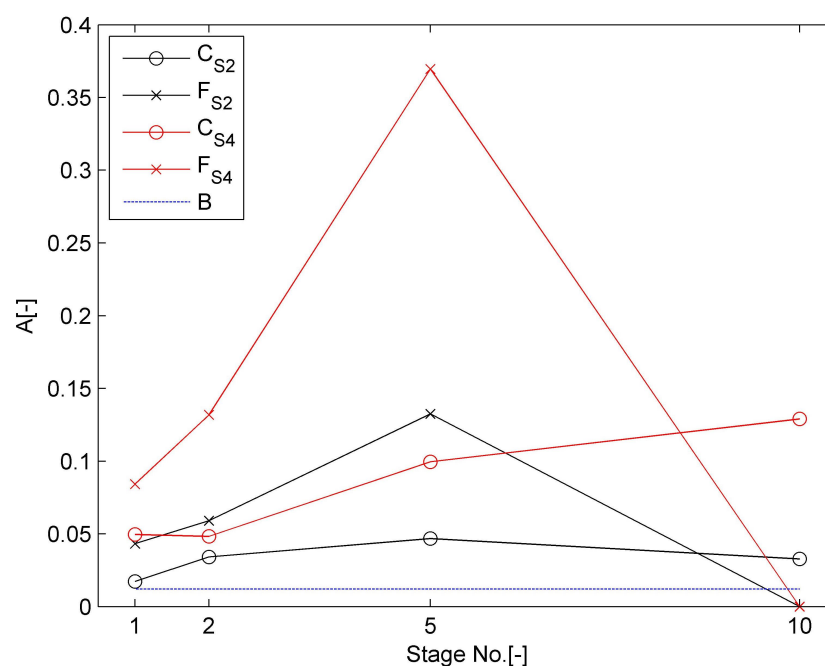
A comparison of indexes F_{Sk} and C_{Sk} is presented in Figure 23. The base values (B) were determined as mean amplitude values for frequencies lower than 200 Hz. Such values are similar for both sensors. It can be seen that both indicator (F_{Sk} , C_{Sk}) values are higher than the base (B), except for the tenth stage, where the natural frequency mode is almost invisible for both sensors. For the remaining stages, the F_{Sk} is much higher than C_{Sk} . However, it is easy to distinguish between both indicators. It is worth mentioning that the C_{Sk} indicators increase or stabilise with time (stages) for both sensors. It can therefore be concluded that the crack propagates. This agrees with the observations performed during the fatigue test.

Figure 23. Comparison of differences in amplitudes for spectrograms for sensors S_2 and S_4 : C—crack, F—natural frequencies, B—base.
