Article

Effects of Vehicle-Induced Vibrations on the Tensile Performance of Early-Age PVA-ECC

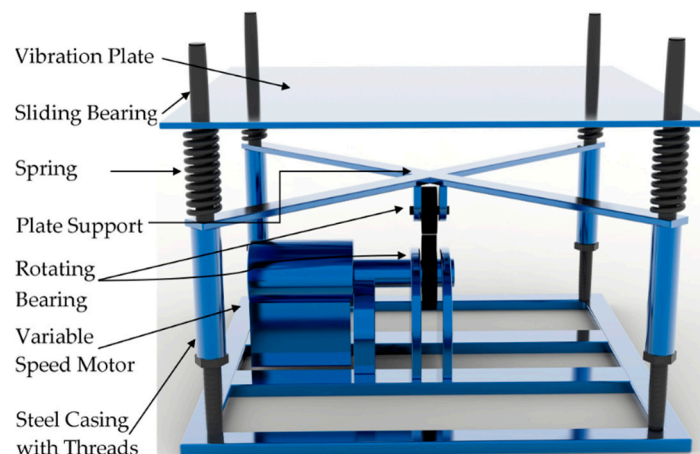
**Figure 1.** Self-improved vibration device based on cement mortar vibration table.

In order to simulate vehicle-induced vibrations, a vibration device was improved based on the cement mortar vibration table (ZH.DG-80, Hebei Dahong Experimental Instrument, Cangzhou, China), as shown in Figure 1. The driving force of the vibration device was provided by a triphasic variable speed motor. The speed of the motor could be adjusted by the frequency converter, and the vibration frequency of the device would then be converted. To ensure that the vibration model was presented as simple harmonic vibration, two rotating bearings with circular eccentricity were added to the vibration device.

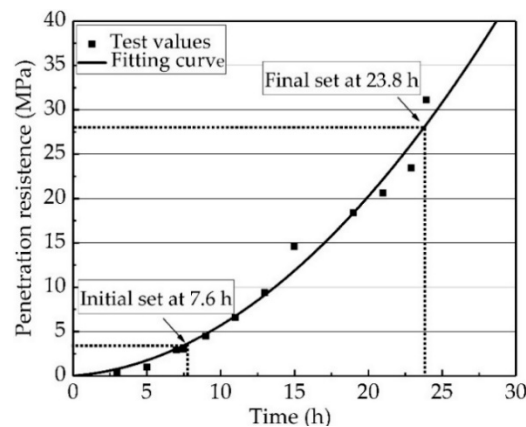
Figure 2. Results from the penetration test showing times of the initial set and the final set.

Before determining the vibration variables, a penetration test needed to be performed to determine the setting time of the PVA-ECC. The setting time of the PVA-ECC was determined based on the penetration resistance test according to JTG E30-2005. The results are shown in Figure 2. From the fitting curve of the time-penetration resistance of the PVA-ECC, the times of the initial set and the final set were obtained, which were 7.6 h (penetration resistance ≤ 3.5 MPa) and 23.8 h (penetration resistance ≤ 28.0 MPa), respectively.

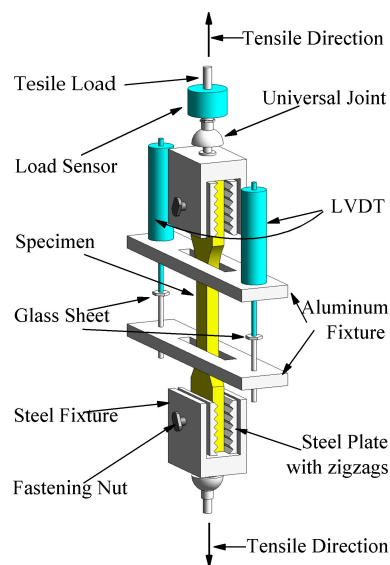
Figure 3. Schematic diagram of the loading device.

The loading device was carefully designed, as shown in Figure 3. To prevent failure occurring at the ends of the specimens caused by uneven extrusion, two steel fixtures were used to clamp the ends of the specimen to produce uniform transmission of the loads. To increase the contact area between the steel fixtures and the sides of the specimen at the ends, four steel plates with zigzag grooves were placed at the contact positions and fastened by four nuts. In order to ensure a uniaxial load and to eliminate eccentric stress for the specimen, two universal spherical hinges were installed at the top of the steel fixture, so that the geometric center line of the steel fixtures could coincide with the axis of the specimen. Before loading, two linear variable differential transformers (LVDTs) were fixed on the

sides of the tested specimen with an aluminum fixture, and the measuring distance was maintained at 90 mm in the middle of specimen.

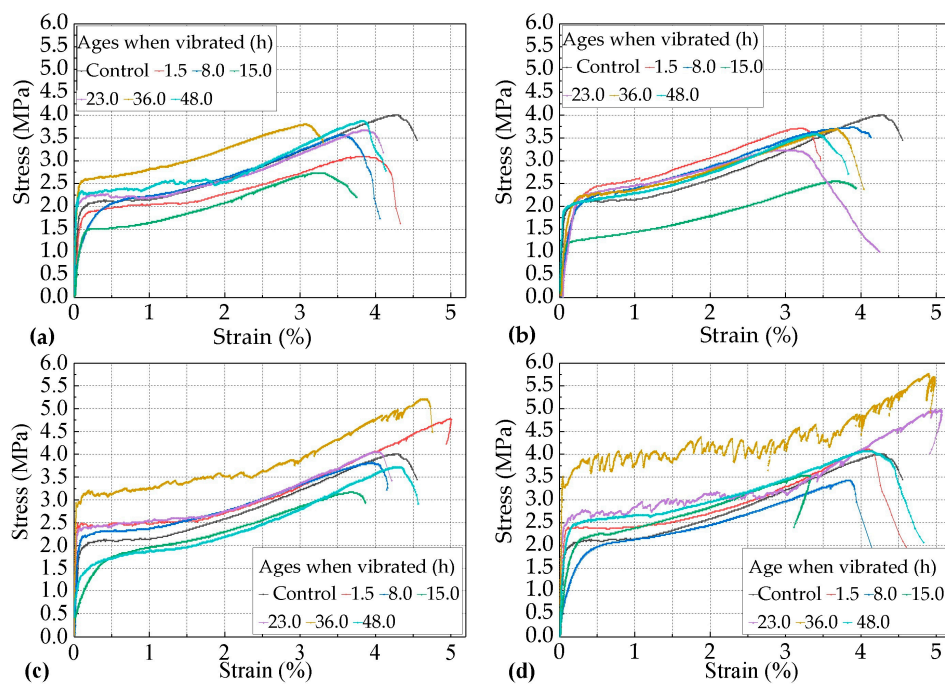
Figure 4. The strain- stress curves of the vibrated PVA-ECC groups and the control group at the ages of 1.5 h, 8.0 h, 15.0 h, 23.0 h, 36.0 h when vibrated subjected to the combination of a constant duration of 5.0 h and different levels of frequency of (a) 2.0 Hz, (b) 3.0 Hz, (c) 4.0 Hz, and (d) 5.0 Hz.

The strain- stress curves of the twenty-four groups of vibrated specimens and the one group of control specimens at different ages when vibrated for 1.5 h, 8.0 h, 15.0 h, 23.0 h, 36.0 h, and 48.0 h, subjected to the combination of a constant duration of 5.0 h and different levels of vibration frequency of 2.0 Hz, 3.0 Hz, 4.0 Hz, and 5.0 Hz, are shown in Figure 4. The rates of cracking strength (σ_{cc}), ultimate tensile strength (σ_{cu}), and strain (ε_{cu}) of the variated specimens over the cracking strength (σ_{vc}), ultimate tensile strength (σ_{vu}), and strain (ε_{vu}) of the control specimens with the increase of ages when vibrated are shown as Figure 5.

Figure 4 shows that every group of PVA-ECC specimens described in this section exhibited remarkable strain-hardening characteristics and super-high toughness. Their ultimate tensile strain stayed steady above 3.0%, indicating that vehicle-induced vibration had no substantial effects on the strain-hardening characteristics and super-high toughness of the early-age PVA-ECC for this condition. Even so, according to the statistics of the twenty-four groups of vibrated specimens and one group of the control specimen, the probability of ε_{vu} being lower than ε_{cu} was approximately greater than 70%. This indicates that the trend of vehicle-induced vibration on the ultimate tensile strain of early-age PVA-ECC was negative overall.

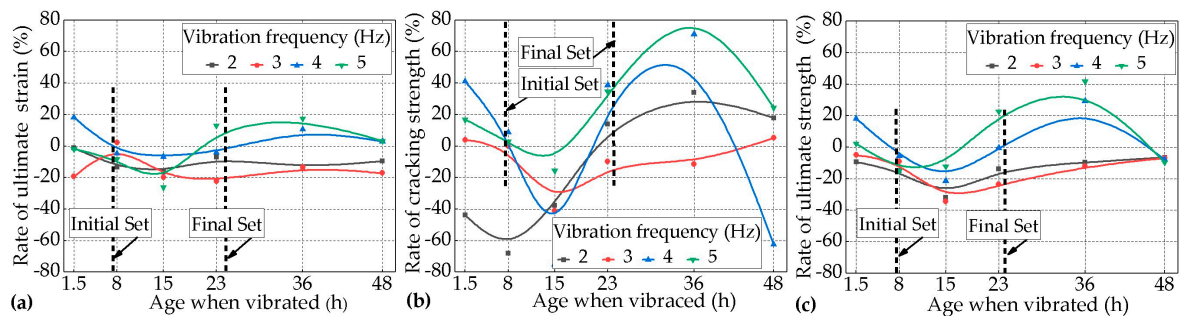
Figure 5. Rates of (a) the ultimate tensile strain, (b) the cracking strength, and (c) the ultimate tensile strength for the vibrated groups over the control group with the increase of the age when vibrated subjected to the combination of different levels of frequency and a constant duration of 5.0 h.

It can be seen in Figure 5a that for the PVA-ECC specimens subjected to the frequency level of 2.0 Hz, their ϵ_{vu} values were lower than ϵ_{cu} throughout the three setting periods, and the most negative effect occurred when the specimens were vibrated at the age of 15.0 h, where ϵ_{vu} changed by -16.55% over ϵ_{cu} .

For the PVA-ECC specimens subjected to the frequency level of 3.0 Hz, their ϵ_{vu} changed by 2.10% over ϵ_{cu} at the age of 8.0 h when the specimens were vibrated, but at the rest of ages when vibrated, the corresponding ϵ_{vu} changed by -13.29% to -22.38% , and the most negative effect occurred at the age of 23.0 h when the specimens were vibrated, where ϵ_{vu} changed by -22.38% over ϵ_{cu} .

For the PVA-ECC specimens subjected to the frequency level of 4.0 Hz, their ϵ_{vu} increased by 18.18% and 10.13% over ϵ_{cu} at the ages of 1.5 h and 36.0 h when the specimens were vibrated, and their ϵ_{vu} changed by -3.96% to -6.67% during the period between ages of 1.5 h and 36.0 h when the specimens were vibrated. This indicates that the effects of vehicle-induced vibrations on the ultimate

It can be seen from Figure 5a–c that the impact trends of the vibrations on both the cracking strength and the ultimate tensile strength of vibrated PVA-ECC groups were approximately equal to that of ultimate tensile strain. The differences of the impact degree of vibrations on the strengths were more significant than that of ultimate tensile strain.

It can be seen in Figure 5b that for the vibrated PVA-ECC group subjected to the frequency level of 2.0 Hz, the most negative age when vibrated occurred at age of 8.0 h when vibrated for cracking strength. Except for this, it can be seen in Figure 5b,c that for all of the vibrated groups subjected to the frequency levels of 3.0 Hz to 5.0 Hz, the most negative ages when vibrated occurred at 15.0 h for cracking or ultimate tensile strength. This result indicates that for all of the twenty-four vibrated groups in this section, the most negative age when vibrated for the strength of the PVA-ECC occurred at the periods during the initial set and the final set.

of 5.0 h at the most negative age when vibrated compared with that of the ultimate tensile strength. Additionally, Figure 5 also shows that the cracking strength was the most sensitive to the variables in this section, and then it followed the ultimate tensile strength and strain. These results were similar to the studies on compressive strength [34], bond strength [35], splitting strength [36] of early-age concrete that was subjected to vibrations during this period.

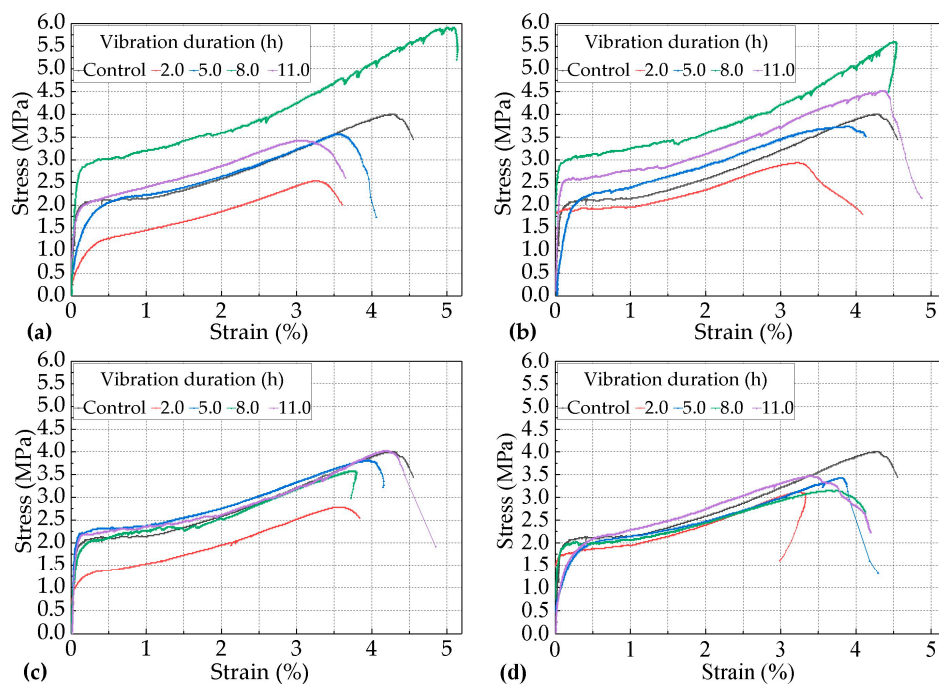
Figure 6. Strain-stress curves of the vibrated PVA-ECC groups subjected to different lengths of vibration duration under the combination of different levels of vibration frequency and the age of 8.0 h when vibrated and, (a) 2.0 Hz; (b) 3.0 Hz; (c) 4.0 Hz; (d) 5.0 Hz.

Figure 6 shows that every group of PVA-ECC specimens described in this section exhibited remarkable strain-hardening characteristics and super-high toughness. Their ultimate tensile strain could stay steady above 3.0% even if the vibrations occurred during the period between the initial set and the final set, with different lengths of vibration duration ranging from 2.0 h–11.0 h. Combined with

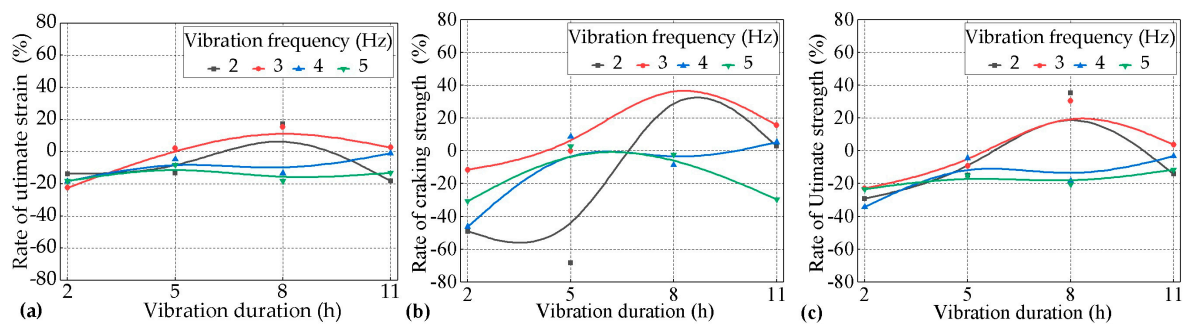
Figure 7. Rates of (a) the ultimate tensile strain, (b) cracking strength, and (c) ultimate tensile strength for the vibrated groups over the control group with the increase of the length of vibration duration under different levels of vibration frequency during the period between the initial set and the final set.

According to Figure 7a, for the vibrated PVA-ECC groups subjected to the frequency level of 2.0 Hz, the rate of the ultimate tensile strain over the control group first increased and then decreased with the increasing of the length of vibration duration. Figure 7a also show that when the vibration duration was 5.0 h, their ε_{vu} decreased by 13.29% over ε_{cu} , and when the vibration durations were 2.0 h and 11.0 h, their ε_{vu} decreased by 13.75% and 18.18% over ε_{cu} , respectively. However, when the vibration duration was 8.0 h, their ε_{vu} increased by 17.25% over ε_{cu} .

It can be seen in Figure 7 that the impact trend of the vibration duration on the cracking and ultimate tensile strength of the PVA-ECC tended to be coincident with that of the ultimate tensile strain for the period during the initial set and the final set under different levels of frequency, ranging from 2.0 Hz to 5.0 Hz, so this trend will not be repeated here.

It can also be seen in Figure 7b,c that for all of the vibrated groups of the PVA-ECC, if they were subjected to relatively higher levels of vibration frequency (4.0 Hz or 5.0 Hz), the effects of the vehicle-induced vibrations on their strengths, including the cracking strength and the ultimate tensile strength, tended to be negative but not obvious when they were subjected to different lengths of vibration duration during the period between the initial set and the final set, compared to the relatively lower levels of vibration frequency (2.0 Hz or 3.0 Hz). In addition, a similar trend was obtained to that of the ultimate tensile strain.

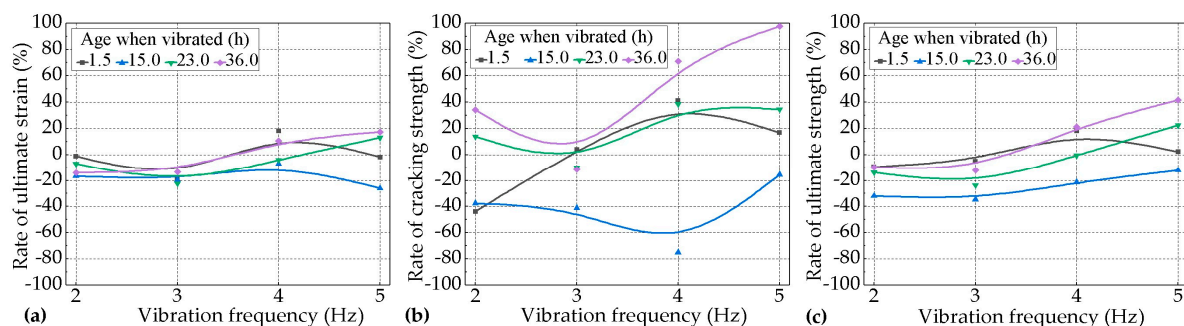
Figure 8. Rates of (a) the ultimate tensile strain, (b) cracking strength, and (c) ultimate tensile strength for the vibrated groups over the control group with the increase of the levels of vibration frequency at different ages with a duration of 5.0 h (Var. 1).

It can be seen in Figure 8 that for most of the vibrated groups of PVA-ECC for Var. 1, the effects of vehicle-induced vibrations on the tensile performance (cracking strength, ultimate tensile strength and strain) of the PVA-ECC tended to be negative at relatively lower levels of frequency and to be positive at relatively higher levels of frequency, except for the groups that vibrated during the period between the initial set and the final set, which tended to be negative throughout the levels of frequency.

It can be seen in Figure 8 that for the vibrated groups of PVA-ECC for Var. 1, the impact degrees of the vibrations on the cracking strength, ultimate tensile strength, and strain were weaker at relatively lower levels of frequency than those of relatively higher levels of frequency. It can be seen in Figure 9 that for the vibrated groups of the PVA-ECC for Var. 2 the impact degrees of the vibrations on

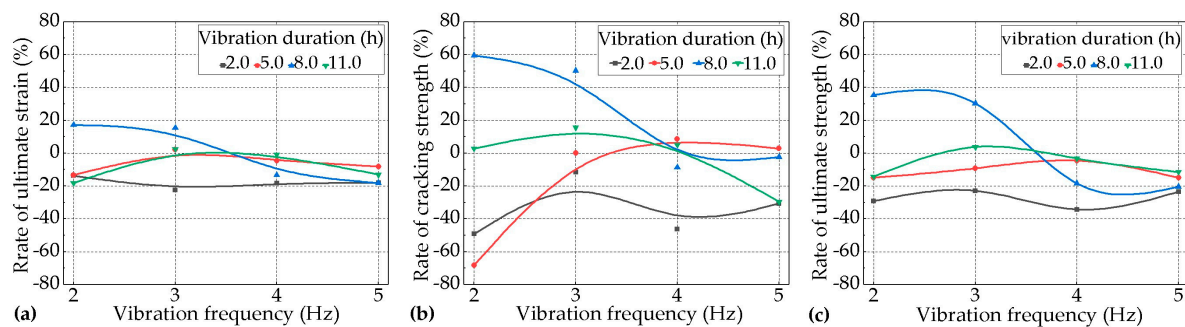
Figure 9. Rates of (a) the ultimate tensile strain, (b) cracking strength, and (c) ultimate tensile strength for the vibrated groups over the control group with the increase of the levels of vibration frequency during the period between the initial set and the final set under different lengths of durations (Var. 2).

The effects of the vibration frequency on the tensile performance of the PVA-ECC were studied under two kinds of variables, as follows: (1) at 1.5 h, 15.0 h, 23.0 h, and 36.0 h, when vibrated with a duration of 5.0 h under different levels of vibration frequency ranging from 2.0 Hz to 5.0 Hz, referred to as Var. 1; (2) with durations of 2.0 h, 5.0 h, 8.0 h, and 11.0 h at 8.0 h when vibrated under different levels of vibration frequency ranging from 2.0 Hz to 5.0 Hz, referred to as Var. 2. The results for Var. 1 and Var. 2 are shown in Figures 8 and 9, respectively.
