Article

Corrosion Resistance Measurement of 316L Stainless Steel Manufactured by Selective Laser Melting

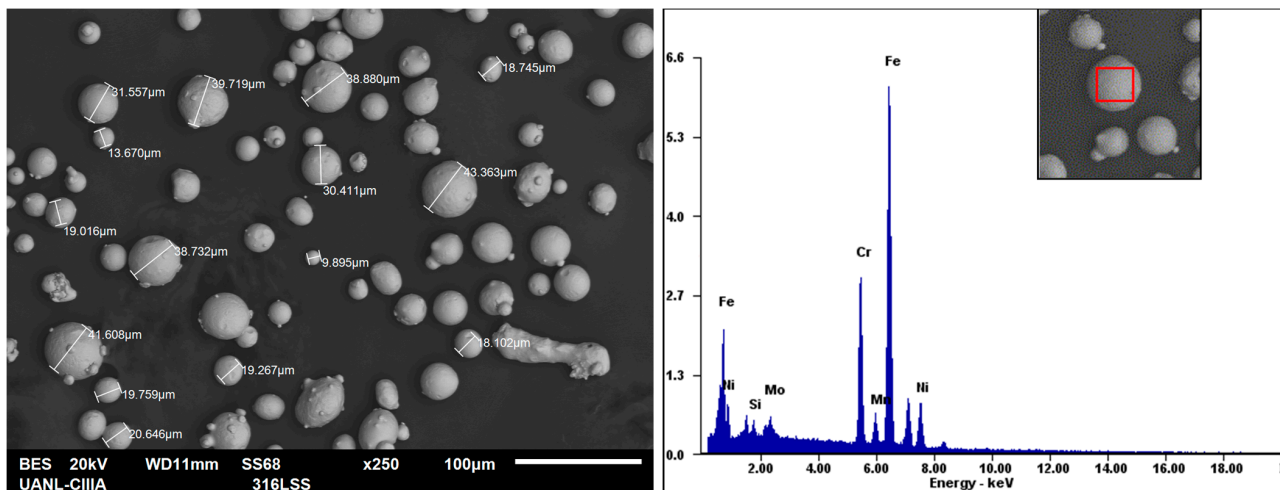
Figure 1. SEM image of the 316L stainless-steel metal powder obtained in this study showing the size of some particles (left side) and EDS analysis in one of those particles (right side).

316L SS alloy powder with a spherical shape (10–45 μm), as shown in Figure 1, produced by LPW Technologies (Runcorn, UK) with the chemical composition (in wt.%) shown in Table 1, was chosen to manufacture cubic samples using the SLM process. The manufacturing of the samples for electrochemical corrosion tests and experimental observation took place in an SLM GmbH 280 HL machine (SLM Solutions, Lubeck, Germany) with the processing parameters shown in Table 2. The SLM process was performed in an argon-filled chamber. The SLM-prepared samples were also analyzed by X-ray fluorescence spectroscopy (XRF) (Olympus, Tokyo, Japan) to obtain their chemical composition, as shown in Table 1.

As Figure 1 shows, measurements in some powder particles were performed in order to verify the particle size supplied by the manufacturer (LPW Technology), together with an EDS analysis on one of those particles, showing its elemental composition with the major alloying elements and having a similar variation with respect to the chemical composition of the powder presented in Table 1, i.e., the Cr and Mo are also incremented in values of 18.20 and 2.85 wt.%, respectively. As for the particle size, measurements in some powder particles were performed, as shown in Figure 1, taking an average of 10 particles in three different zones of the SEM image.

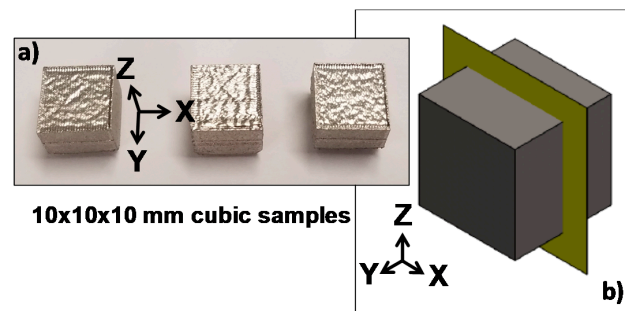
Figure 2. (a) Cubic samples prepared by the SLM process. (b) Cutting plane used as a reference to obtain the cross-section of each sample.

Figure 2 shows the parts manufactured by SLM (Figure 2a), as well as the sample, in a digital form with a cutting plane to show how the samples were cut in order to obtain the cross-section of each specimen (Figure 2b). In this study, the XY and XZ (Z-axis is parallel to the build direction) planes of the samples were selected as the testing surfaces to carry out the electrochemical tests and verify how the surface orientation influences the final electromechanical properties. Although Figure 2b only shows the vertical cutting plane, some samples were also cut in a horizontal direction (XY plane), cutting all the specimens in half.

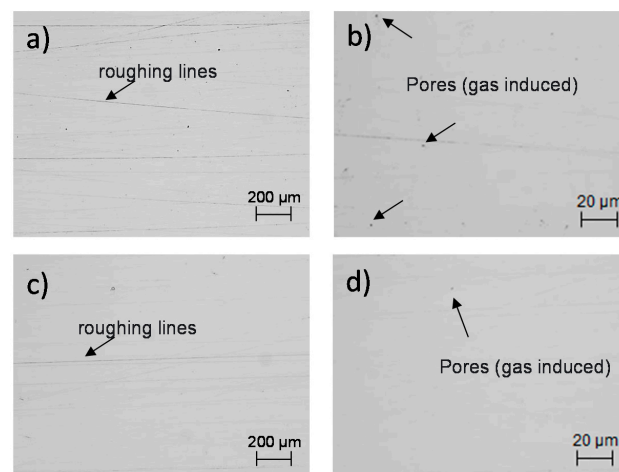
Figure 3. Metallographic images of the SLMed 316L SS horizontal and vertical surfaces showing porosity. Images: (a) (50X) and (b) (500X) XY plane, and (c) (50X) and (d) (500X) XZ plane.

In order to observe the initial features of the treated surfaces after the polishing process, a superficial observation using the optical microscope was performed on the horizontal and vertical surfaces. This optical observation was carried out for scanning the possible SLM defects that were developed during the laser process. For this, four magnifications in the optical microscope were taken into account to show a selected area of the testing surface, corresponding to the XY and XZ plane of the material. Figure 3 shows the metallographic images of the two analyzed surfaces, which were labeled with a and b, and c and d, for the horizontal and vertical surfaces, respectively. It can be observed that there existed porosity in form of irregularities, inclusions, irregular, and spherical defects. It is worth mentioning that a detailed analysis of the SLM irregularities is also considered in Section 3.1. For this, a ZEISS EVO scanning electron microscope (SEM) (Carl Zeiss, Oberkochen, Germany) was used, as well as to analyze and observe the corrosion products after the corresponding measurements, Section 3.4.

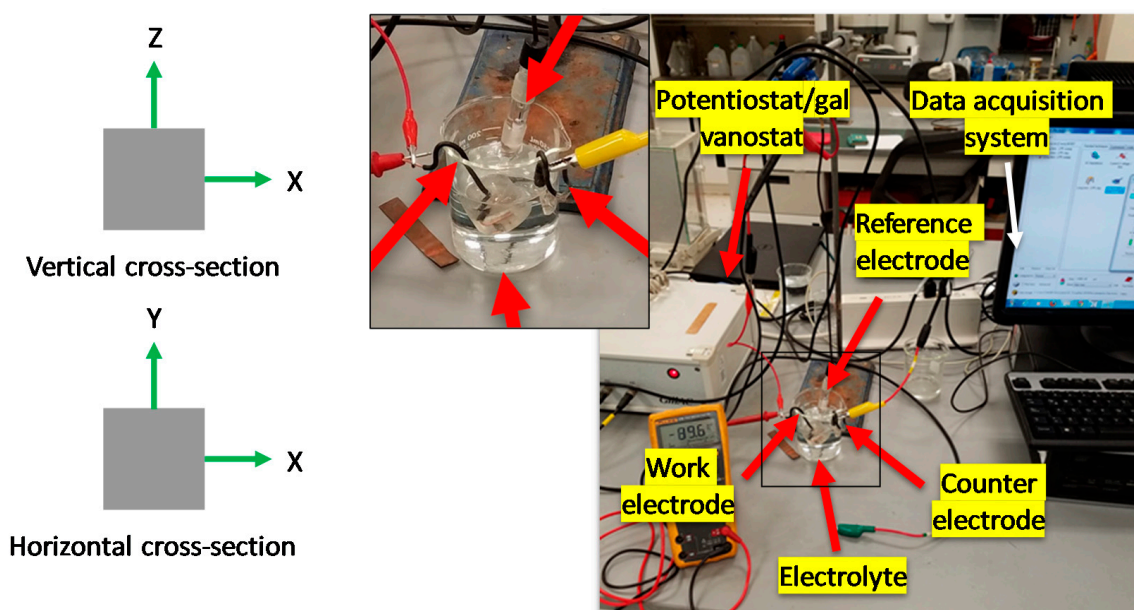
Figure 4. Experimental setup used to perform the corrosion tests; left side, and horizontal and vertical cross-sections (Z axis is parallel to the build direction) of the work electrodes.

The corrosion tests were carried out using a linear polarization resistance (LPR) [35] and electrochemical noise (EN) [36] experimental setup, as shown in Figure 4. A Gill-AC potentiostat/galvanostat/ZRA (Zero Resistance Ammeter) (ACM Instruments, Cumbria, United Kingdom) and a three-electrode cell integrated the test system, where a saturated calomel electrode (SCE), a platinum mesh, and the SLMed 316L SS sample made up the reference, counter, and work electrode, respectively.

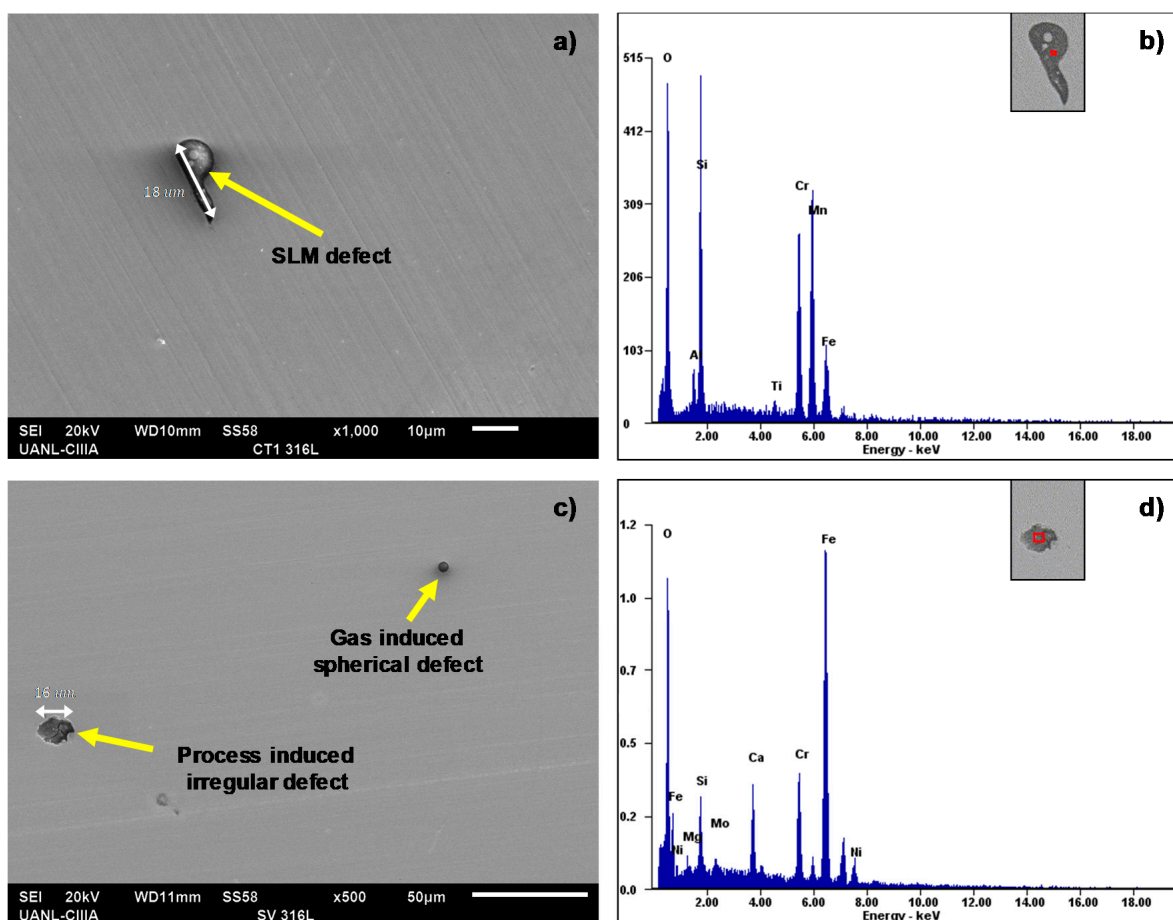
Figure 5. SEM images of the polished surfaces of the samples displaying some SLM defects in the material (left-hand side) (a,c; 100X and 500X, respectively) and chemical composition obtained by EDS of those irregularities (right-hand side; b,d).

X-ray energy-dispersive spectroscopy (EDS) was also performed in order to characterize the morphology of the specimen's defects before making the electrochemical measurements. For this, a selected area of the horizontal and vertical testing surface was explored in which imperfections with their respective shape and chemical composition were identified. Figure 5 shows two SEM micrographs displaying some irregularities with their corresponding chemical composition. In this case, Figure 5a presents an SLM defect of $10 \mu\text{m}$ longitude in the horizontal surface. Its elemental composition at a specific area inside of it, red zone in Figure 5b, showed high contents of Si and Mn, as well as O. The irregularity shown in Figure 5c with its respective chemical composition in Figure 5d presented high contents in Fe and O and was in the vertical surface of the material. The

compositional analysis of the SLM defect shown in Figure 5a confirmed the results by Chao et al.'s [30] study, where it was reported that the SLMed 316L SS alloy is susceptible to content spherical and irregular defects with Si and O. In addition to this, it can be observed that the SLM defects shown in Figure 5a,c had a different shape with each other; i.e., in Figure 5a, the pore had an outstretched shape, and in Figure 5c, there were two types—spherical- and irregular-shaped pores. Although the SLM defect presented in Figure 5a was not completely spherical, it seems that it was formed from a spherical SLM defect. According to this, it can be established that the horizontal surface of an SLMed material suffered from shape-outstretched pores formed from spherical pores, while the vertical surface had spherical and irregular pores. It is well known that spherical pores are provoked by gas induced from the liquid metal during the fast solidification process, and irregular defects are associated with the lack of metallic powder [37].

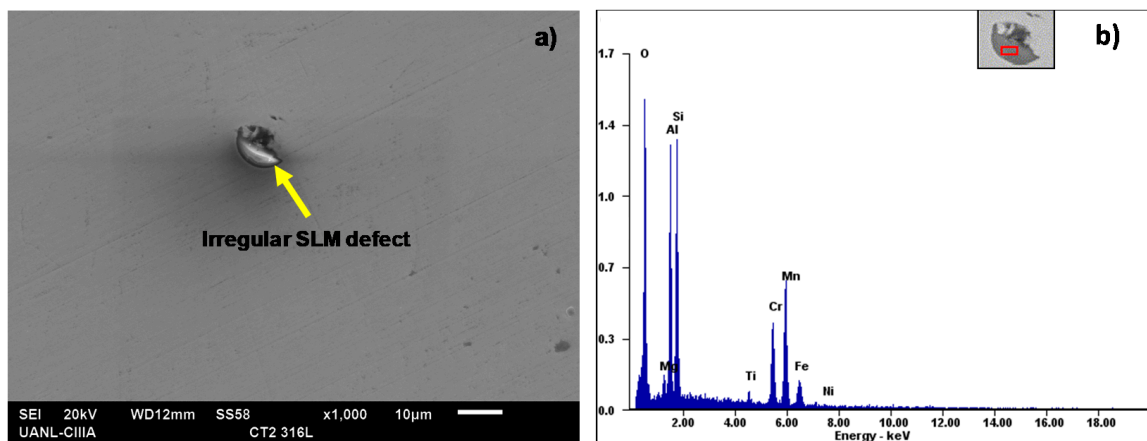
Figure 6. (a) SLM inclusion found on the polished surface and (b) its EDS chemical composition showing high contents of O, Al, Si, and Mn.

Although EDS analyses were carried out at the microscopic level (SEM), these agree with the results of nano-inclusions (TEM) reported by Chao et al. [30], where the elemental composition of the nano-defects reported high contents of Si and Mn. In fact, Saeidi et al.'s [38] study pointed out that nano-inclusions are formed due to the accumulation of O, Al, Si, and Mn. Based on this, the SEM image of the horizontal surface shown in Figure 6 confirmed the same, i.e., certain impurities with high contents of Mn, Cr, and O were also localized, which could lead to the formation of (MnCr)O inclusions. Even though these defects cannot be considered as localized pitting sites, the Cr content accompanied by the high Si content could mean the formation of silicates, as reported by Kong et al. [17].

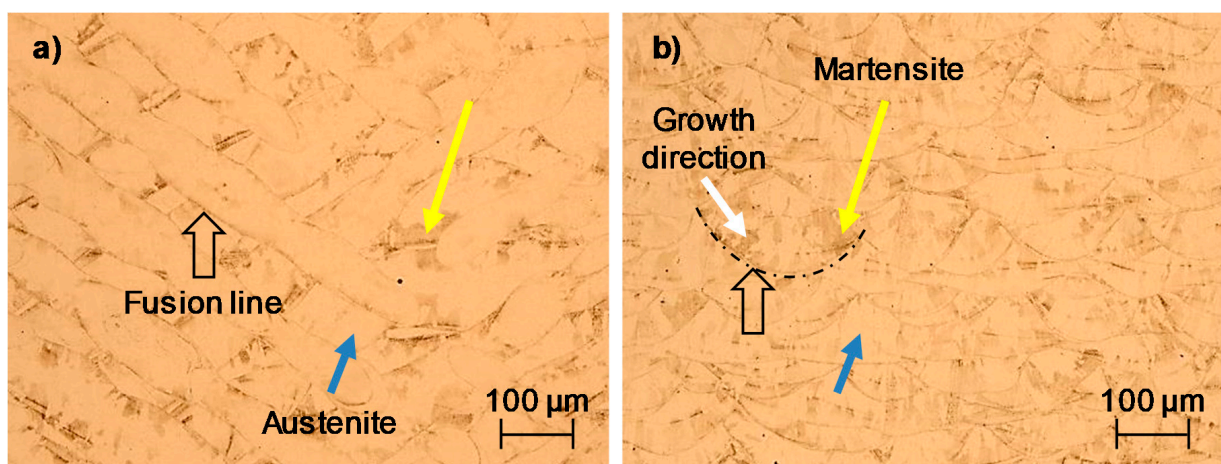
Figure 7. Representative optical micrograph showing the SLMed 316L SS microstructure of the horizontal (a) and vertical (b) surfaces. Growth direction is indicated with a white arrow while the fusion line is shown with an open arrow.

Figure 7 shows the microstructure of the SLMed 316L stainless steel. The micrograph was obtained by optical microscopy (OM), which shows the resulting micro/macrostructure of the horizontal and vertical surfaces, normal and parallel to the build direction, respectively. It can be observed from the shape of the melt pool for both surfaces and for certain points how grains tend to grow up from the fusion line to the center of the melt pool. It is well known that the growth direction to the melt pool center is due to the thermal gradients produced by the SLM process, which are higher in the melt pool center than along the fusion line [37–39]. In addition, the microstructure was characterized by martensitic with a dark brown tone, pointed out with the yellow arrow, whereas austenite is shown with a clearer brown tone and pointed out with the blue arrow. It can be observed from Figure 7a,b that the fusion lines or melt pool boundaries were generated by the Gaussian distribution of the laser energy density. Although the melt pool boundaries were not so distinguishable, it is possible to appreciate the shape of the melt pool for each metallographic image. Figure 7a shows the melt pools with the shape of enlarged ovals located at 90° due to the scan rotation between the successive layers (SLM processing parameter mentioned in Table 2), and Figure 7b illustrates the cross-section of the melt pool with a semicircular shape, typical of the SLM process.

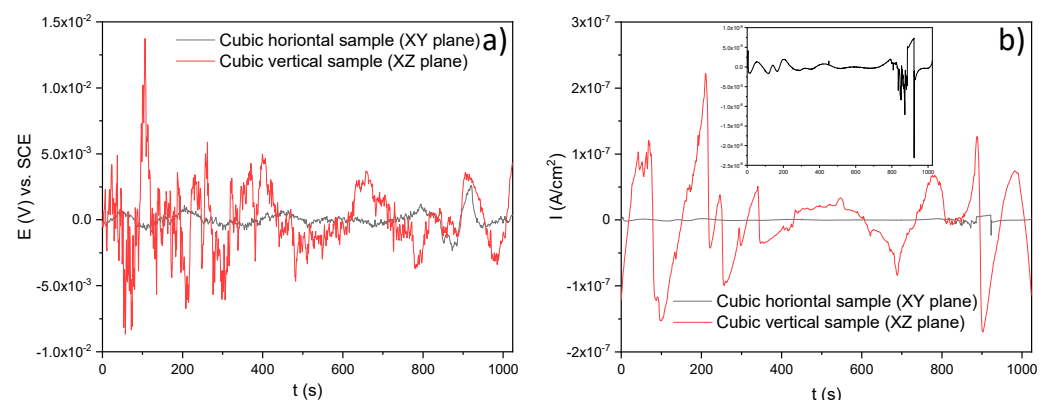
**Figure 8.** Time series in potential and current of the SLMed 316L SS in 3.5 wt.% NaCl: (a) potential versus time and (b) current versus time.

Electrochemical noise (EN) tests were also performed in this research. Although linear polarization resistance (LPR) gave a prediction about the corrosion resistance of the SLMed 316L SS, it is difficult to understand the type of corrosion. For this, Figure 8a shows the potential time series of the sample in the experiment when it was immersed in a chloride-containing solution at room temperature ($20 \text{ }^\circ\text{C} \pm 2$). Figure 8b shows the current time series of the samples. Herein, it can be noticed that the XZ sample seemed to be more active than the XY sample. This is because the corrosion current density of the vertical sample increased rapidly for certain periods of time, even recording a few transients of high frequency and amplitude compared with the horizontal sample, as shown by the red line. According to Gaona et al. [34], the characteristics of those transients can lead to localized corrosion. On the other hand, it can be noticed that the horizontal sample maintained a constant potential during the test. Although there were also some transients in the XY sample, the stability in its corrosion potential indicates that it could have been generated by a passive film formed by chromium oxide, even after the cutting process of the samples. Additionally, the surface orientation also influenced the corrosion behavior and the film oxide composition [23,42]. In fact, the corrosion film formed naturally after cutting generated a small barrier to the aggressive agents of the electrolytes such as Cl[−] ions. Nevertheless, once the system began to interact, this passive film had a path to the dissolution of metal ions (M⁺) in the anodic zones, while in the cathodic zones, the reduction of oxygen was carried out through the formation of OH[−] ions.

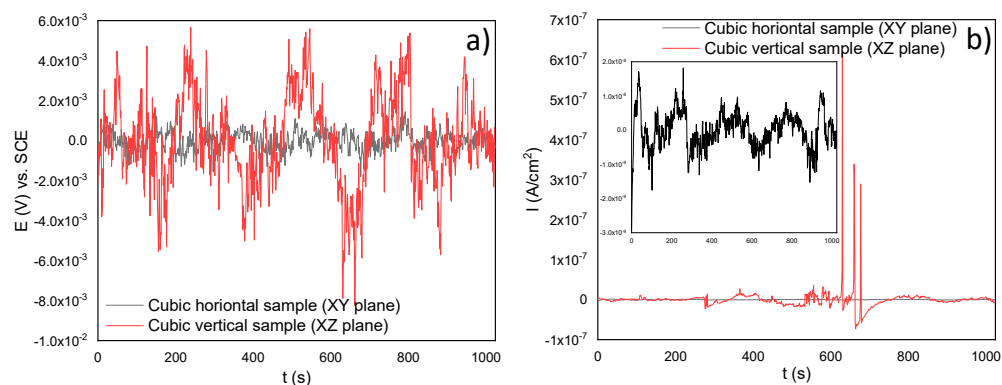
Figure 9. Time series in potential and current for the SLMed 316L SS in 20% H_2SO_4 : (a) potential versus time and (b) current versus time.

Figure 9 shows the corrosion behavior of the SLM material developed by the electrochemical noise (EN) test using H_2SO_4 . In this case, the horizontal sample also tried to maintain a constant potential while the vertical sample increased its potential by several periods of time and then decreased throughout time. In Figure 9b, it seems there were a few transients in the current that could mean pitting corrosion for both samples.

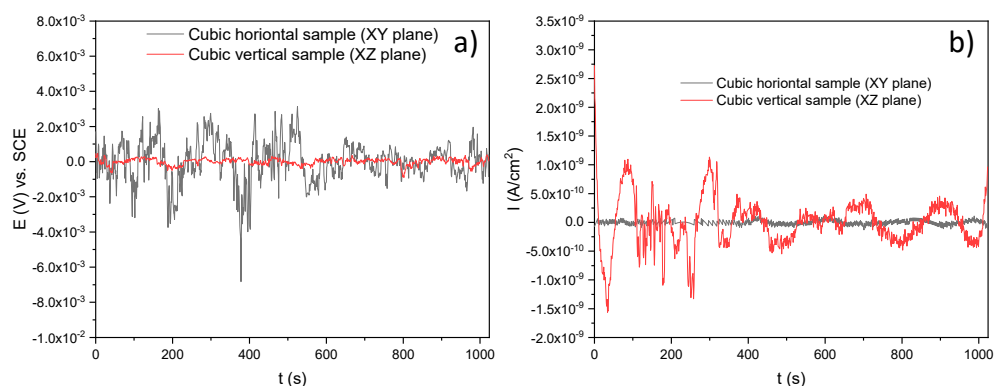
Figure 10. Times series in potential and current for the SLMed 316L SS in H_2O : (a) potential versus time and (b) current versus time.

Figure 10a,b shows the time series in potential and current, respectively, of the horizontal and vertical samples immersed in H_2O . Note that the electrochemical response of the XZ sample marks several transients that could mean metastable pitting typical of these alloys [44] (Figure 10b); fortunately, its corrosion potential remained constant (Figure 10a). In the case of the XY sample, this slightly increased its corrosion potential and tended to passivate due to its constant corrosion current density. However, the vertical sample seemed to be more active than the horizontal sample as it had higher transients.

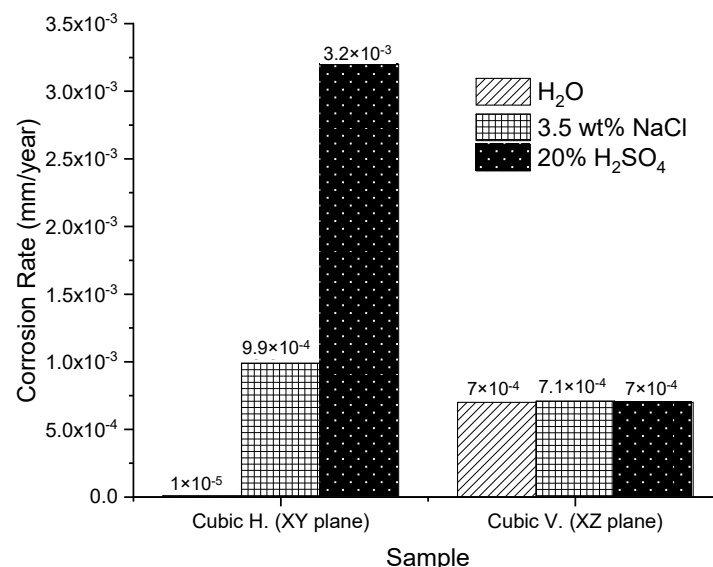
**Figure 11.** Comparison of the corrosion rate between the samples in the three electrolytes. The number of points for each corrosion test was 1024 points at a rate of 1 point per second. The average corrosion rate for each performed test is shown.

In Figure 11, a histogram is illustrated in order to compare the corrosion rate between the two samples (horizontal and vertical), taking into account the three electrolytes. In effect, it can be observed that the minor corrosion rate was presented in the XY sample, immersed in H₂O. On the contrary, the sample with the worst corrosion behavior was also horizontal but immersed in H₂SO₄ as it had a major corrosion rate (3.2×10^{-3} mm/year) according to the graph. It is worth mentioning that the obtained results of the corrosion current densities were an average of the anodic and cathodic reactions registered on the surface of the material immersed in the corresponding electrolyte throughout the testing time.

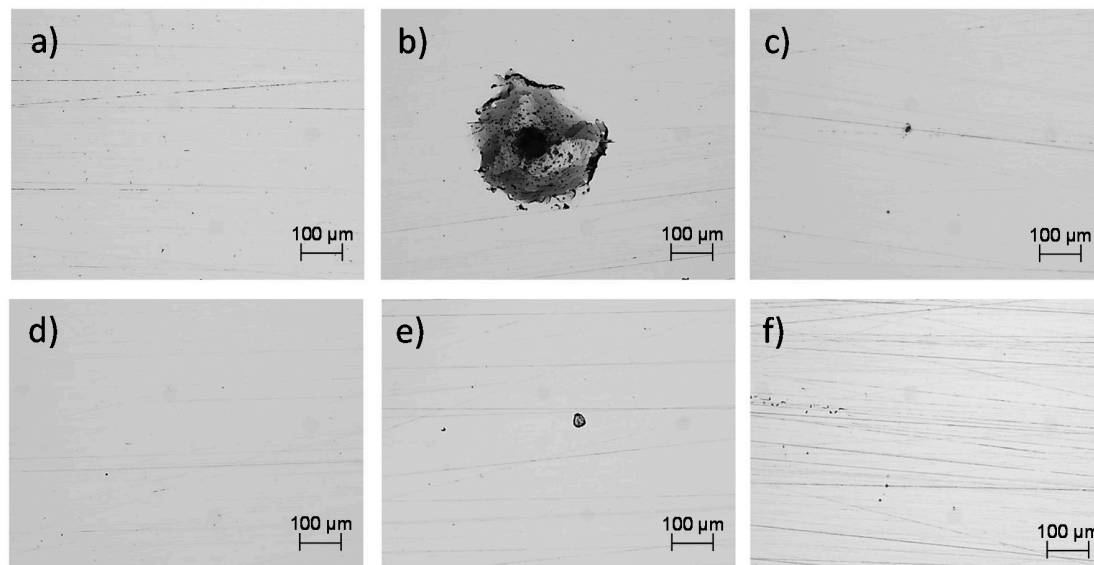
Figure 12. Morphologies of the specimens after the electrochemical tests. Optical microscope at 100X. XY plane: (a) H₂O, (b) NaCl, and (c) H₂SO₄; XZ plane: (d) H₂O, (e) NaCl, and (f) H₂SO₄.

Figure 12 shows the optical microscope images after the electrochemical tests, in which a localized attack was observed in the NaCl solution, as a product of the Cl ions present. In

the electrolyte of H₂O and H₂SO₄ the corrosion mechanism was uniform; however, the acid generated a greater dissolution of the oxide layer formed by the AM 316L stainless steel.

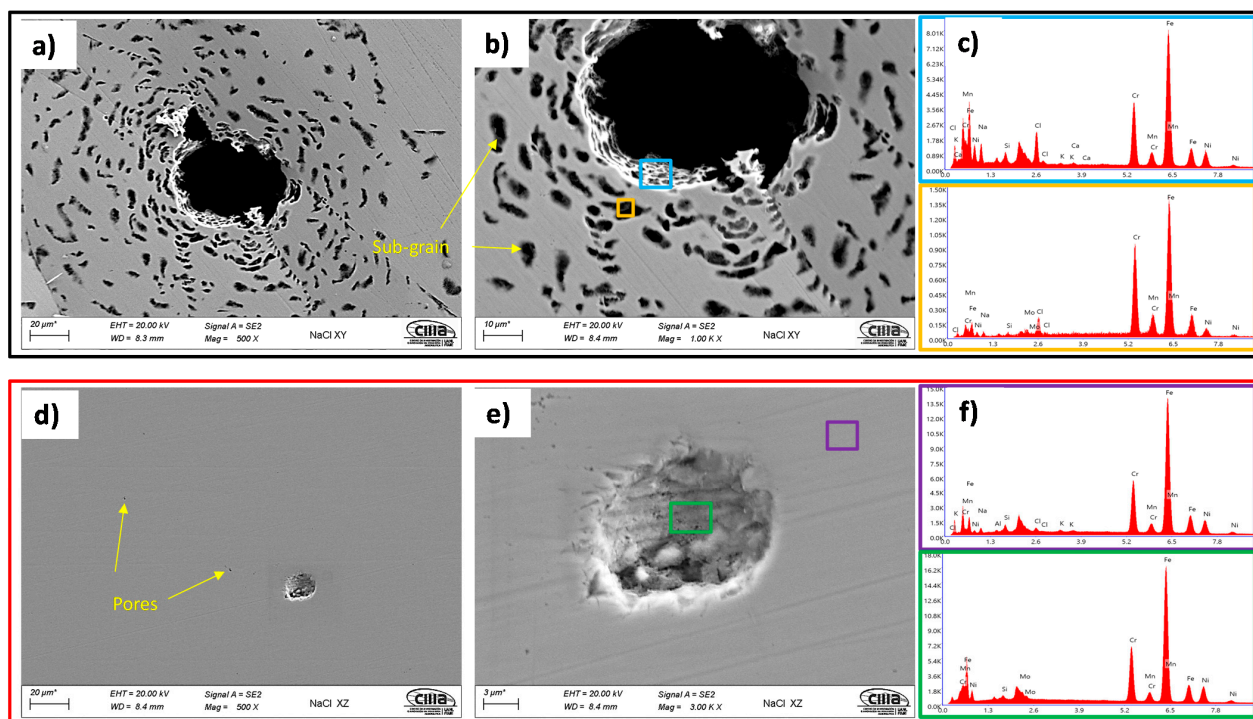
Figure 13. Morphologies of the specimens after the electrochemical tests in 3.5 wt.% NaCl at 500X and 1000X. XY plane (a–c); XZ plane (d–f). ZEISS EVO scanning electron microscope (SEM).

In Figure 13, the morphologies taken via SEM and EDAX analysis of the XY and XZ specimens evaluated in NaCl are shown. It is observed that the pits were developed within the subgrains due to the galvanic pair that developed between the Mo-enriched phases (subgrain boundaries) that were segregated during the fabrication due to the rapid solidification, which does not give time to the Mo atoms to complete the diffusion [46,47] and the Fe-enriched phases.

Through EDAX analysis, the presence of the element chlorine can be observed for both specimens in the XY and XZ planes, which will preferentially attack the subgrains that act as anodes and the grain boundaries enriched in Mo as the cathode [28]. In addition, the presence of the elements of the base material (chromium, nickel, molybdenum, and manganese) and the traces of elements that correspond to the test electrolyte are also influenced.

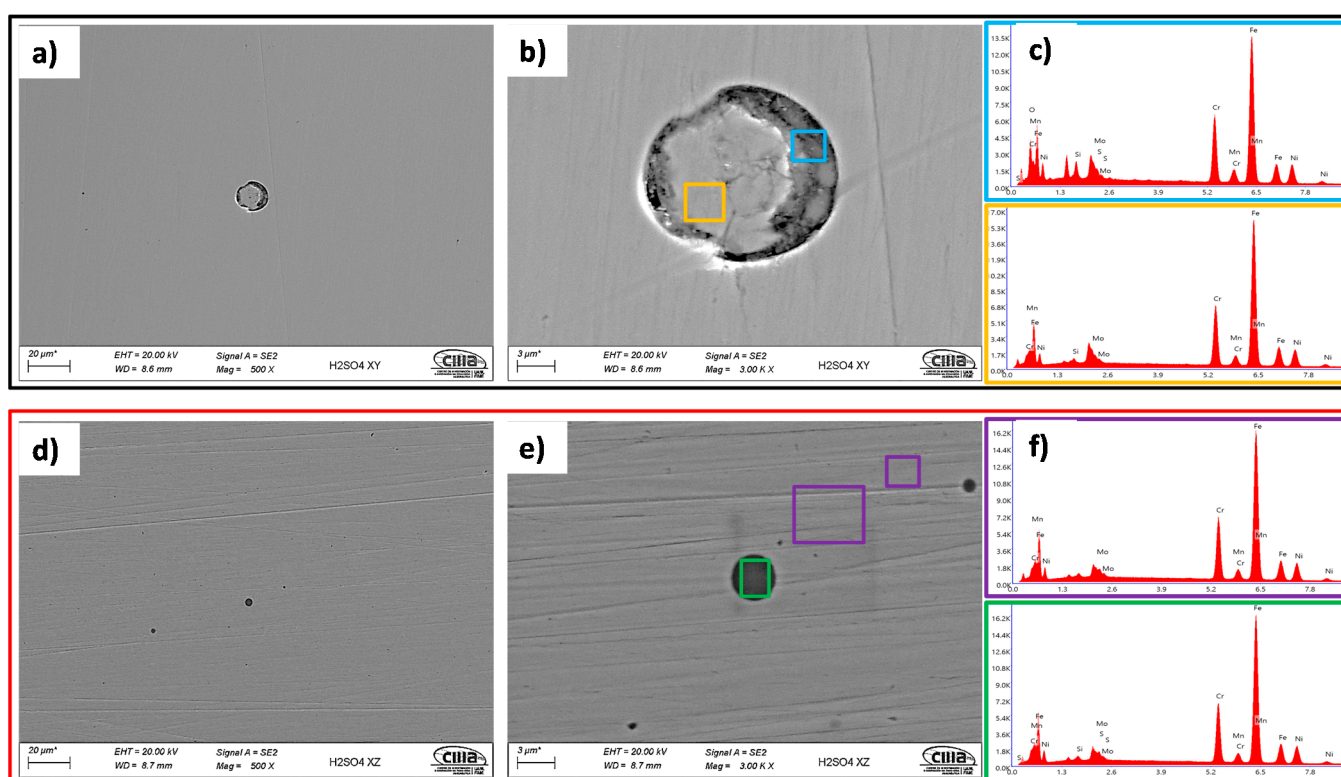
Figure 14. Morphologies of the specimens after the electrochemical tests in H_2SO_4 at 500X and 1000X. XY plane (a–c); XZ plane (d–f). ZEISS EVO scanning electron microscope (SEM).

The corrosion process of the 316L AM alloys in the H_2SO_4 electrolyte presented a very different behavior from that observed in a saline environment. In this case, for the specimens in the XY plane, the corrosion process was generated over the entire surface of the sample, and in some cases, it developed within the imperfections of the material, developed by the manufacturing process, specifically in the pore walls. The EDAX analyses showed the presence of sulfur, which, together with the acidic pH of the electrolyte, developed the corrosion process; the corrosion products were not identified in the imperfection core, which indicates that the process developed through the walls (Figure 14).
