# Jumping Wave Characteristic during Low Plasticity Burnishing Process

**Abstract:** During the low plasticity burnishing process of soft materials such as carbon steel with a hardness of up to 40 HRC (Rockwell grade) a raised structure of the material known as the Jumping Wave forms in front of the tool roll. This phenomenon significantly disturbs the burnishing process, but is very poorly described in the literature. This article presents studies of this phenomenon on the example of burnished 1.0562 steel. The research concerns the changes in the surface structure of the processed material as well as changes in the structure of the material during this process. The research shows changes in the geometric structure of the surface made in the 3D system and their parametric description. Moreover, the work presents an analysis of the metallographic structure in the tool zone. The research showed occurrence of material slippages in the wave in front of the tool, which creates an additional structure on the surface. These tests make it possible to better understand the process of changes that take place in the surface layer of the processed element in the low plasticity burnishing pro

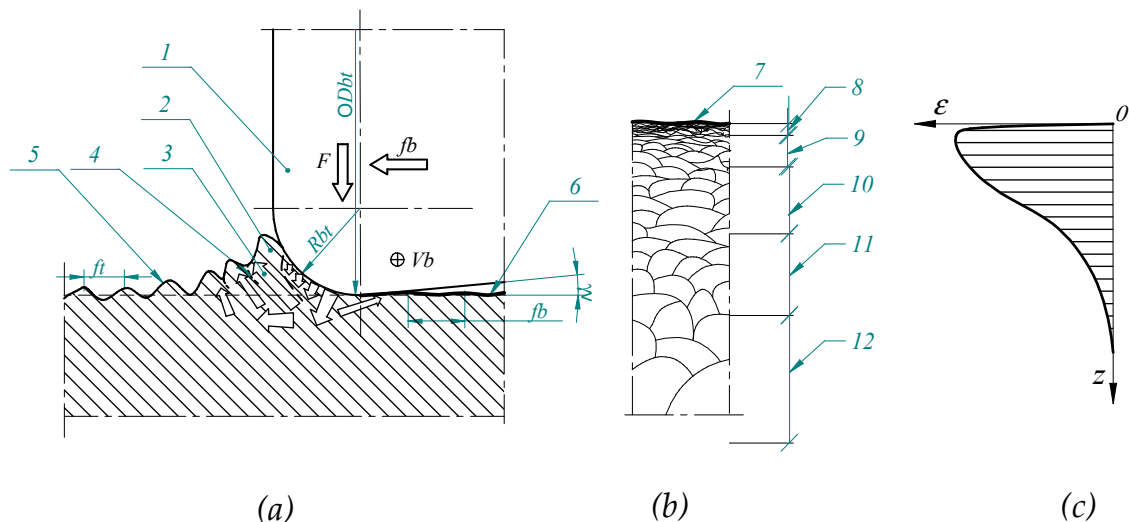
**Figure 1.** Smoothing and strengthening rolling burnishing: (a)—scheme of process, (b)—structure of surface layer after burnishing (c)—graph of deformation in the surface layer after burnishing process, 1—burnishing roller, 2—structure of material before burnishing tool (jumping wave), 3—schematic presentation of displacement of material grains, 4—slipping surface of burnishing material 5—surface before burnishing, 6—surface after burnishing, 7—zone of geometric structure of surface, 8—zone of significant grain deformation, 9—zone of predominated of the grain deformation, 10—zone of plastic and elastic surface deformation, 11—zone of elastic deformation, 12—the core of material,  $V_b$ —burnishing speed,  $f_b$ —burnishing feed rate,  $F$ —burnishing force,  $R_{bt}$ —rounding radius of burnishing tool,  $D_{bt}$ —diameter of burnishing tool,  $\gamma$ —angle of surface smoothing.

Figure 1a shows the scheme of rolling burnishing process. The process is carried out by means of a roller whose geometrical shape is described by parameters: diameter ( $D_{bt}$ ), rounding radius ( $R_{bt}$ ) and the angle of surface waviness suppression ( $\gamma$ ). A tool of this type is usually made of hardened tool steel or cemented carbide. The surface used to suppress the waviness is in the shape of a truncated cone with an apex angle of  $2\gamma$ . It is designed

to limit the outflow of burnished material behind the tool. This Figure shows a schematic representation of the wave that is created in front of the burnishing tool. The wave is caused by the influence of the tool on the material whereby the material is pushed out from the deeper layers of the processing part and then pressed back in again by the tool. This phenomenon causes a partial orientation of the material grains and in the near-surface area these grains are also strongly deformed. The rising of the material in front of the tool generates significant shear stresses, which results in material slippage and in the creation of additional surface irregularities on the wave front. These phenomena are schematically shown as items 3 and 4 in Figure 1.

Figure 1b shows schematically the structure of the surface layer that is obtained in the burnishing process. The surface layer has different properties at different depths and the literature [1] uses the division of the zones diversified in terms: hardness, internal stresses and material structures. The first zone (item 7 in the Figure 1) on the component surface is the roughness zone includes the scope of irregularities of the surface created as a result of processing. In the cold plastic deformation process are reduced the structures of irregularities, mainly their shapes and height. Under the roughness zone is occurred zone which is characterized as a material grain fragmentation area. The material grains in this zone are crushed and moved along surface (item 8 in the Figure 1). This zone is characterized by the high hardness and high compressive stresses. This zone is often divided into additional sub-zones depending on the level grain fragmentation (item 9 in the Figure 1). During planning of the manufacturing process, it should be taken into consideration that too much deformation range and movement of the material in this zone may cause the formation of the discontinuities and micro cracks, which may cause surface flaws. The next zone (item 10 in the Figure 1) is a plastic deformation zone. In this zone the material grains are not fragmented but are deformed only plastic and they have obtained an elongation shape. This zone is characterized by slight material strengthening, increase hardness and also compressive stress. Processing parameters, including the burnishing force, determine the depth of changes in the surface layer of the processing material and

also impact on the thickness of particular zones. The deepest zone referred to is the elastic deformation zone (item 11 in the Figure 1). Material in this zone is only elastically deformed by the stresses occurring there. Part c in Figure 1 shows schematically the range of displacements in the top layer structure resulting from the burnishing process.

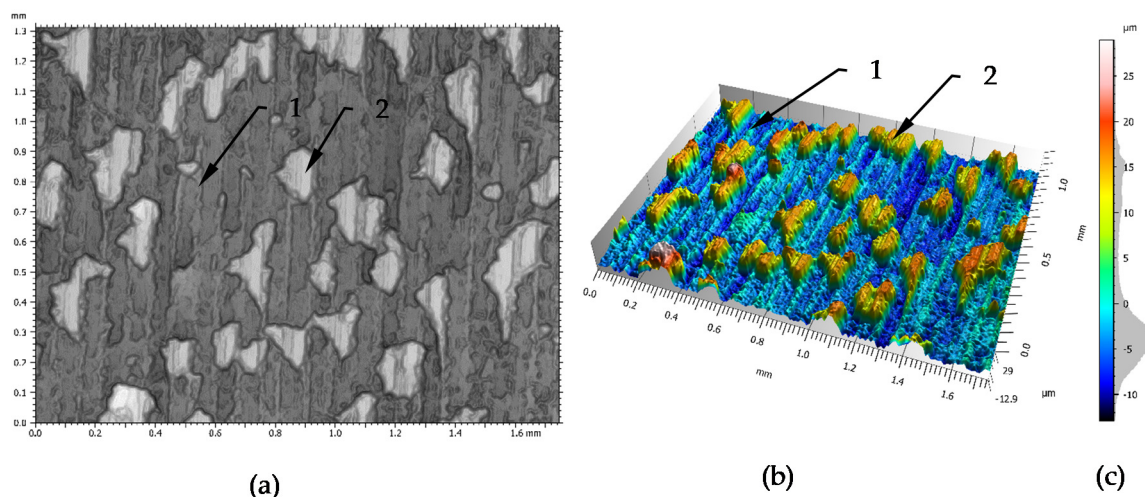
**Figure 2.** Surface structure after turning: (a)—photograph of surface, (b)—3-D surface scanning, (c)—scale of height and the ordinate histogram, 1—turning tool trace, 2—hard material grains on the surface. The surface topography measurements were made with objective 10× EPI and Z-Scan step of 2 μm.

Research of the wave formation process in front of the burnishing tool were performed on steel specimens (material data—Table 1) that had been turned before burnishing (processing data—Table 2). Figure 2 shows the surface structure of the samples after turning, which was measured by a confocal microscope. In this Figure are visible traces (1) of the cutting tool and particles of protruding above the surface (2) of the processed material.

The surface structure seen in Figure 2 was measured and described by the roughness surface parameters. The results of this geometric structure made according to ISO 25178 [47] are presented in Table 3. Based on the 3-D view (Figure 2) and a proportion of  $S_p$  to  $S_v$  parameter (Table 3) it can be confirmed the occurrence of single hills of the geometric structure of the surface. The maximum height ( $S_z$ ) value was 41.8 μm and the plateaus were predominant and maximum peak height ( $S_p$ ) represented it to almost 70% of maximum height ( $S_z$ ). Presented skewness parameter ( $S_{sk}$ ) was used to evaluate deviations in the height distribution. Positive skewness ( $S_{sk} = 1.12$ ) indicates the presence of high plateaus above a smoother valley. The kurtosis ( $S_{ku} = 3.09$ ) value was slightly higher than 3, which indicates the presence of some sharp valleys in the texture. The root mean square height ( $S_q$ ) value was about 25% higher than arithmetical mean height ( $S_a$ ) value. Such differences are characteristic for irregular random profile, where individual maximum and minimum height values, observed in the profile, have greater effect on  $S_q$  than on  $S_a$ .

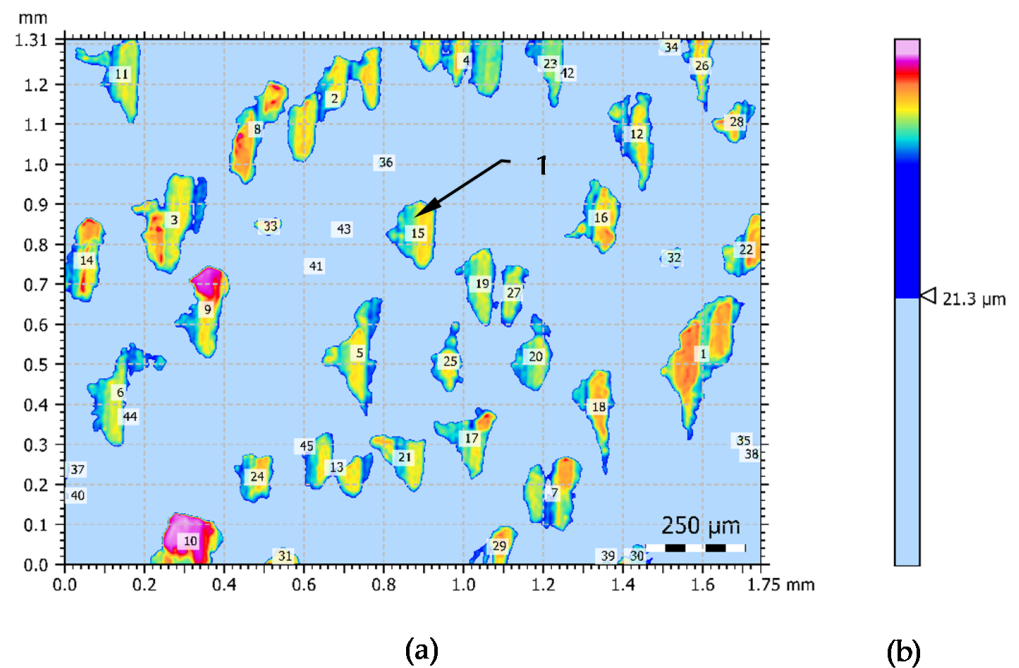
**Figure 3.** Island analysis of the turning surface: (a)—view of island, (b)—cut-off value of threshold of the island across a 0–1.8  $\mu\text{m}$  scale, 1— island on the surface.

Due to the dominance of peaks/plateaus in the surface structure, additional analyses have been made in purpose of more precise description of this structure. On the basis of the data in Table 3 it was assumed that the lack of individual islands in the structure presented in Figure 2 would reduce this structure to a height of about  $20 \mu\text{m}$ . The cut-off threshold is assumed to be  $21.3 \mu\text{m}$ . The outline of the islands surface structure and the magnitude of the threshold is presented in Figure 3. In this Figure may be seen that a few large elements of the peaks reach a considerable height.

Peaks that change the symmetry of the surface structure were characterized by additional parameters. The parameters which describe the structure visible in the Figure 3 are presented in Table 4.

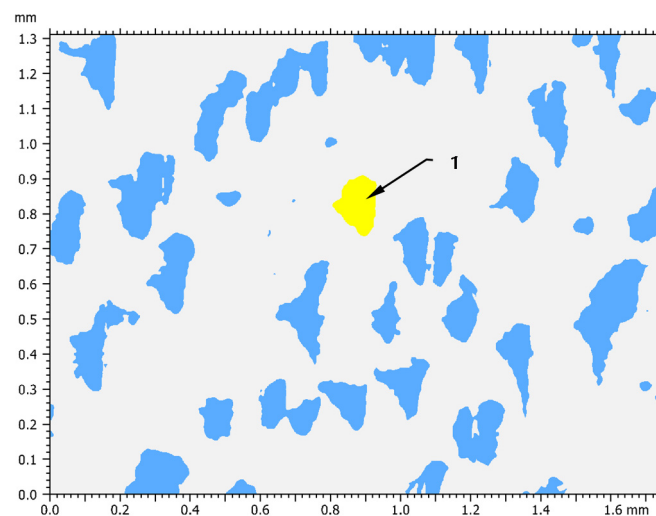
**Figure 4.** Grains analysis of the turning surface: 1—exemplary grain.

The grains presented in Figures 2 and 4 represent a harder structure of the material and are an important element in the burnishing process. Therefore, an additional analysis of surface granularity based on the outlines of this structure was performed.

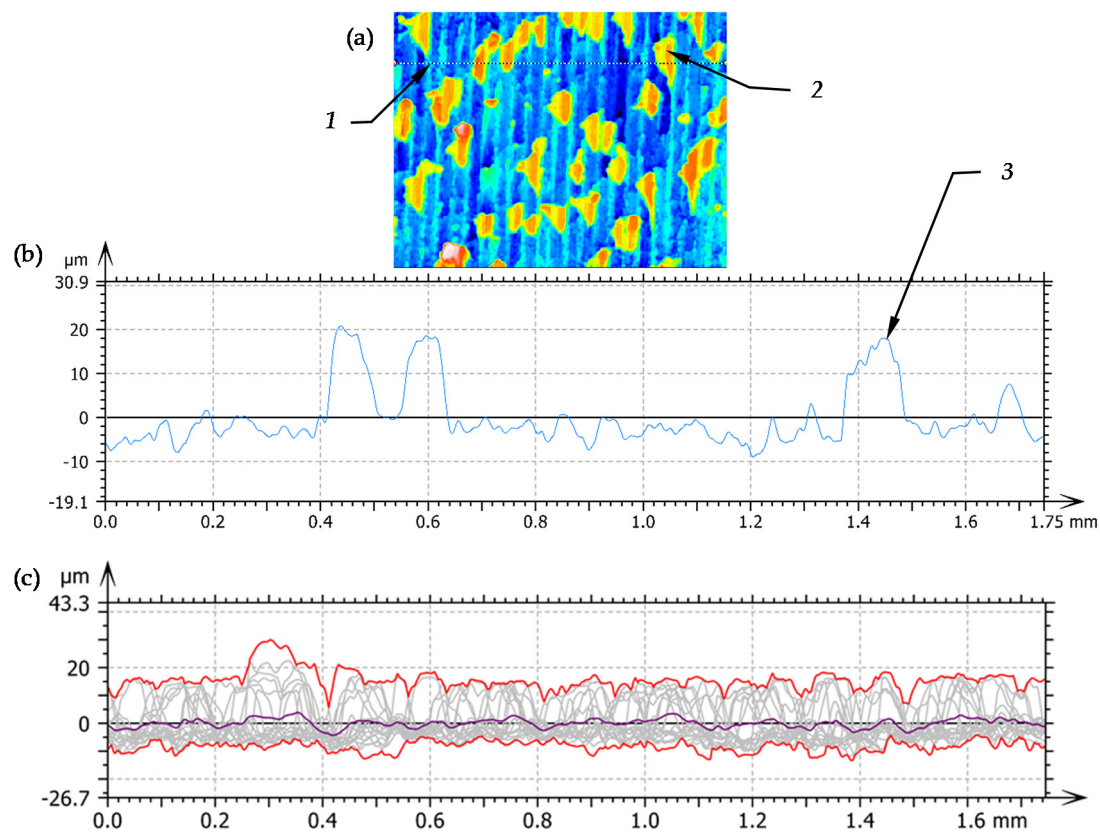
**Figure 5.** Extracted profile of surface after turning: (a) front view of turned surface, (b) profile of turned surface, 1—line of surface cross section, 2—surface peak, 3—profile surface peak, (c) the series of 19 west-east profiles extracted from the surface with upper/lower envelope and mean profile.

In order to compare the grain size to the substrate structure, a profile analysis was performed, where the surface profile was carried out by selected structure grains. Figure 5a,b shows the location of the profile in relation to the existing grains and the obtained profile. Additionally the series of 19 west-east profiles were extracted from the surface with upper/lower envelope and mean profile (Figure 5c) and statistical values of selected parameters of P-profile were included in Table 7.

On the presented profile you can see the structure of unevenness of the floor, the height of which does not exceed 10  $\mu\text{m}$ . The harder grains of the structure create hills with an additional height of 20  $\mu\text{m}$  protruding above the basic structure profile. The obtained profile was characterized by the parameters for the unfiltered profile, of which values are shown in Table 7. Analysing the parameters, it is possible to notice that single grains do not significantly affect the value of the average parameter, which is parameter Pa.

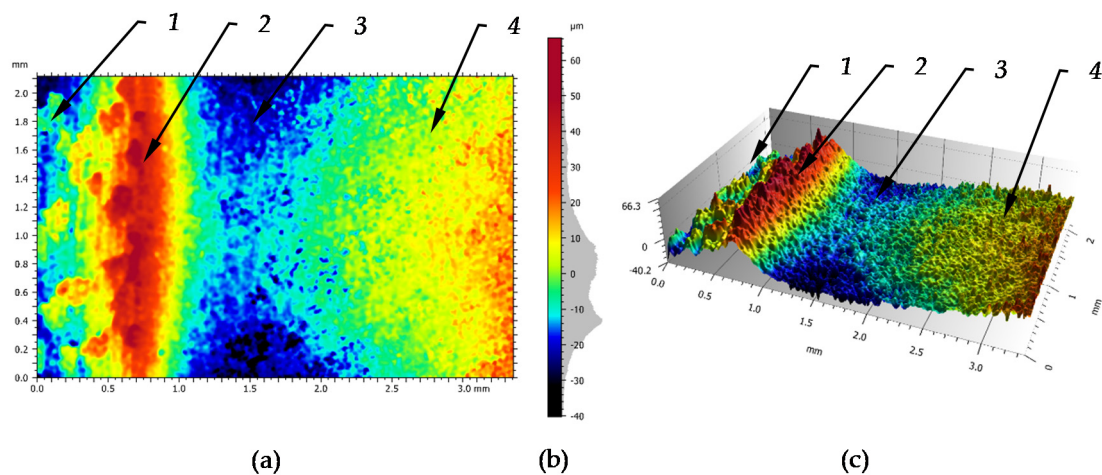
**Figure 6.** Surface deformation structure caused by the burnishing tool with visible effect of jumping wave: (a)—front view, (b)—scale of height and the ordinate histogram, (c)—3D view, 1—surface structure after turning, 2—jumping wave pushing by the tool, 3—surface structure under burnishing tool, 4—surface structure after burnishing.

The prepared surface was then subjected to the process of burnishing. The burnishing parameters are shown in Table 2. Figure 6 shows the structure of the surface occurring in the burnishing zone. The obtained structure is disturbed by elastic deformations of the material occurring in this zone, but these are small changes and their influence has been omitted in the study. This structure was obtained by stopping the kneading process and moving the tool away. In this Figure the zone of the surface structure can be specified before burnishing slightly deformed by the wave forming in front of the tool, this structure is marked as a 1. The area of wave crest as a zone of maximum deformation of the processed material which is formed before the burnishing tool is marked 2. The maximum tool pressure zone is marked as 3 and the area of the surface structure after burnishing is marked as 4.

Table 8 shows the surface parameters of the wave shown in Figure 6. These data are not generally the utility value, since such forms of processing usually are not left on the workpiece. However, for cognitive reasons, they are quite interesting from the point of view of the characteristics of this formation. E.g., parameter  $S_z$  informs about the total height of the forming wave, parameters  $S_p$  and  $S_v$  represent heights of hills to pits etc.

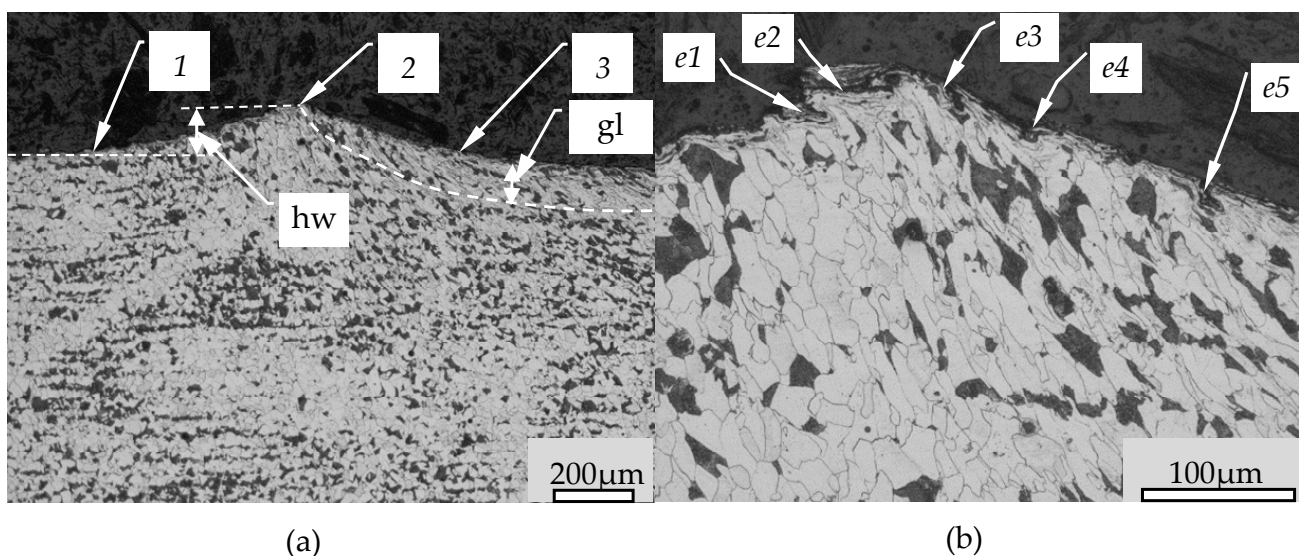
**Figure 7.** Jumping wave zone cross section: (a)—cross section from the jumping wave area (magnification 50×), (b)—top of jumping wave (magnification 200×), 1—surface structure after turning, 2—Top of Jumping wave, 3—structure under burnishing tool, e1–e5—subsequent changes in the structure of the surface flaws, *g1*—thickness of deformed layer, *hw*—height of jumping wave.

The Figure 7 presents the cross section of the “Jumping wave” before burnishing tool. In this Figure, the item 1 shows the surface before pressing, the item 2 crest of the wave and the item 3 presents the surface of influence of the burnishing tool. The pressure of the burnishing tool raises the processing material on the height indicated in Figure 7 by the item  $hw$ . Underneath the surface of the burnishing tool there is also a deformed zone marked  $gl$ . Significant deformation of the material structure can be seen in this zone. The wave in front of the tool is formed by the material rising in front of the tool. Even though in this structure material is pushed in over surface, however, the grains structure in the jumping wave does show slight differences from the core while the slight orientation of the grains towards the flow of the material can be observed. In the wave the rising is

differentiated, which causes shear stress to occur between the different material zones. Shear stress causes slippages between zones in the generated wave. The displacement of the material layers in the wave causes creating additional surface irregularities in front of the burnishing tool. In Figure 7b are seen irregularities which occur when the layers of material slip in the wave and then move underneath the kneading tool where they are further deformed. Such a deformation scheme introduced additional defects (flaws) to the surface. The subsequent elements of the process of flaws creation is marked in Figure 7b as items e1–e5. In this Figure it can also be seen that the stresses that causes the wave of material creation also induced a change in the dominant direction of the grain arrangement in the plastic deformation zone. In this process, the workpiece material first flows upwards creating a wave and then is compressed by the burnishing tool, creating a zone of directional grain orientation. The movement of the material at different depths below the surface varies slightly.

The displacement of material on the surface of the processing element can be described in a form of point which is placed in the surface and its movement is specified relative to the workpiece. In this case it is first lifted by the wave in a vertical direction, then pressed by the burnishing tool, and returns to the surface level, but the path of return is different. This path is a diagonal curve of which direction corresponds with the feed, and in the last phase of the burnishing process there is a slight move back.

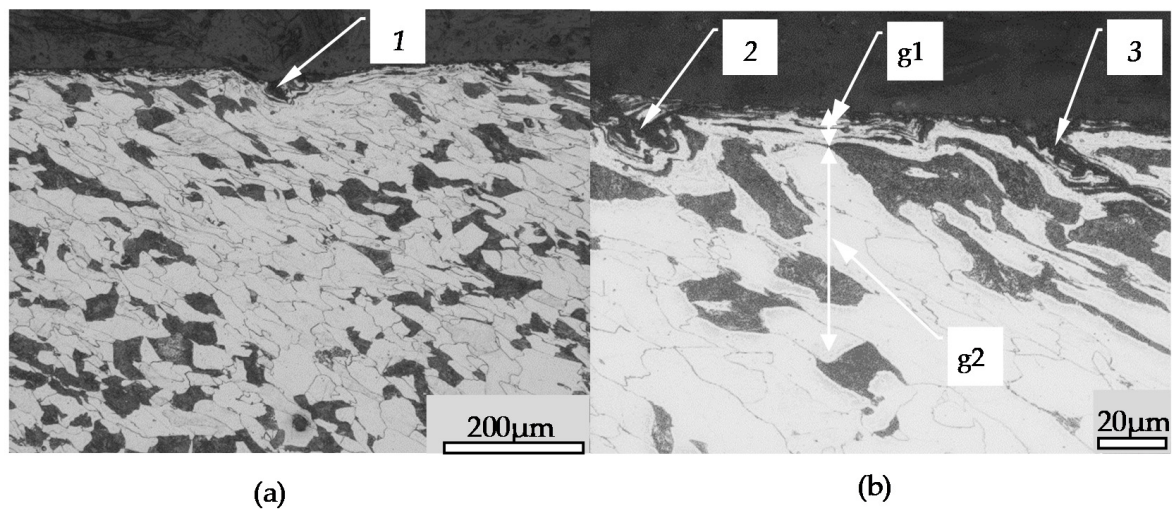
**Figure 8.** Surface flaws structure after the burnishing process: (a)—common view (magnification 100×), (b)—magnification of the surface flaws (magnification 500×), 1–3—surface flaws, g1—zone thickness of grain crushing and deformation, g2—zone thickness of the grain orientation.

Figure 8 shows the surface after burnishing. In this Figure item 1 shows the surface defect caused by the material slipping in the wave. Figure 8b shows an enlargement of the surface zone in which specific grain formations of the material marked as 2 and 3 are visible, as well as crushing zones *g1* and *g2* grain orientation which are visible. Very distorted and fragmented grains of material can be seen in zone *g1*. In zone *g2*, however, the grains are only slightly deformed and oriented by the tool.

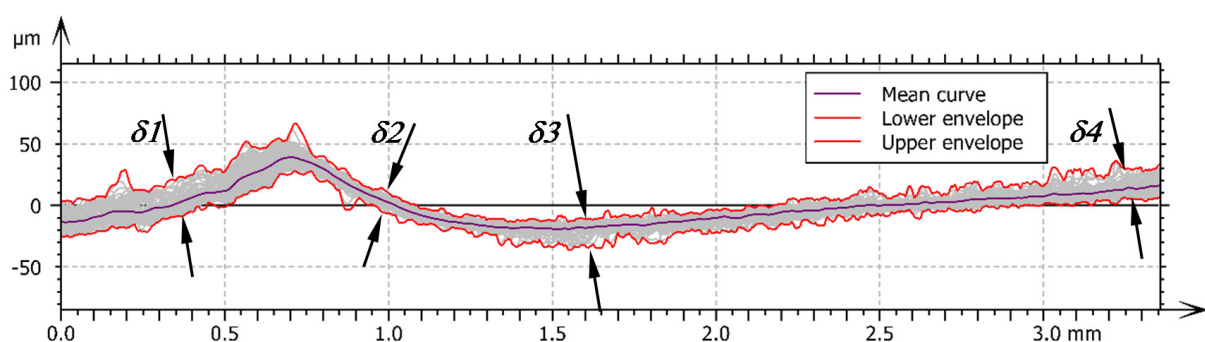
**Figure 9.** The sum of profiles of jumping wave structure:  $\delta 1$ —the thickness of the roughness structure after turning,  $\delta 2$ —the thickness of the roughness structure in front of the burnishing tool,  $\delta 3$ —the thickness of the roughness structure in bottom of the burnishing tool,  $\delta 4$ —the thickness of the roughness structure after burnishing.

Figure 9 shows a set of the profiles of the working section of the burnishing process. The thicknesses of the roughness zone are different in each segment of the burnishing process section. In the first segment is the wave which increases the initial roughness by the phenomena which occurs in the wave. In this segment the single irregularities are visible which were created by the slipping of burnishing material in the wave. The structure thickness in this segment is marked  $\delta 1$ . In the second segment of the burnishing process may be observed the roughness zone under the tool. This is the zone of direct action of the tool which the tool presses raised material against the surface of the workpiece. The roughness zone is smallest in this segment and is marked  $\delta 2$ . In segment three, the map surface is outside of the working area of the tool but is still in the suppress of waviness zone by the tool. The small range of reverse flow of material occurrence in this place causes the roughness zone to increase which is marked  $\delta 3$ . In the fourth zone, the surface is outside the tool; it is marked  $\delta 4$ . The mainly difference from zone 3 is the change in the roughness structure, i.e., from a predominantly valleys structure to a predominantly peaks structure, which may be due to the reverse flow of material described above.

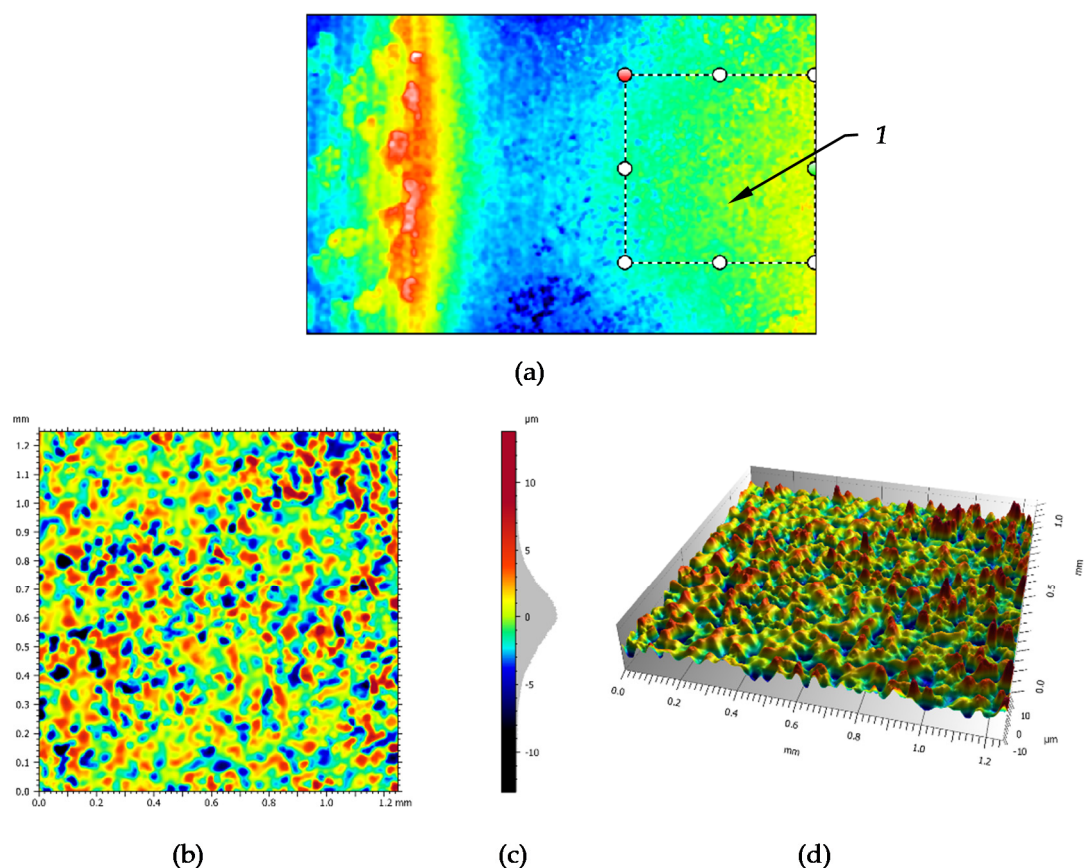
**Figure 10.** Surface structure occurs in the finishing segment of the burnishing zone: (a)—view of burnishing zone with the signed extraction area, (b)—front view of extracted area, (c)—scale of height and the ordinate histogram, (d)—3D view of extracted area.

The fragment area was separated from the contact zone of the conical part of the burnishing tool designed to decreasing surface waviness; the place is shown in Figure 10a. The enlargements of this fragment are shown in Figure 10b,d. In Figure 10c it can be seen that the ordinate distribution of the profile is basically symmetrical. Surface roughness parameters of this fragment are shown in Table 10.

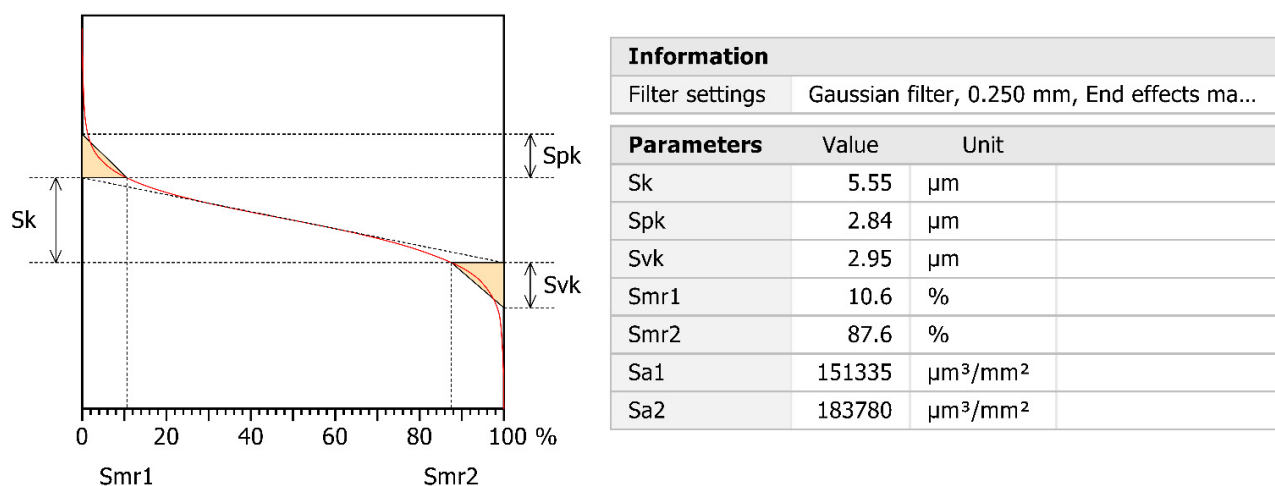
**Figure 11.** 3D material ratio curve and its parameters for the extracted area surface.

From the point of view of utility of the surface, the parameters of material ratio curve are also important, which are presented in Figure 11. The curve presented is symmetrical where the values of reduced peaks and valleys have levelled values. Its relevant parameters are listed in the Table in Figure 11.

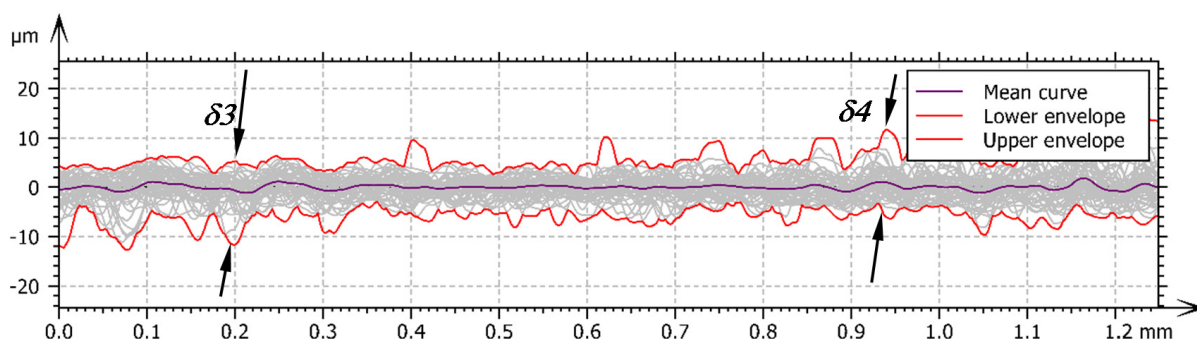
**Figure 12.** The sum of profiles of finishing segment of the burnishing zone:  $\delta 3$ —the thickness of the roughness structure in bottom of the burnishing tool,  $\delta 4$ —the thickness of the roughness structure after burnishing.

Figure 12 shows the assembly of profiles of the separated area. What may be seen is that in the zone of  $\delta 3$  markings, the surface is dominated by pits, while in the zone  $\delta 4$  additional peaks appear. This phenomenon may be caused by a slight flow of materials in the surface layer in the direction opposite to the feed vector in the burnishing process. Table 11 shows the statistical approach of the parameters of the surface profiles which are composed in the roughness zone visible in the Figure 12.

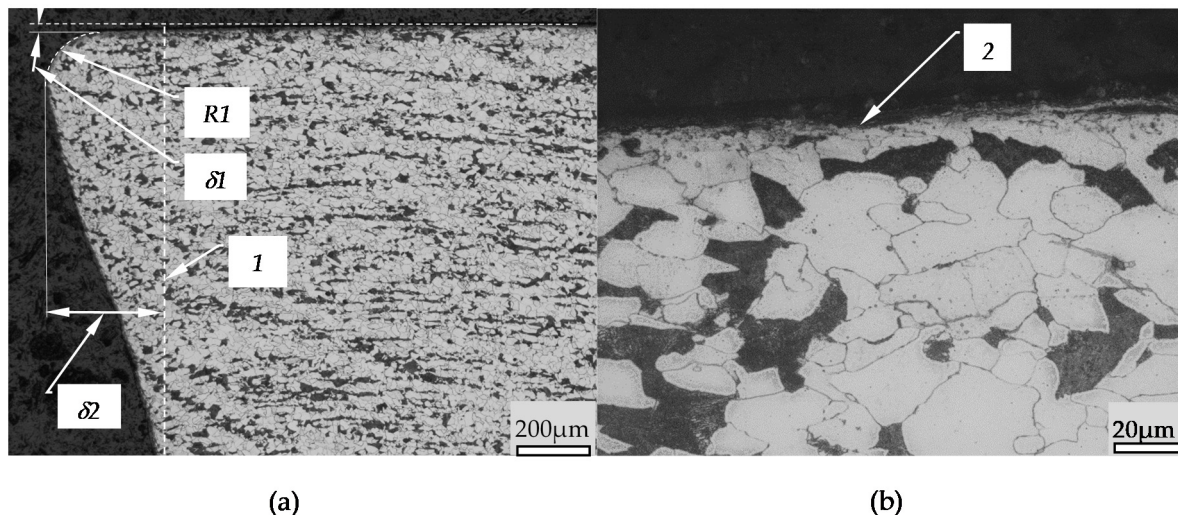
**Figure 13.** The cross-section of the shaft face surface: (a)—cross-section of the outflow which formed on the face surface from the jumping wave before the burnishing tool (magnification  $50\times$ ), (b)—the cross-section of the surface boundary of the out flow (magnification  $500\times$ ), 1—the outline of the face, 2—depression on the surface, R1—rounding radius of the face out flow,  $\delta 1$ —the lowered surface value in the facing zone,  $\delta 2$ —value of the distance of the out flow on the face surface.

Figure 13 presents an outline of the frontal surface, which was sucked out by moving the waves beyond the boundary of the burnished surface. The amount of pushed out material given to the frontal surface boundary varies with the distance from the processed surface. The shape of the obtained material structure indicates that the stresses above the yield point occur at a much greater depth. The grain structure of the stuffed material does not differ significantly from the core. The pressure of the rollers also caused a decrease in the crumpled surface in the frontal area. It can be seen that the maximum value of the displaced material occurs at a depth of  $\delta 3$ . The defects are on the surface in the form of grains strongly deformed, marked 2.

- The shape of the outflow of the material wave beyond the front surface indicates that the stresses above the yield point during burnishing may occur at a much greater depth than would be apparent from the plastic deformation exists in the structure of the workpiece material.
