Article

# Application of GeoSHM System in Monitoring Extreme Wind Events at the Forth Road Bridge

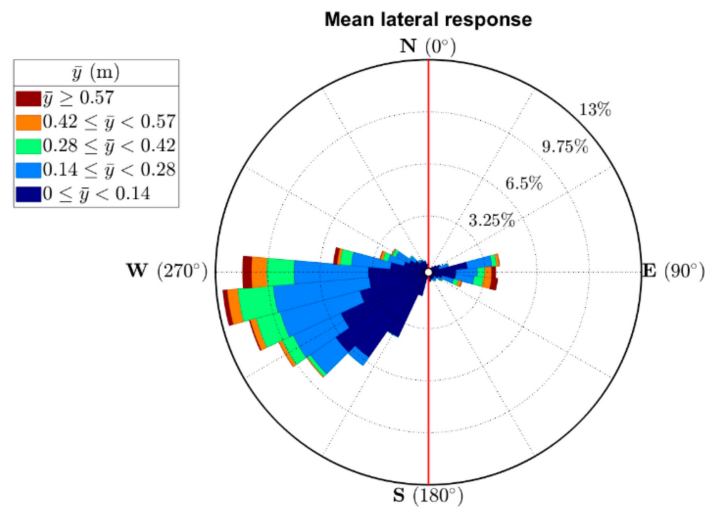
Figure 6. Wind rose of the mean lateral response. The  $x$ -axis of the bridge is aligned with the red line.

The wind roses in Figures 6 and 7 illustrate the variation of the bridge response measured at the mid-span of the FRB against the wind direction. Despite being the dominant wind, not all westerly winds are accountable for large bridge response. As shown in Figure 6, the majority of South-West winds cause very small mean lateral displacement. Strong wind from the directions that are normal to the bridge axis tends to cause larger mean and RMS lateral and heaving displacements. Figures 8 and 9 describe the dependence of the lateral and heaving response on the normal component of the 10-min mean wind speed. Separating the 10-min summary statistics by the wind directions, it is evident that, compared to northerly and southerly winds, easterly and western winds cause larger normal components of the mean wind speed and induce much larger bridge response in both the lateral and heaving directions.

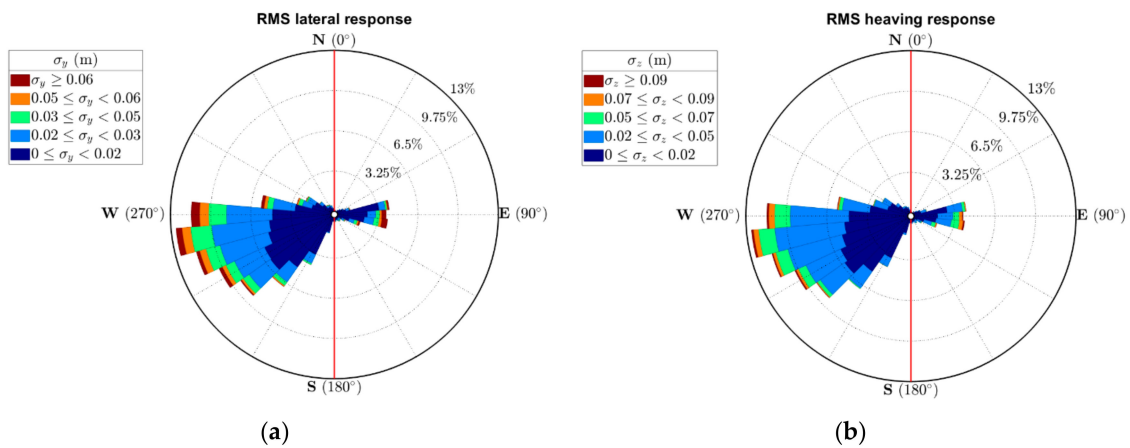
Figure 7. Wind roses of (a) the RMS lateral response and (b) the RMS heaving response. The  $x$ -axis of the bridge is aligned with the red lines.
