Enhanced Non-Destructive Testing of Small Wind Turbine Blades Using Infrared Thermography

Abstract: This study presents a foundational step in a broader initiative aimed at leveraging thermal imaging technology to enhance wind turbine maintenance, particularly focusing on the challenges of detecting defects and object localization in small wind turbine blades. Serving as a preliminary experiment, this research project tested methodologies and technologies on a smaller scale before advancing to more complex applications involving large, operational wind turbines using drone-mounted cameras. Utilizing thermal cameras suitable for both handheld and drone use, alongside advanced image processing applications, we navigated the significant challenge of acquiring high-quality thermal images to detect small defects. This required a concentrated analysis of a select subset of data and a methodological shift towards object detection and localization using the You Only Look Once (YOLO) model versions 8 and 9. This effort not only paves the way for applying these techniques to larger-scale turbines but also contributes to the ongoing development of an integrated maintenance strategy in the wi

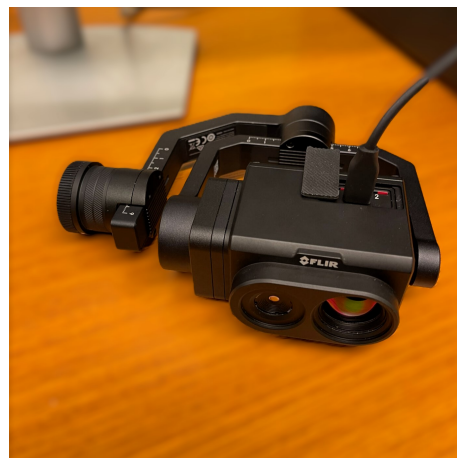
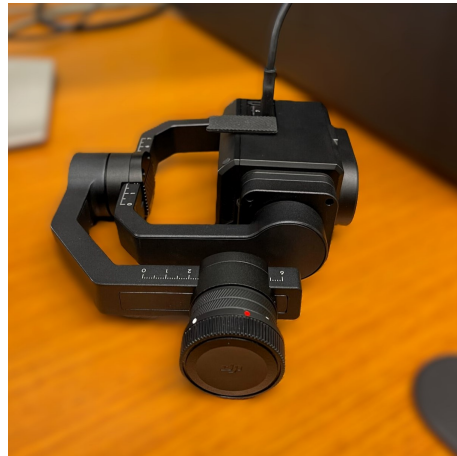
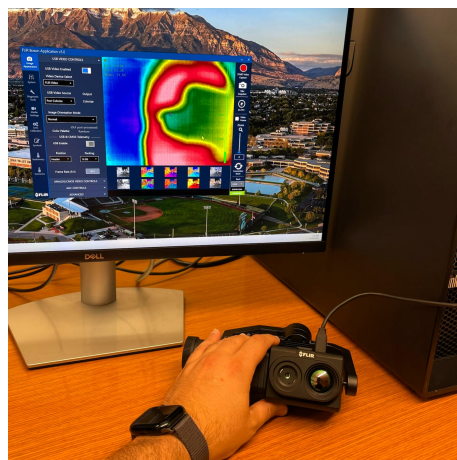
Figure 3. (a) FLIR Vue TZ20 camera, (b) camera connector gimbal, and (c) camera connected to FLIR Boson GUI 3.0 application.

This research utilized the FLIR Vue TZ20 camera, shown in Figure 3 specifically engineered for drone operations. The camera features a spectral range of 7.5–13.5 μm and thermal sensitivity (NETD) < 50 mK at f/1.0. It features a dual thermal camera system with a 20 \times digital thermal zoom, allowing for both wide and focused field-of-view options. This versatility is crucial for capturing detailed thermal data across various inspection scenarios, from public safety to industrial inspection. The camera operated in conjunction with FLIR Boson GUI 3.0 on a Windows platform, designed to enhance the development and deployment of thermal imaging solutions. The suite offers a user-friendly interface for the efficient management and processing of thermal images. The camera was connected to the drone using the gimbal depicted in Figure 3b, which ensured stable mounting and precise control during flight. The interface and connection setup are illustrated in Figure 3c. For further technical details, the FLIR website provides extensive information on the Vue TZ20-R's specifications and integration capabilities with DJI Matrice M200 v2- and M300-series drones via the Skyport V2.0 gimbal. The deployment of this camera in our project focused on capturing high-quality thermal images that revealed minute defects in the WTBs, a task compounded by the complexities of outdoor environmental conditions.

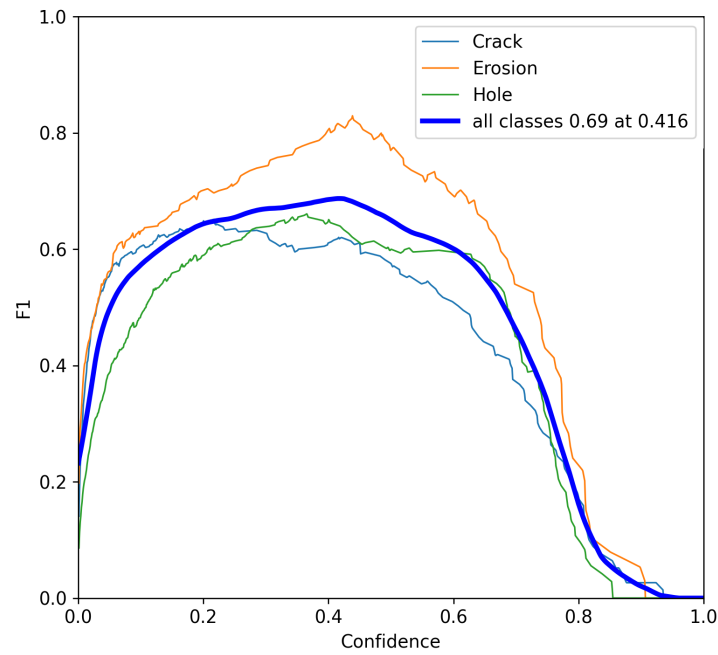
Figure 10. F1–confidence curve for YOLOv8.

The F1–confidence curve, shown in Figure 10, plots the harmonic mean of precision and recall for all the three classes against different confidence levels. The curve peaks at an F1 score of 0.69 at a confidence threshold of 0.416, suggesting an optimal balance between precision and recall at this threshold for all classes.

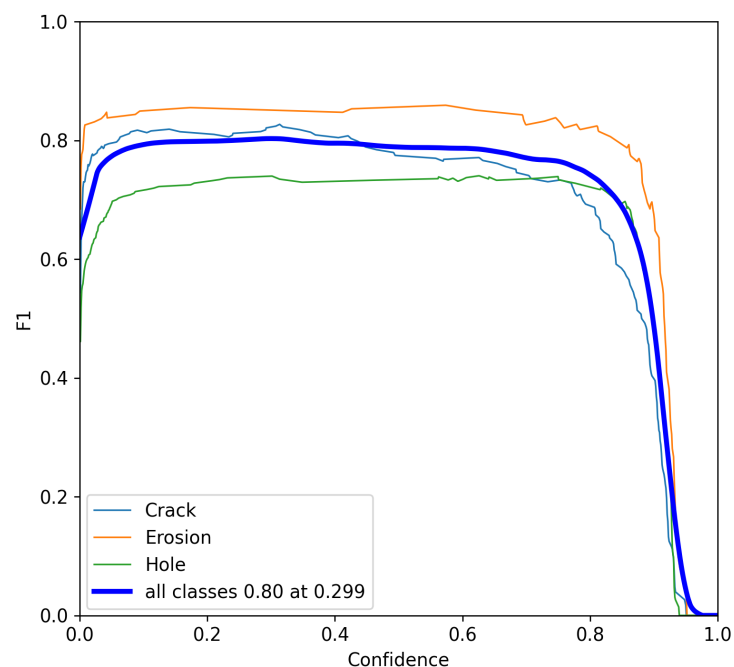
Figure 17. F1–confidence curve for YOLOv9.

The F1–confidence curve for YOLOv9 is illustrated in Figure 17, demonstrating the harmonic mean of precision and recall at various confidence levels. This curve will be compared to YOLOv8’s to evaluate if the newer model achieved a better balance between precision and recall.
