# Effectiveness of Nanotechnology Treatments in Composite Aircraft Applications

**Abstract:** This paper aims to verify the effectiveness of a process of superficial protection based on nanotechnologies produced by 4Ward360 and specifically developed for aeronautical applications on composite material aircraft. The Dardo aircraft, a composite VLA category manufactured by CFM Air, was taken as a reference case and two application/investigation areas were identified. The potential anticorrosive behavior of the nanotechnology treatment was investigated when applied to the metal joints of the aircraft, such as the wing–fuselage attachments usually made of Al-2024-T3 aluminum alloy. Furthermore, the potential increased effectiveness in cleaning was investigated as another possible application concerning the parts made of composite material both solid and in a sandwich configuration and the plexiglass parts of the canopy.

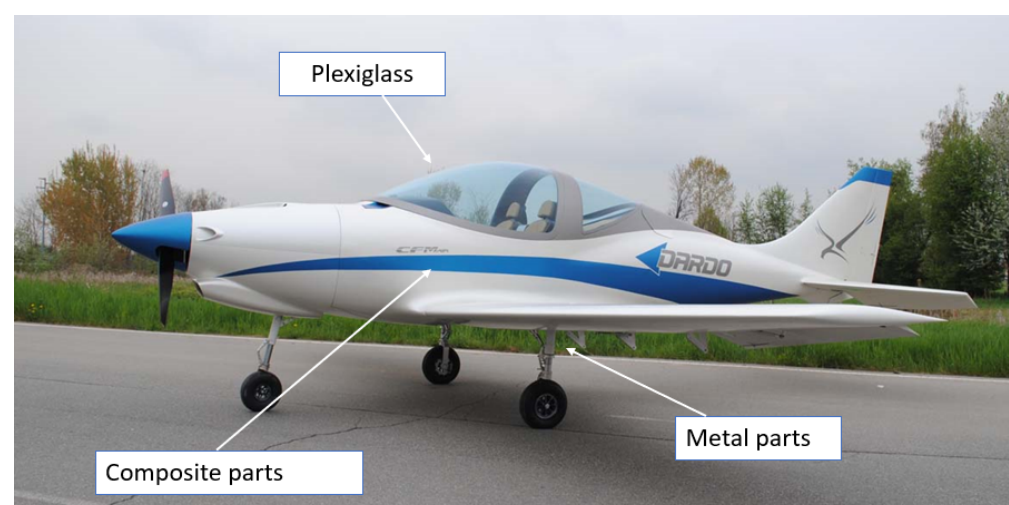
The Dardo aircraft (Figure 1) is a light aircraft designed to operate from short fields as are typically found in logistically austere environments. It is able to operate up to a service ceiling of 12,000 ft, and never exceeds a speed of 170 KCAS. It must also carry a max fuel content of 80 Kg that allows for an endurance of 4 h. The nominal range is in the order of 350 NM.

**Figure 1.** Dardo aircraft.

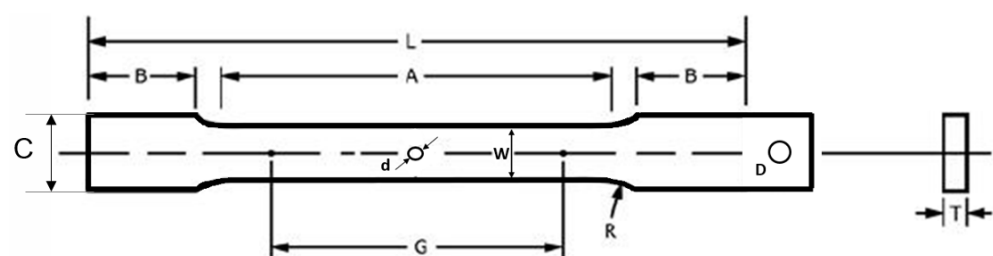
The dimensions of each specimen can be deduced from Figure 2 and Table 1. The standard specimens were modified by introducing two holes, a central one of 2 mm necessary to increase the stress intensity factor and therefore limit the duration of the next fatigue test. A second hole of 5 mm was present at one end to allow immersion in the corrosion tank.

**Figure 2.** Specimen's geometry definition.

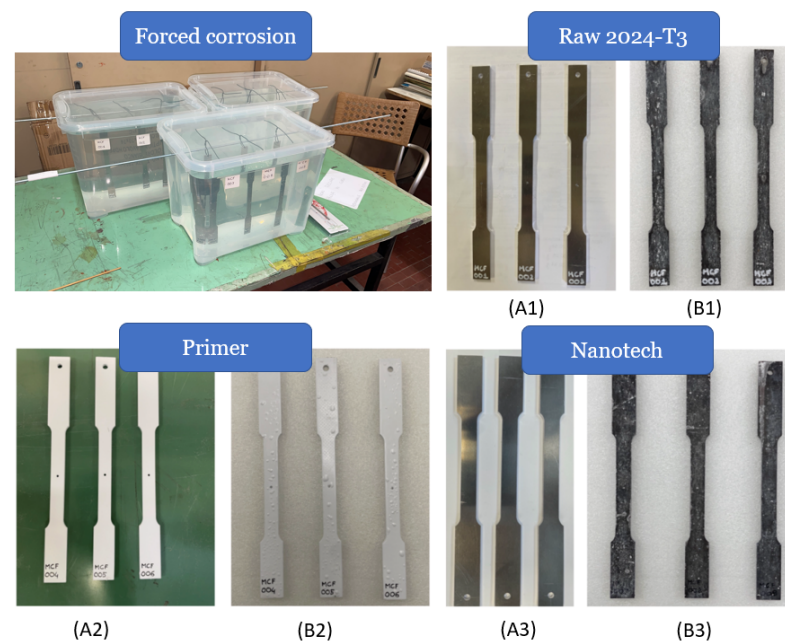
In image (A) of Figure 3, it is possible to observe the aluminum specimens marked with the identification code, before immersion in the bath and in (B) immediately after the phase of extraction from the corrosive bath. A loss of luster was noted for the raw aluminum specimens, a darker coloring and the presence of numerous encrustations of salt as well as a lower smoothness to the touch. A loss of luster was noted for the Al-primer together with surface bubble formation as previously mentioned. Finally, for the specimens treated with nanotechnologies, a loss of luster of the metal and a darker coloration were noted but with less formation of salt encrustations. Also in that case, a reduction in smoothness was found.

**Figure 3.** Specimens: (A1–A3) before corrosion; (B1–B3) after corrosion. “Raw 2024-T3”: aluminum without corrosion protection; “Primer”: aluminum treated with a standard primer; “Nanotech”: aluminum treated with nanotechnology.

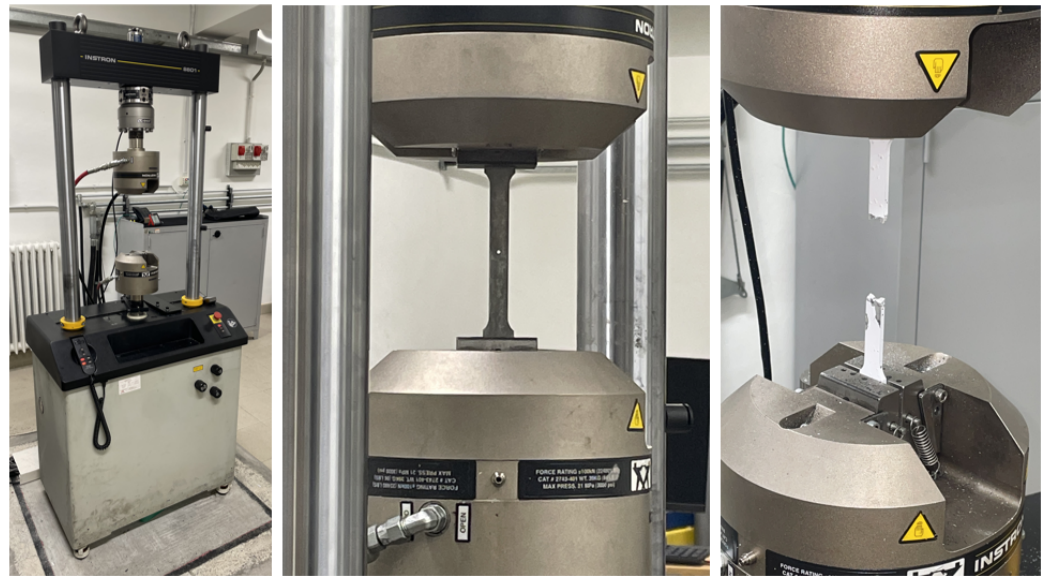
The INSTRON 8801 machine (Figure 4), available at Politecnico di Torino-DIMEAS structural laboratories, was used to carry out the fatigue tests. In addition to the 9 specimens subjected to corrosive treatment, the other 4 specimens were added, bringing the total of those mechanically tested to 13 in order to have a direct comparison between the same types of surface coatings with the only discriminating factor being the corrosive process undergone. All the samples reported in Table 2 were subjected to the fatigue test, highlighting those that underwent the corrosive process. Table 2 also shows the three selected load levels, the maximum and minimum force of the applied cycle, and the frequency of load application. The need to conduct fatigue tests, operating with three different load levels, arises from the need, albeit with the limitation of the reduced number of specimens, to approach the definition of the S-N curves [10,16].

Figure 4. Specimen installed in the fatigue test machine.

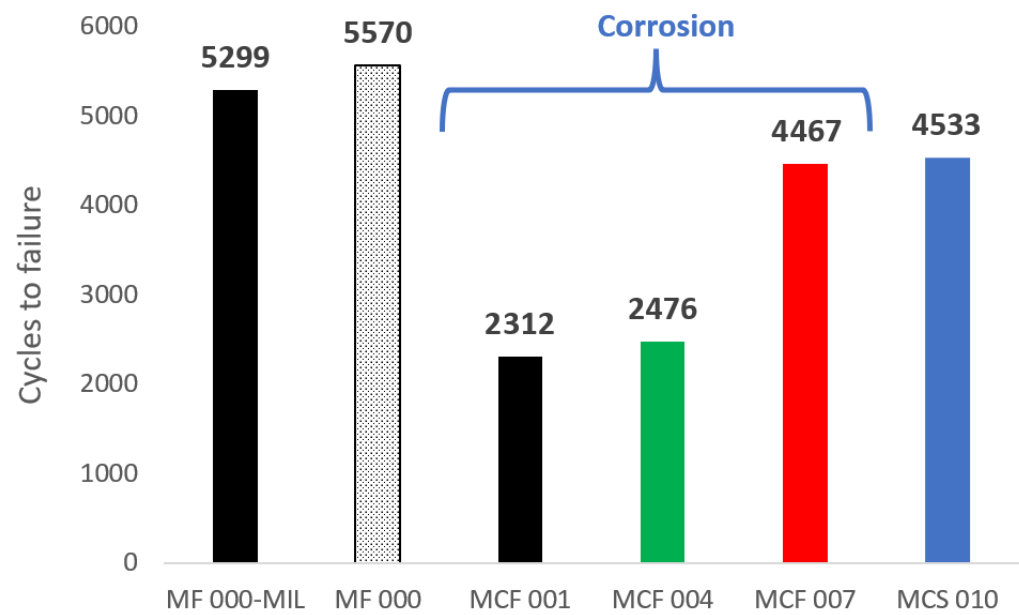
Figure 5 presents the number of cycles to failure of the specimens subjected to load type 1 corresponding to  $F_{max} = 11$  kN,  $F_{min} = 0$  kN, and a frequency of  $f = 5$  Hz. The specimens subjected to corrosion are also indicated. For this load, we note a significant reduction in fatigue life for the untreated MCF001 specimen and also for the Al-Primer specimen (MCF004) compared to the uncorroded case MF000, demonstrating the evident reduction in fatigue life due to the corrosion effect. The specimen treated with nanotechnologies (MCF007) in this case had a very similar behavior to that of the specimen of the same category not subjected to the corrosion process (MCS10), demonstrating an increased protective property against corrosion with an increase in fatigue life of +48% compared to raw Al, of +44% with respect to Al-Primer, and a small reduction of −1.44% when considering the uncorroded Nanotech specimen.

**Figure 5.** Load type 1:  $F_{max} = 11$ , kN  $F_{min} = 0$ , and kN  $f = 5$  Hz.

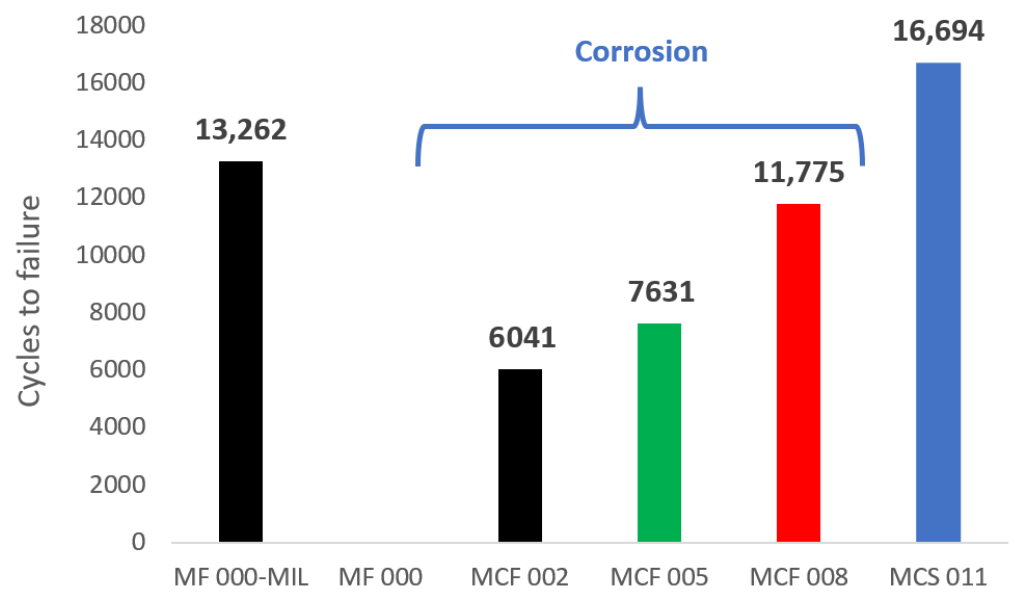
The results relating to the intermediate load level indicated with type 2 and corresponding to  $F_{max} = 9$  kN,  $F_{min} = 0$  N, and a frequency of  $f = 5$  Hz are shown in Figure 6. Also in this case, an excellent behavior of the specimens treated with nanotechnologies and subjected to the corrosion process can be noted. In particular, the MCF008 specimen had an increase in life of +48% compared to raw aluminum (MCF002), +35% compared to the specimen treated with primer (MCF005), and a reduction of −29% compared to the specimen treated with nanotechnology but not corroded (MCS11). Finally, considering the lowest load level indicated in Figure 7 with type 3 and corresponding to a cycle defined by  $F_{max} = 6$  kN,  $F_{min} = 0$  N, and a frequency of  $f = 5$  Hz, we still noticed a better behavior of the specimen treated with nanotechnologies albeit reduced compared to the previous case. In this case the MCF009 specimen had an increased fatigue life compared to raw aluminum (MCF003) of +39%, while compared to the primer (MCF006), the life increase was 33%, and the reduction compared to the uncorroded case (MCS012) increased to −66%.

**Figure 6.** Load type 2:  $F_{max} = 9$  kN,  $F_{min} = 0$  kN, and  $f = 5$  Hz.

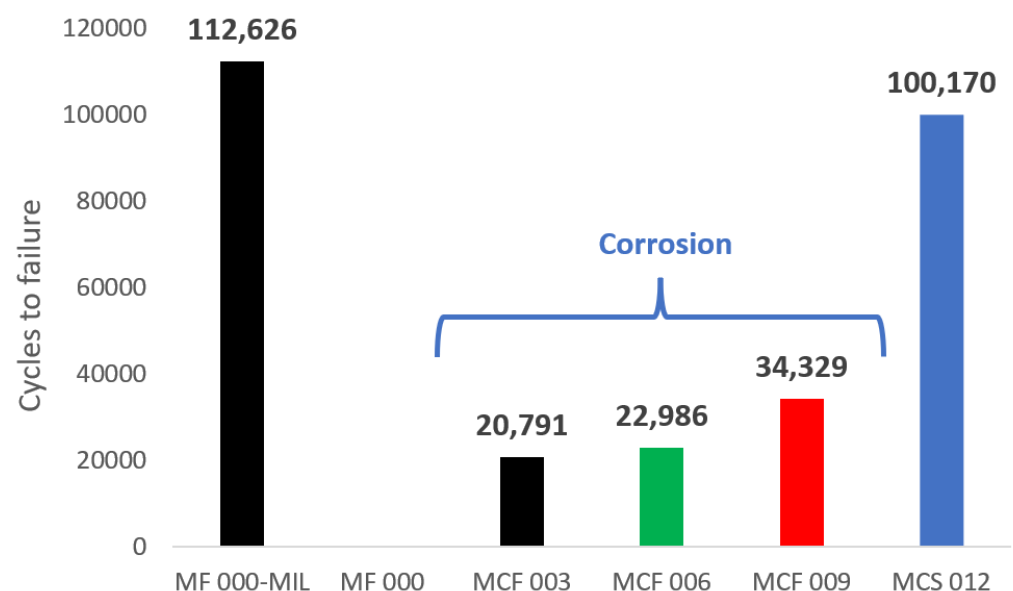
**Figure 7.** Load type 3:  $F_{max} = 6$  kN,  $F_{min} = 0$  kN,  $f = 5$  Hz.

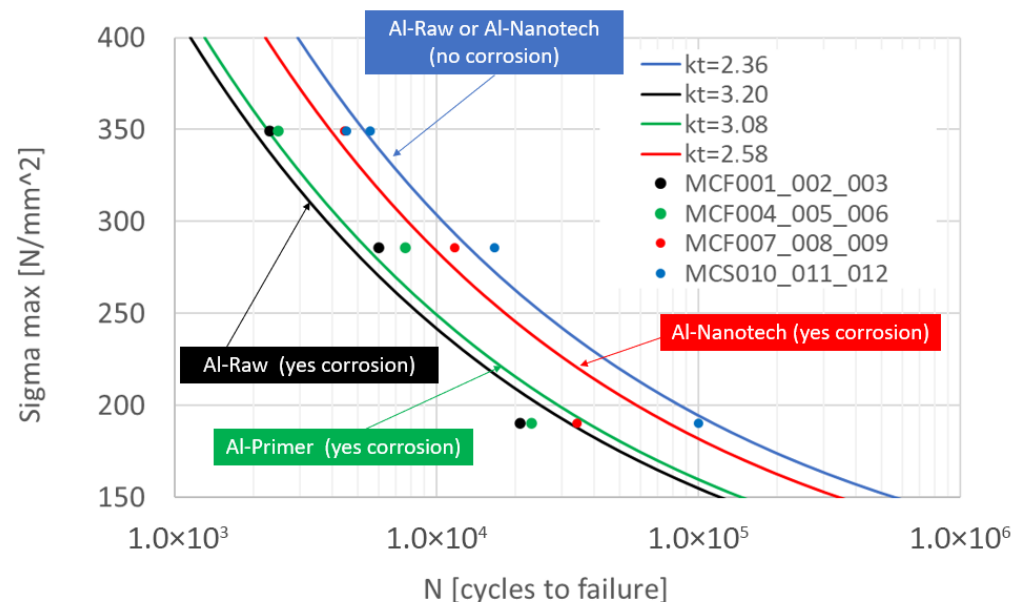
Figure 8 shows the S-N curves considered for the different cases discussed. In blue are the specimens not subject to corrosion, in black are the corroded and unprotected specimens, in green are the specimens protected with primer, and finally, in red are the specimens protected with nanotechnologies and subjected to the corrosion test. In all specimens subjected to corrosive immersion, a greater effect of corrosion was observed at lower loads (load types 2 and 3), confirming not only an increase in the stress concentration factor (kt) but also a change in the slope, as indicated also in [9].

**Figure 8.** S-N curve: blue: no corrosion; black: corroded specimens; green: primer protection; red: nanotechnology protection.

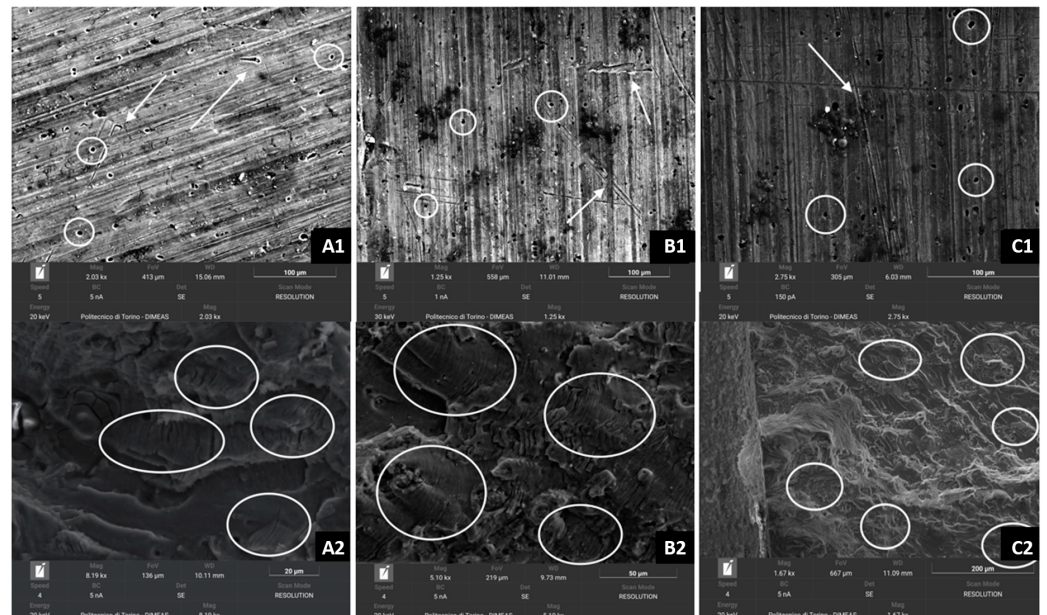
From the electron microscope (SEM) analysis, as reported in Figure 10, production damage (scratches and streaks) could be seen on all specimens subjected to corrosion as well as signs of surface pitting [19]; however, they were more consistent in size and number in the case of raw aluminum and primer treatment, where a detachment from the metal surface was observed. Pitting corrosion also occurred in the case of aluminum treated with nanotechnologies, but with characteristics at first sight decidedly more limited than what occurred in the other two cases.

Figure 10. SEM analysis: (A1,A2) MCF002; (B1,B2) MCF005; (C1,C2) MCF008.

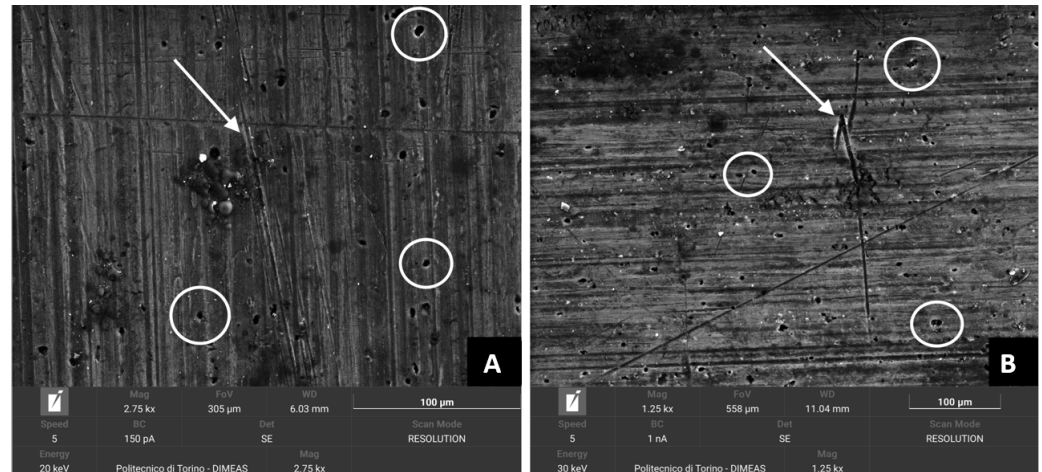
Considering the limited number of specimens considered in this study and observing Figure 11, it can be cautiously stated that at the same magnification, the corroded specimen, MCF 008, had the same number of holes and imperfections as the uncorroded one, MCS 012, both treated with nanotechnology, and only increased in size. The raw aluminum samples showed notable differences: an increase in the number of imperfections in the corroded sample, MCF 002, compared to its uncorroded counterpart, MF 000. This aspect shows a general improvement in the ability to resist corrosion for the nanotechnology-treated specimens.

**Figure 11.** Specimen surfaces MCF 008 (A) and specimen MCF 012 (B).

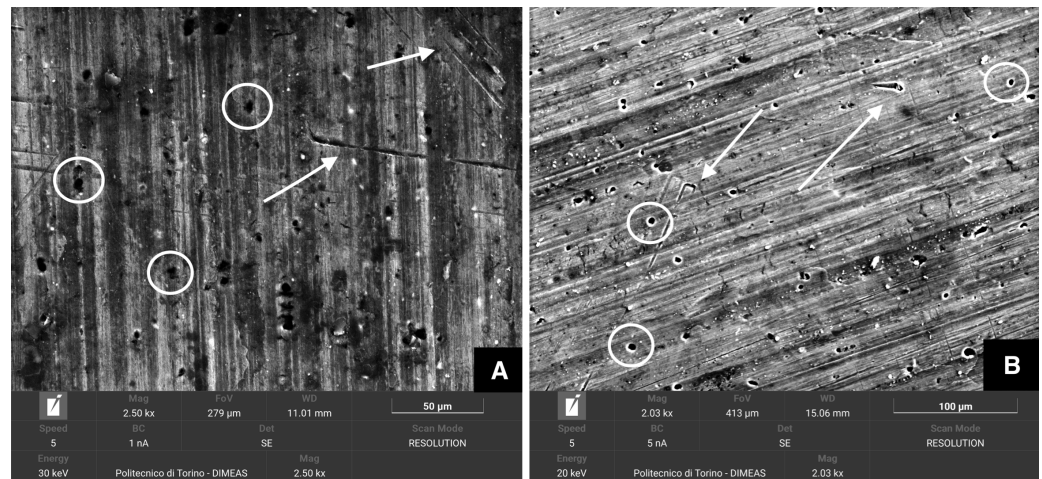
The analysis conducted by an SEM microscope provided better evidence of how corrosion affected the surface finish of the metal: to observe the same type of damage related to the machining and fabrication of the metal specimens, the corroded raw aluminum specimen, MCF 002, was analyzed at a lower magnification, compared to the uncorroded raw aluminum specimen, MF 000, see Figure 12.

**Figure 12.** Specimen surfaces MF 000 (A) and specimen MCF 002 (B).

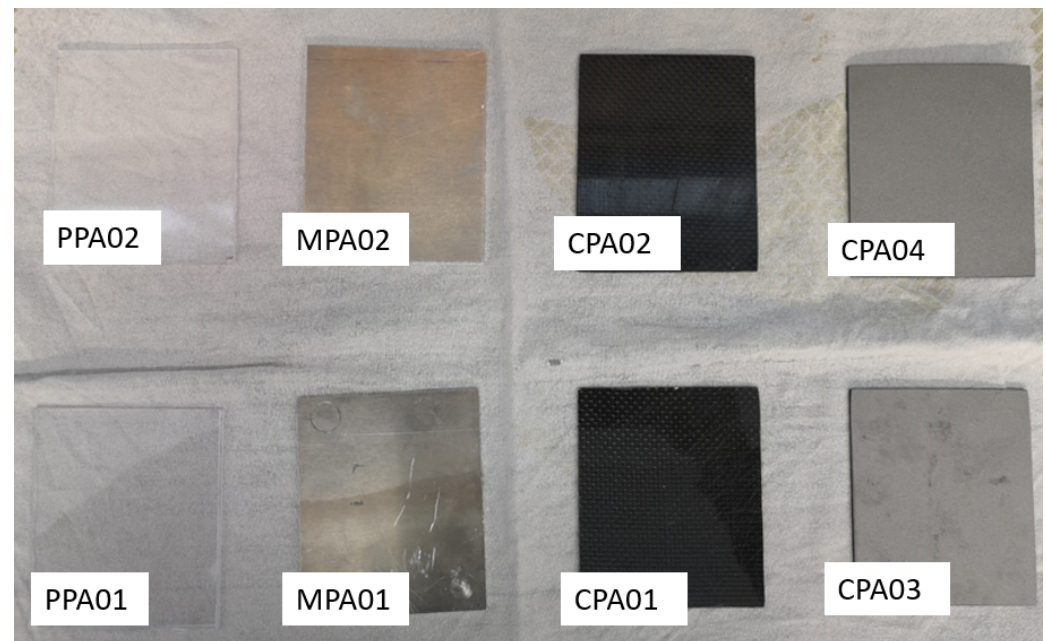
Table 4 and Figure 13 show the specimens subjected to cleaning tests.

**Figure 13.** Specimens under cleaning tests, see Table 4 for label definitions.

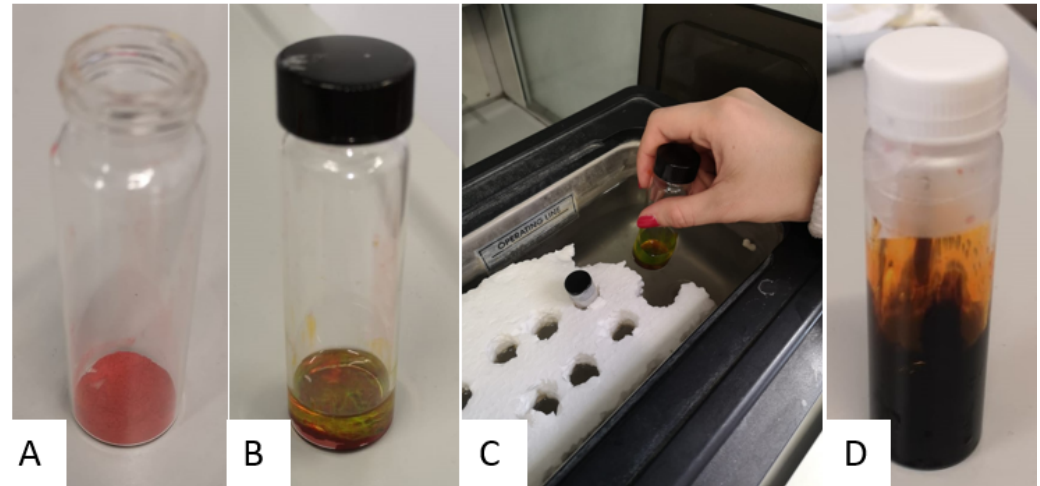
The fouling agent was a mixture consisting of 98% polyethylene glycol (PEG 400), 1% black dye, and 1% sodium fluorescein (Figure 14A). Sodium fluorescein was combined

with polyethylene glycol inside a small container (Figure 14B) and the mixture was made homogeneous by means of an ultrasound sonicator alternating mixing periods with stop periods (Figure 14C). Last, the black dye was added. The mixture thus produced had to be stored in the sealed container for at least one night before use (Figure 14D).

**Figure 14.** Fouling solution preparation: (A) sodium fluorescein (B) mixture of 1% sodium fluorescein and 98% of PEG400 (C) ultrasound sonicator (D) final mixture with addition of 1% black dye .

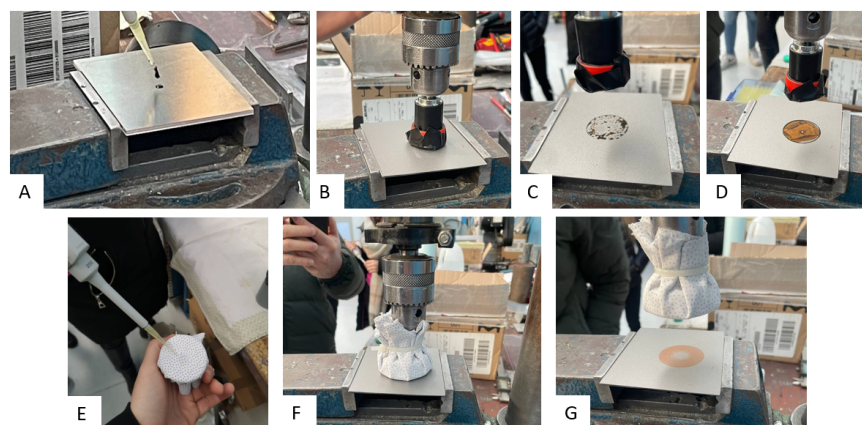
The application of the fouling agent started by positioning the specimens to be treated on the work table and filling the tip of the 0.025 mL repeating pipette with the fouling solution. A series of drops were dropped until an 80  $\mu$ L drop was deposited approximately in the center of each specimen.

The dirt head consisted of a 30 mm diameter polishing head with a Teflon adhesive tape glued to the relative surface to make it impermeable to the fouling agent. The cleaning head consisted of a 50 mm polishing head covered with four layers of cotton fabric, previously left for one night in a desiccator loaded with a saturated solution of potassium carbonate, with a humidity level of approximately 45%. The specimen had to be arranged in such a way that the fouling head rested exactly by gravity above the drop of dirt. The spindle was then started and left to act for one minute. Finally, the covered cleaning head was used after the cleaning tissue had been moistened in the center with 0.025 mL of water. The cleaning head was left to work for 22 s. At the end of the procedure, the cleaning head was removed without friction.

**Figure 15.** Dirtying procedure (A–D) and cleaning procedure (E–G).

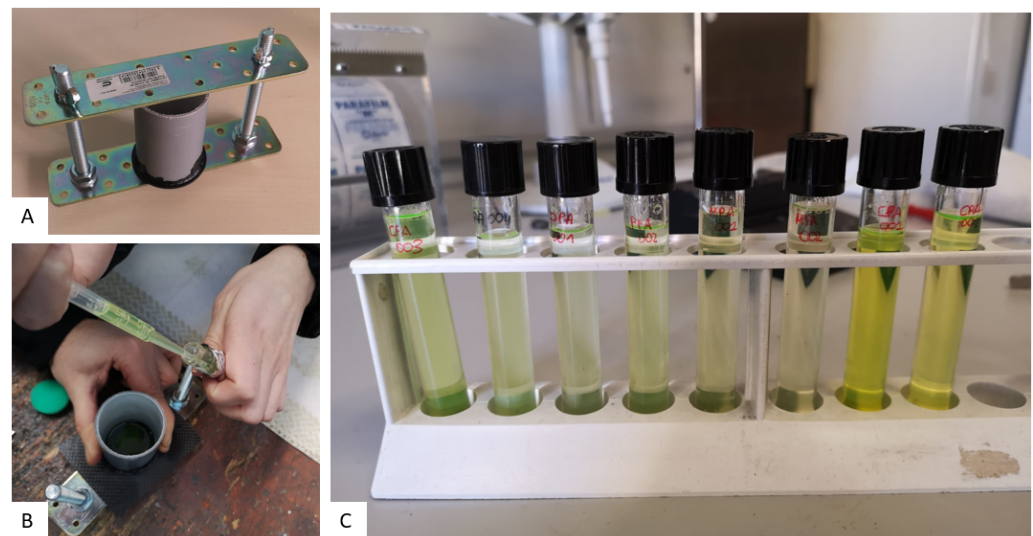
The procedure for removing the residual dirt, often barely visible, from the central portion of the specimen on which the fouling/cleaning procedure was carried out was then started. To do this, 10 mL of distilled water was introduced into the extraction device within 30 min of the fouling procedure, respecting some indications given by the regulation. The first specimen was placed face up within the clamp frame of the extraction fixture. The sealed tube was then placed in the center of the specimen, so that the seal defined the solution extraction area. Once the tube had been locked in the frame with a slight pressure generated by the screwing of the wing nuts, 10 mL of distilled water was added, stirred, and left to rest for 3 min. Finally, with a Pasteur pipette, a portion of the solution obtained was inserted into the test tube, correctly labeled, and placed on the rack, while the subsequent samples were extracted.

**Figure 16.** Extraction of residual dirt: (A,B) extraction fixture; (C) test rack with solution samples.

With the same amount of time to carry out the cleaning procedure, it can be noted that the Al2024 sample treated with nanotechnologies had a 16% increase in dirt removed, and the raw carbon treated with nanotechnologies had a 7% increase in dirt removed. The painted carbon treated with nanotechnologies had a 15% increase in dirt removed. Finally, the plexiglass treated with nanotechnologies had a decrease in dirt eliminated of 23%. Despite the apparently negative result obtained on the plexiglass, the results obtained on the composite and on the metal are promising in terms of efficacy of nanotechnology in terms of cleaning improvement. Likely, the ability of surfaces treated with nanotechnologies to be easier to clean (at least for CFC and Al2024) is due to the hydrophobicity characteristic that silicon nanoparticles are capable of attributing to the substrate on which they are applied. This property is also observable in Figure 15 where a visual comparison is made on the distribution of dirt in one treated and one untreated specimen. Extraction of the residual dirt and solution samples preparation is shown in Figure 16.
