Supplementary Materials: Study on Durability and Dynamic Deicing Performance of Elastomeric Coating on Wind Turbine Blade

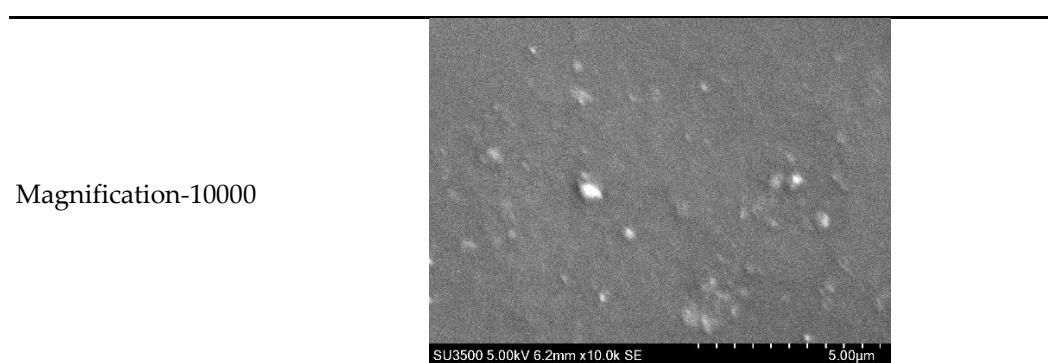
Magnification-500

Magnification-1000

Magnification-3000

Figure S1. The SEM picture with different magnification of natural aging coatings.

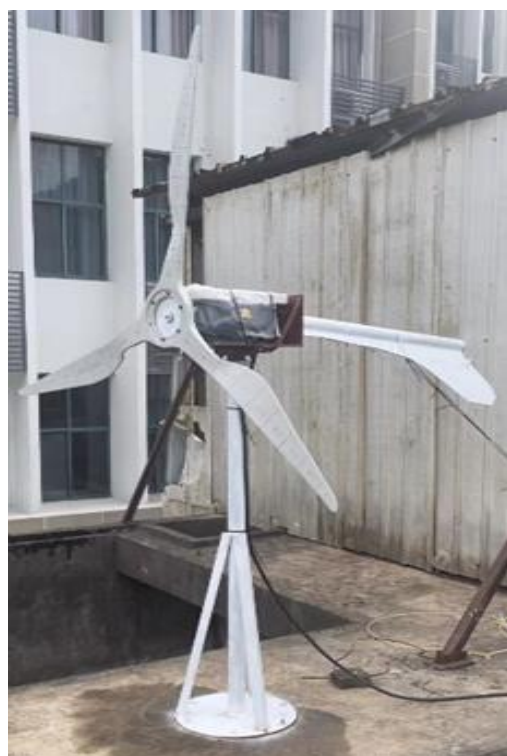
Figure S2. The wind fan used for the durability test of the elastic deicing coatings.

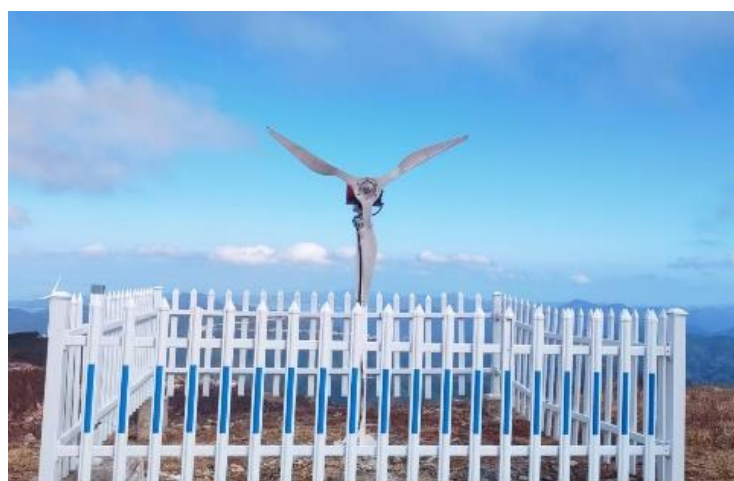
Figure S3. Wind turbine used for dynamic deicing test.
