# Damage Investigation on the Carbon Tows during Rewinding and Braiding Processes

**Keywords:** carbon fiber; damage; rewinding; braiding process

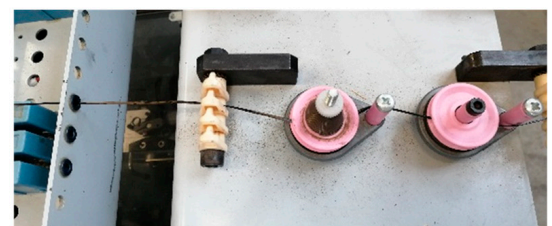
**Figure 1.** Scheme of the winding machine with configurations of the bobbin orientation.

The degradation of carbon tows that occurs during the rewinding step was tested on a 2PVLU\220 Ratera<sup>®</sup> winding machine [28]. Two bobbins can be rewound simultaneously on this specific device. A potentiometer allows the user to control the speed at which the bobbin is rewound by increasing or decreasing the speed of rotation of the bobbin as well as the speed of displacement in putting the carbon tow on the bobbin. C. Cherif [29] showed that a low production speed may be more appropriate for brittle and fragile carbon-based products in order to minimize friction [30]. In this study, the influence of winding machine parameters on the degradation of carbon tows was investigated. Three parameters were considered: the speed used during rewinding and orientation (or placement) of the bobbin and angle (defining the position of the delivering bobbin) at which the tow is introduced into winding machine. For the orientation of the bobbin in relation to the winding machine, two configurations were considered. The concept of a winding machine is represented in Figure 1, with the two configurations of the bobbin orientation. When this bobbin is parallel to the axis of the winding machine, only the carbon tow is in a position to be unwound (configuration denoted as Parallel). If this bobbin is placed perpendicular to the axis of the winding machine, it then turns on itself to unwind the roving fed to the winding machine (configuration denoted as Perpendicular).

The delivering bobbin turns on itself to unwind the tows

The tow is unwound without the bobbin moving

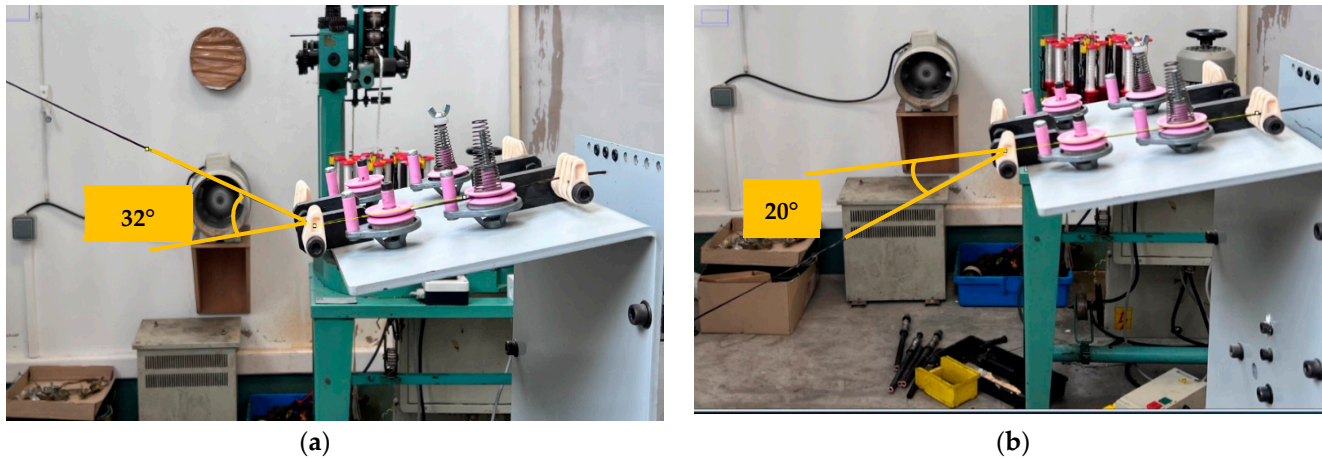
**Figure 2.** Positions of the delivering bobbin: (a) high position ( $32^\circ$ ), (b) low position ( $20^\circ$ ).

For the position of the delivering bobbin, two different angles were chosen. When the delivering bobbin is placed on the highest position of the creel, carbon tows enter into the winding machine at an angle of  $32^\circ$ , as shown in Figure 2a. In the lowest position of the creel, the carbon tows enter the winding machine at an angle of  $20^\circ$ , as shown in

Figure 2b. The  $32^\circ$  angle is the highest value possible on this winding device, and will apply the most friction to the tows. The second position, associated with a lower angle ( $20^\circ$ ), is considered a more general rewinding configuration [23]. This position parameter was studied to analyze if the angle value applied during entry to the rewinding machine has a significant influence or not on the degradation of the tows.

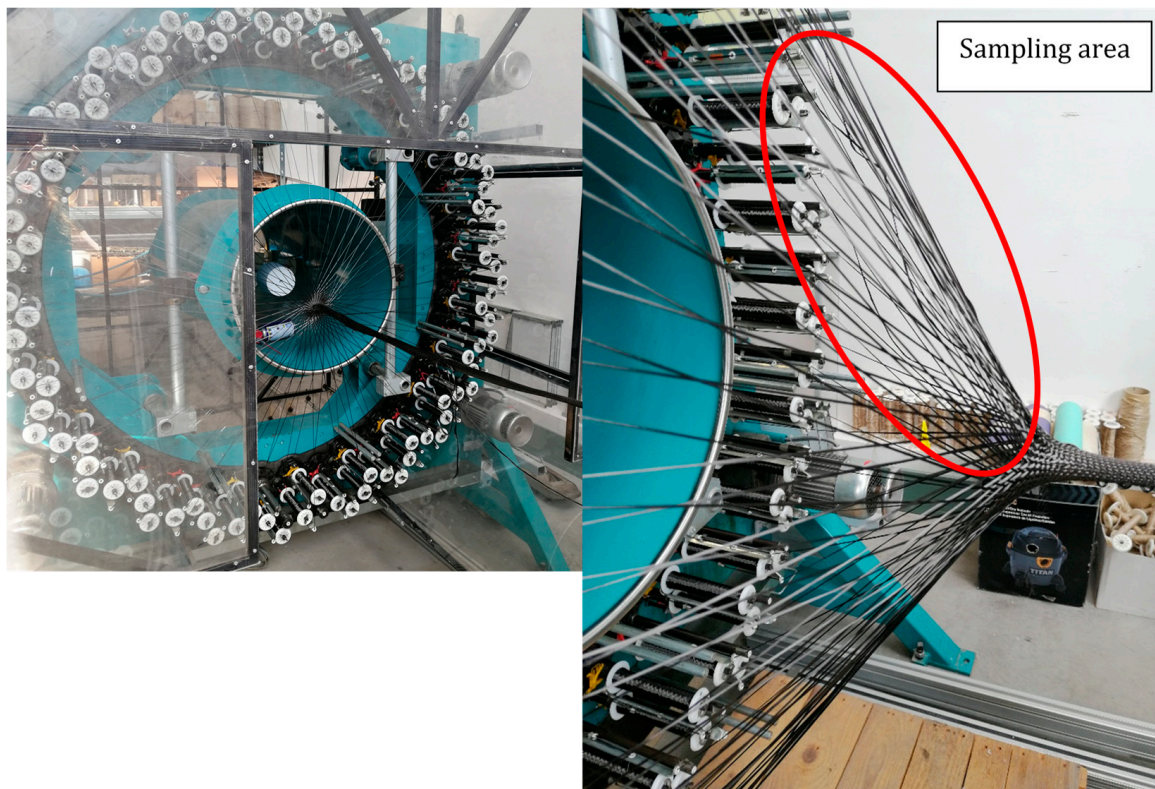
**Figure 3.** Braiding machine (left) and sampling area (right).

Once the carbon tows were rewound, the bobbins could be placed on the braiding machine. A HERZOG radial braiding machine with a capacity of 144 spools (96 and 48 for bias and axial tows, respectively) was used in the GEMTEX laboratory (Figure 3). It has been described in previous works [31–34]. As explained in the Introduction, tension plays a key role in the degradation of carbon tows and has an influence on braid parameters.

These visual observations were confirmed by the degradation of the carbon tows extracted from the sampling area (Figure 3), and quantified thanks to the criteria defined in the image analysis method detailed in Figure 4. The degradation criteria for carbon tows used in the production of both braids are given in Figure 9. These values showed 15% degradation when the stiffest springs were used (carbon tows of Braid 2), compared to 8% degradation with the less stiff springs (carbon tows of Braid 1). Results in Figure 9 show the same tendency observed in the rewinding step: a higher tension results in a higher degradation of the carbon tows. The values of the degradation criteria were quantitatively higher than those measured during the rewinding process (Figure 5). The influence of this degradation on the mechanical behavior of carbon tows was studied via the comparison of the tensile behavior of carbon tows extracted from the sampling area during the production of Braid 2 with that of the initial tows, as shown in Figure 10. Compared to the initial properties of the carbon tows before braiding, the degradation of carbon tows during the braiding stage affected their tensile properties. From these curves, parameters associated with these mechanical behaviors are compared in Table 5. This comparison shows a loss of properties equal to 17%, 30% and 27% for the strain at break, the load at break and the tenacity, respectively. These values are in accordance with the loss reported in several studies on the degradation of tows used in the winding process [19–21]. Compared to the influence of degradation on the mechanical behavior during the rewinding step (Figure 7b), these results show the significant influence of the level of damage during the braiding step.

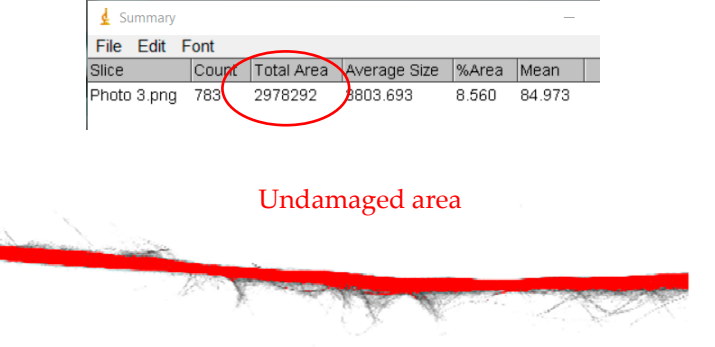
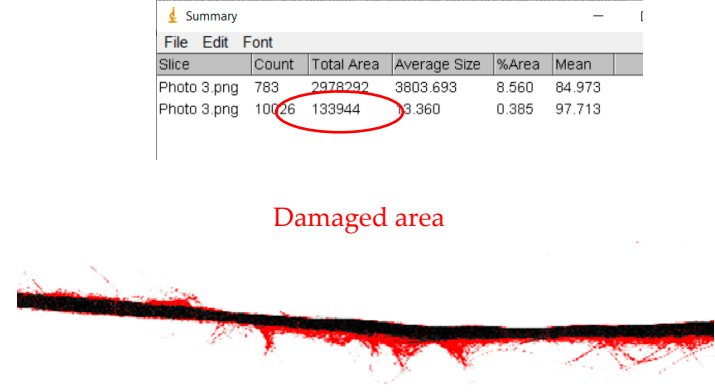
Figure 4. Image analysis of damage and definition of degradation criteria.

In this study, the samples were analyzed via image analysis and with tensile tests. Each tow sample was scanned at a resolution of 600 ppx. The images were then imported into the image processing software ImageJ [38]. The analysis was based on the damaged and non-damaged areas of the tow where no filament was broken or misaligned. The areas considered were highlighted in red by the software. Adjustments could be made manually to be as accurate as possible. Once the areas were selected, the software translated the selected surface into a value corresponding to the number of pixels located in the zone. The ratio of the area of damaged surface to the total surface considered allowed us to define a percentage of degradation of the tow occurring during the rewinding and braiding processes. The steps of this approach are described in Figure 4.

<p>The damage-free area is selected; the software highlights this zone in red. At this stage, the user can modify the selection criteria to adjust the selection. Once the selected area is approved by the user, the software translates that selection into a value associated with the number of pixels in the red zone.</p>

<p>Computation of a degradation criteria defined by the ratio of damaged area to total area (<b>Equation</b>).</p>	$Degradation(\%) = \frac{Damaged\ area}{Undamaged\ area + Damaged\ area} \times 100$

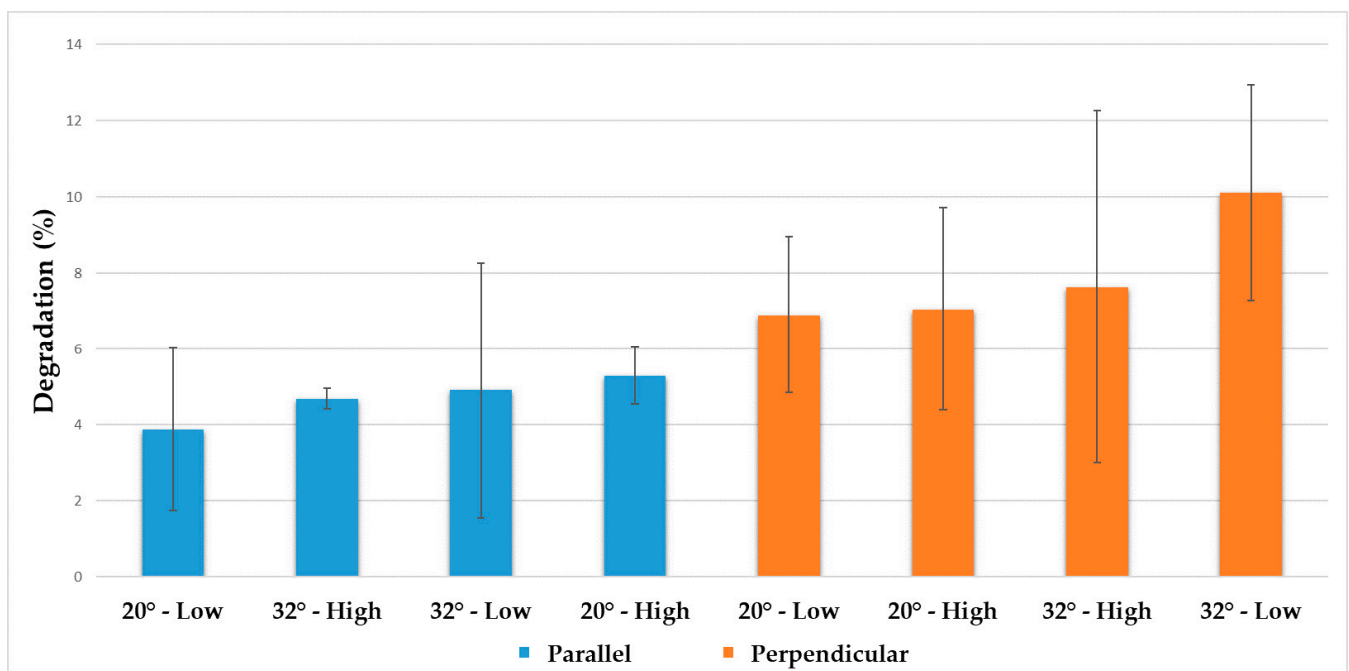
**Figure 5.** Evolution of degradation criteria as a function of rewinding parameters.

Following the designed experiment, as introduced previously (Table 2), Figure 5 shows the degradation criteria values, computed with Equation, for the height configurations, denoted with values of the three rewinding parameters used in this study.

Figure 5 shows that when the delivering bobbin was placed perpendicular to the axis of the winding machine (configuration in orange on the graph), a greater degradation was seen

than when it was placed parallel to this axis (configuration in blue on the graph), regardless of the configurations of the speed or position parameters. In the parallel configuration, the delivering bobbin was aligned with the production axis. Therefore, the tows were free to unwind from the bobbin with no restriction. However, in the perpendicular configuration, the delivering bobbin had to roll in order to free the tows. Because the tows need to be transferred from the delivering bobbin to the receiving one, they were the ones driving the movement of the delivering bobbin. Therefore, the tows must be stretched and under tension during the rewinding process. The heavier the delivering bobbin is, the more tension is applied to the tows, increasing the rubbing of the tows against the guiding parts of the machine. This added friction results in a higher degradation percentage, in accordance with the observations made by Czichos [15] and the findings of several studies [18–21]. The highest position of the delivering bobbin (with an angle of 32°) seemed to increase the degradation of carbon tows, especially when this parameter was associated with a perpendicular orientation. Here, again, a higher angle value can be translated to higher stress for the carbon tows, and more friction where the angle is formed. The influence of rewinding speed (configurations: Low or High) seems to be low regardless of the other parameters.

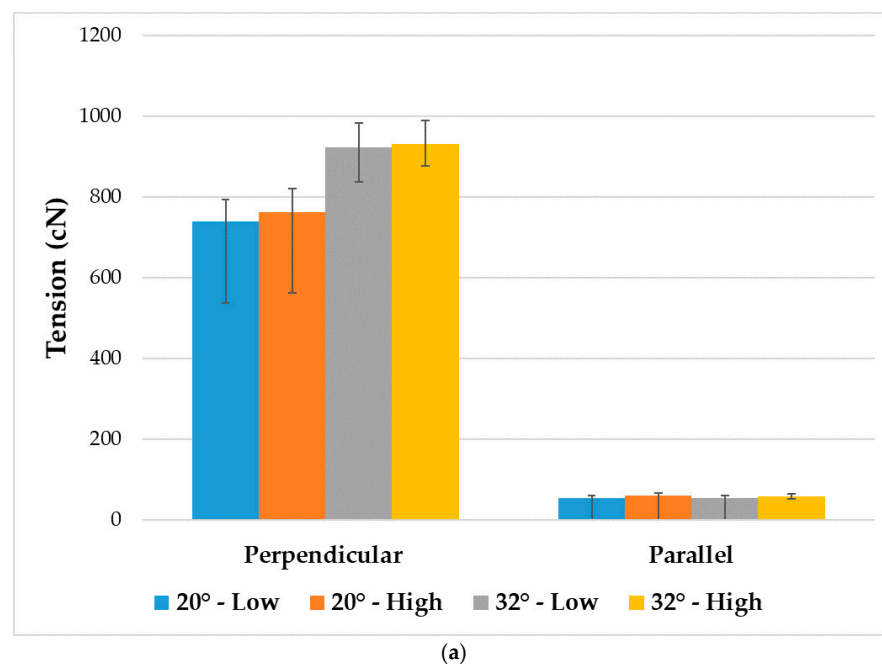
Figure 6. (a) Tension during rewinding process; (b) pictures of carbon tows after rewinding.

To explain this phenomenon, tension loads applied to the tows were measured using the digital tensiometer, placed after the entrance of the winding machine, as shown in Figure 6a.

Figure 6a shows that when the delivering bobbin was placed perpendicular to the axis of the winding machine, the weight of the bobbin provided additional tension for the roving, which was significant compared to the tension values measured when the delivering bobbin was placed parallel to this axis. As shown previously for the degradation criteria, an angle of 32°, associated with the highest position of the delivering bobbin, increases tension on carbon tows. Figure 6b shows carbon tows with two extreme values of the studied parameters after the rewinding step. For samples with the configuration “32°-Low-Perpendicular”, which had a higher value of the damage criterion, as shown in Figure 5, and higher tension applied on carbon tows, as shown in Figure 6a, the damage was clearly visible compared to samples with the configuration “20°-Low-Parallel”. These results show the link between the tension applied on carbon tows and the degradation occurring during this rewinding step.

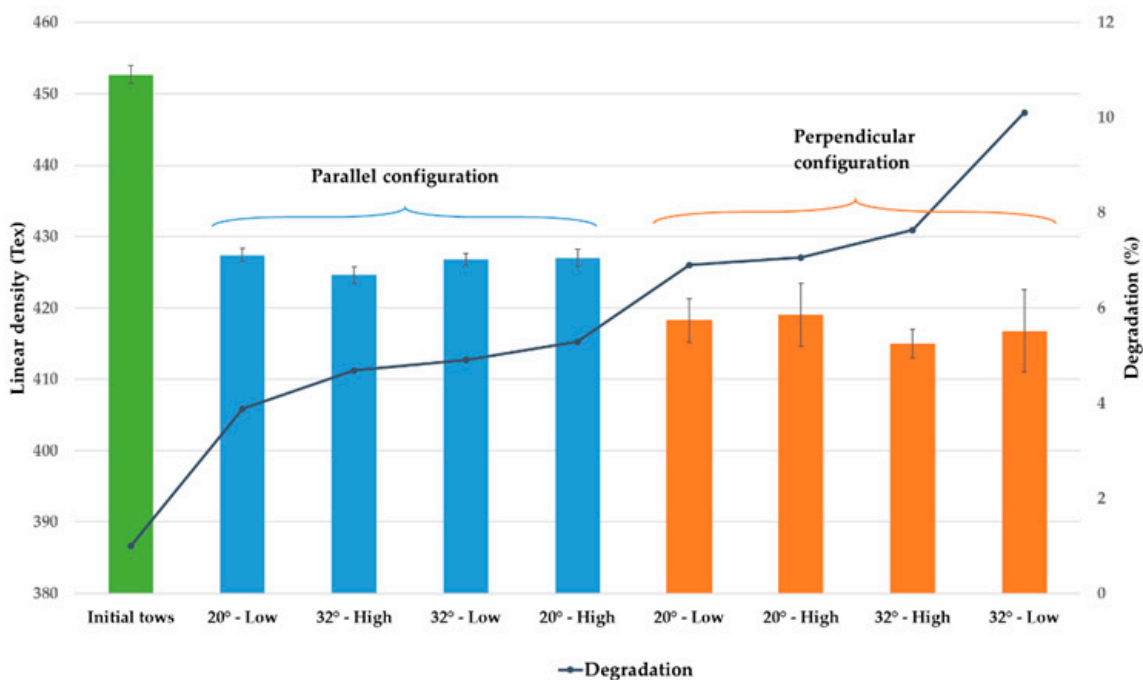
Figure 7. (a) Linear density of samples before and after rewinding; (b) tensile characteristics of samples before and after rewinding.

At the scale of tows, the level of damage was quantified with the measurement of the linear density and the tenacity at break of samples after rewinding. Figure 7a shows the comparison of the linear density of samples relative to the initial value before rewinding, as given in Table 1. The superposition on this curve (in black in Figure 7a) of the evolution of the degradation criterion shows a clear trend in the evolution of the linear density: the more the tows were damaged, the more the linear density decreased. For the most damaged samples, we observed a relative decrease of 6.3% in the yarn count. As shown in Figure 6b, the degradation of carbon tows took the form of filament breaks as well as surface fibrils due to friction, which indicates material loss and a decrease in the linear density of the tows. Figure 7b compares the tensile characteristics of the most damaged sample with that of the initial tows. We can deduce that the level of damage does not involve, at the tow scale, a significant decrease in mechanical properties.

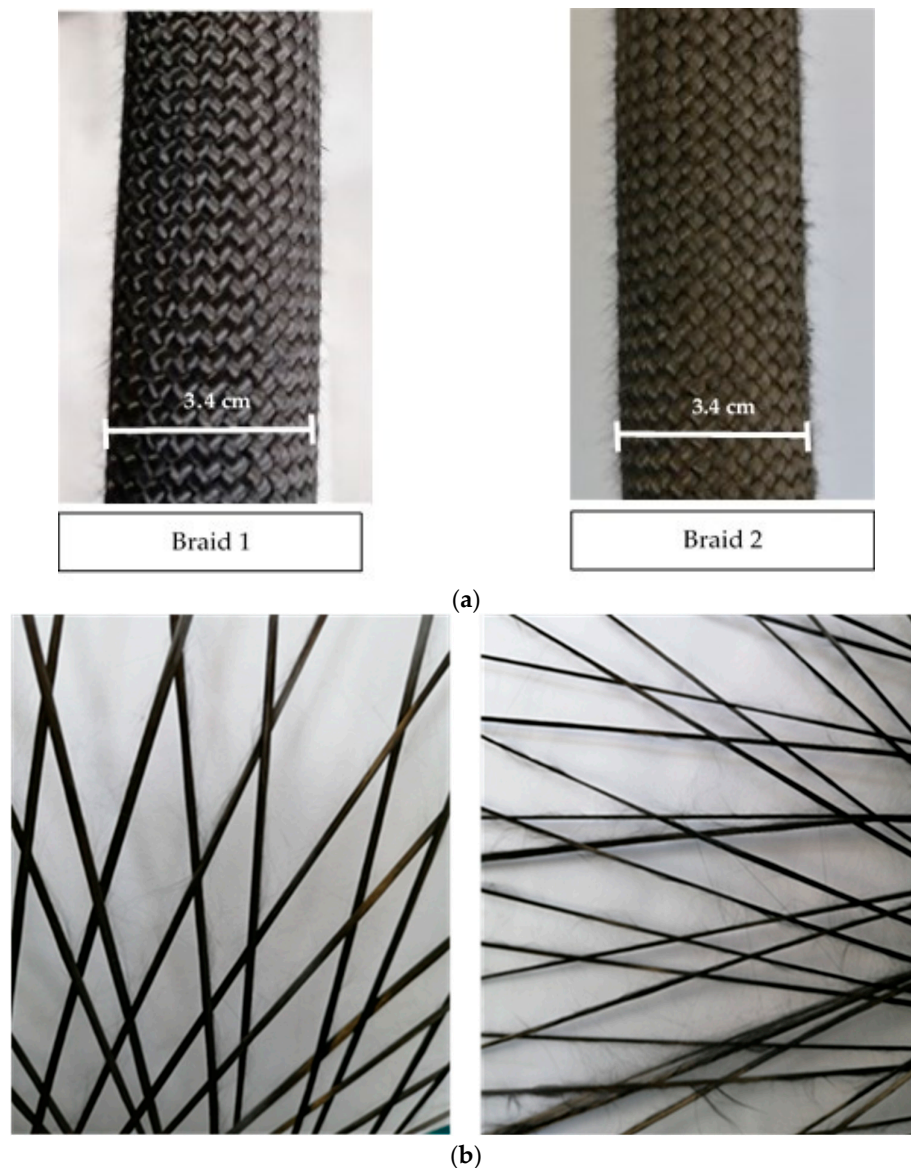
Figure 8. Braid production: (a) braid appearance; (b) carbon tows in sampling area.

As presented in Section 2.3, two types of braids (Braid 1 and Braid 2) were manufactured with the braiding parameters given in Table 3, which differed in the springs used. Figure 8 shows the products obtained as well as the state of the carbon tows in the sampling area (defined Figure 3). We can clearly note a difference between the two products. Compared to Braid 1, for Braid 2, which was manufactured with stiffest springs, the carbon tows were under a higher tension and had more fibrils or misalignments of fibers (Figure 8b). The corresponding braid (Braid 2) was hairier, with a lot of fibrils on its surface (Figure 8a).

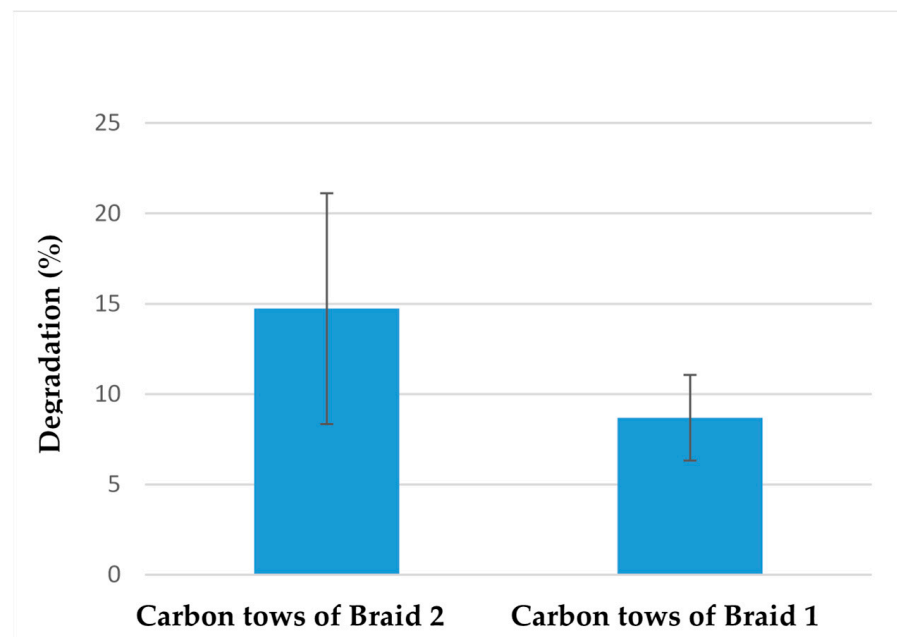
Figure 9. Degradation of carbon tows during the braiding step.

These results show that the degradation initialized during the rewinding of the tows increased during the braiding step. The braiding process produces much more friction between tows than the rewinding stage. The angles at which the tows must pass through the braider's winding system are very high, and the tension control system pushes the tows, resulting in additional damage in the friction zones. As illustrated in Figure 11, the degradation of the tows is associated with different types of defects, such as fiber clusters that are stuck in the eyelets of the bobbins, broken filaments that interlace the tows together, and, in some cases, the break of tows during braiding. These defects lead to production stops and a lower quality of the braid obtained.
