Reliability and Degradation of Solar PV Modules—Case Study of 19-Year-Old Polycrystalline Modules in Ghana

Abstract: Fourteen (14) rack-mounted polycrystalline modules installed on the concrete roof of the solar energy applications laboratory at the Kwame Nkrumah University of Science and Technology (KNUST) in Ghana, a hot humid environment, were assessed after 19 years of continuous outdoor exposure. The physical state of the modules was documented using a visual inspection checklist. They were further assessed by current-voltage (I-V) characterization and thermal imaging. The modules were found to be in good physical state, except some bubbles on front side and minor discolouration/corrosion at edge of the cells. Compared with reference values, the performance decline of the modules observed over the exposure period was: nominal power (P_{nom}), 21% to 35%; short circuit current (I_{sc}), 5.8% to 11.7%; open circuit voltage (V_{oc}) 3.6% to 5.6% and 11.9% to 25.7% for fill factor (FF). It is hoped that this study will provide some helpful information to project developers, manufacturers and the research community on the long-term performance of PV modules in Ghana.

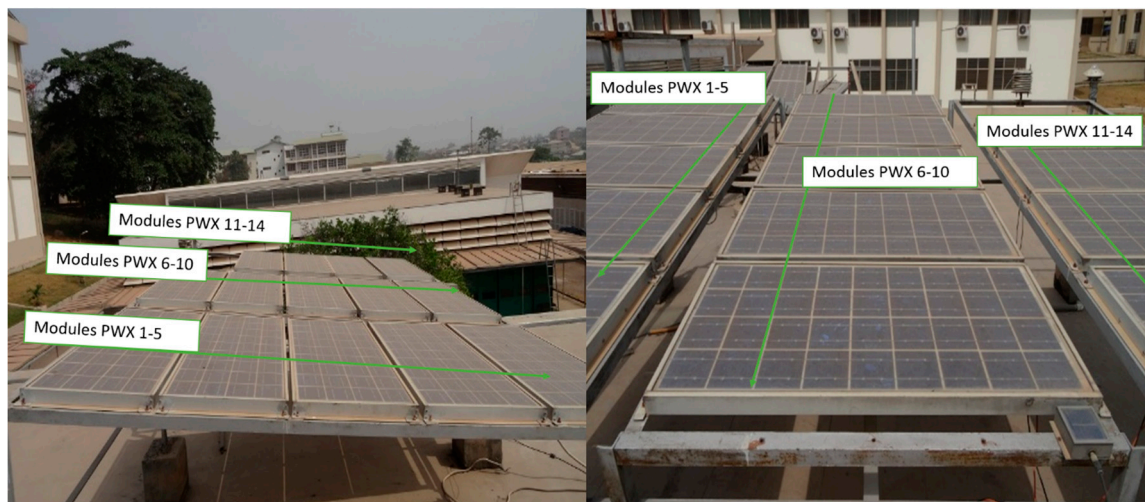
The modules are oriented toward south with a fixed inclination of approximately 15° to the horizontal. For the purpose of the assessment and measurements, the modules were labelled from PWX1 to PWX 14 as shown in Figure 6.

Figure 6. Picture of installation from different views showing modules labelled as PWX 1–14.

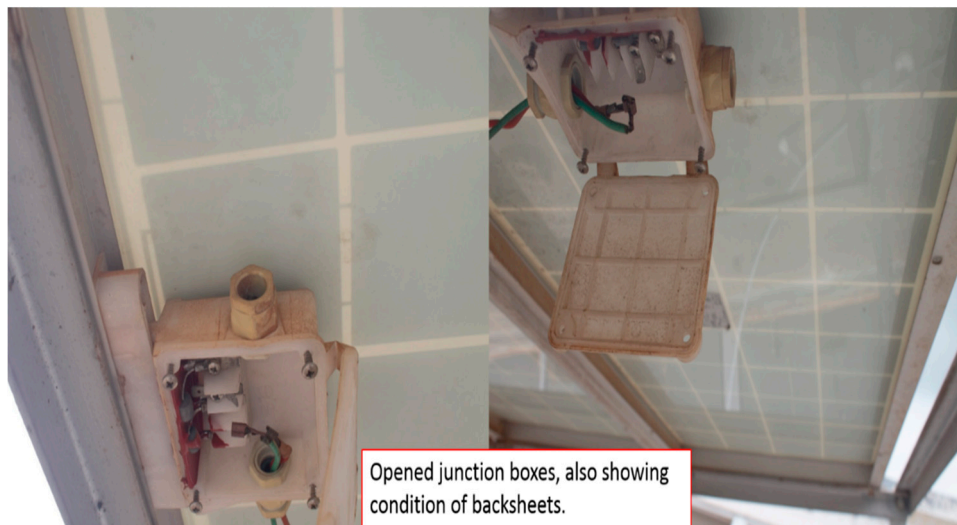
and metallization. Some minor corrosion/discolouration at the edge of some cells was also observed (Figure 9).

Figure 9. Junction box of modules, also showing backsheet.

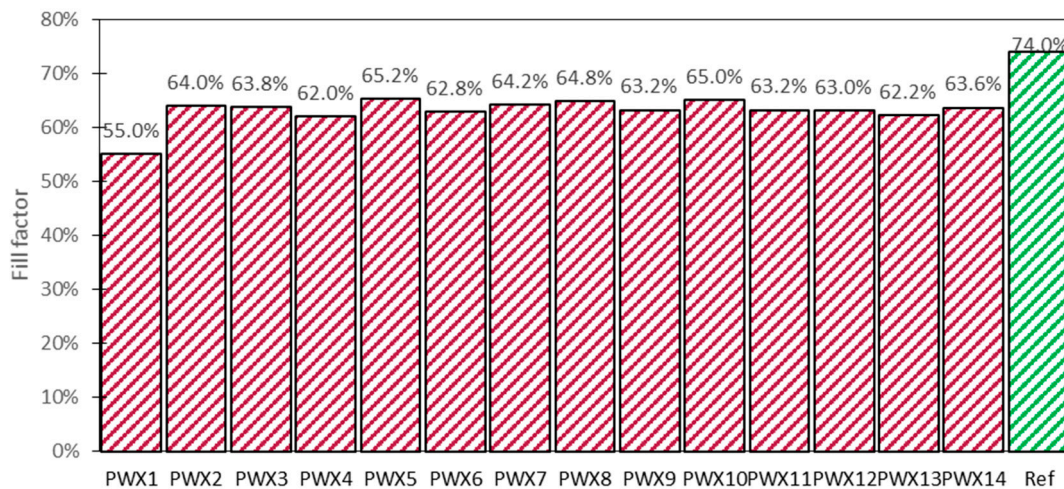
The fill factor of the modules (Figure 14) was in the range of 55% (PWX 1) to 65.2% (PWX 5). This represents a decline of 11.9% to 25.7% with a median of 14.3% over the period of exposure; compared with the original value of 74%. On an annual basis, this translates to 0.6%–1.4% and median of 0.8%. Even though the coefficient of variation of the fill factor of the modules is 4%, module PWX 1, exhibits markedly higher loss of fill factor compared with the rest of the modules. Figure 15, shows the I-V curves of the modules studied. The power loss of module PWX1 (Section 3.2.1), in particular, is traceable to fill factor loss. Loss of fill factor is generally attributed to increase in series resistance of the modules ([38,40]), arising from factors such as corrosion and thermo-mechanical fatigue of the solder bonds and interconnection. Indeed, the shape of the I-V curve arising from fill factor loss, as is the case with module PWX 1 (Figure 15), is reproducible from the 1-diode PV cell model by increasing the series resistance [61].

Figure 14. Fill factor of modules at STC.
