Development of a hydrogeological conceptual model for shallow aquifers in the data scarce Upper Blue Nile Basin

Supplementary material

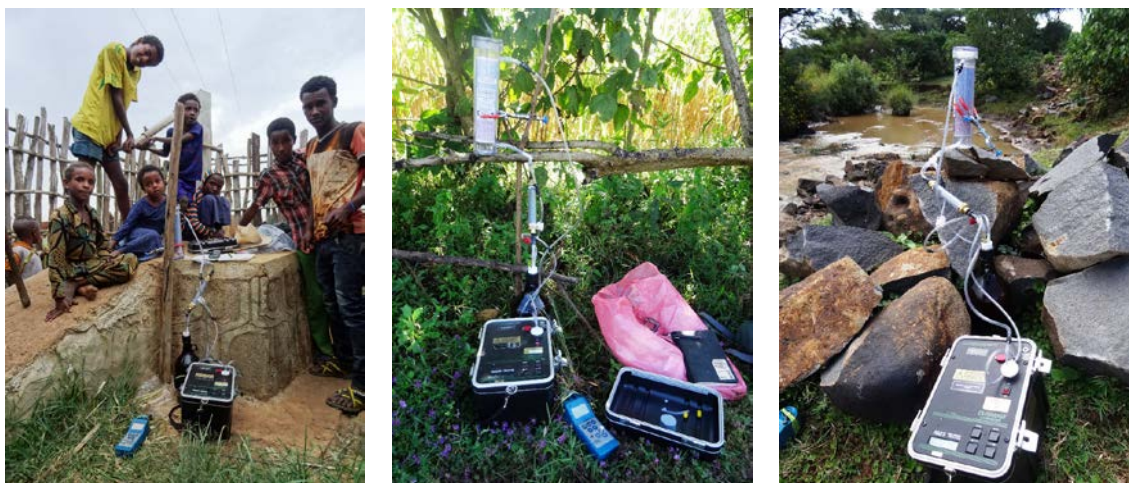
Figure S-1. Photographs showing radon-222 testing. The in-situ EC, pH, and temperature meter is also visible.

A DURRIDGE RAD7 with the “Big Bottle System” was used for in-situ measurement of radon-222 concentration in water. Radon-222 testing was conducted in accordance with the DurrIDGE Company Inc. manuals, comprising:

1. Equipment set up.
2. Purging of the equipment for at least 10 minutes and until a maximum internal relative humidity of 10% was achieved.
3. Careful sampling of water directly into the “big bottle” avoiding turbulent flow and degassing.
4. Running the test for at least 45 minutes with monitoring of radon-222 concentration, internal relative humidity and water temperature.
5. Removal of sample and minimum of 8-minute post-test purge before equipment disassembly.

The initial test was unsuccessful; purging took several hours to reduce the relative humidity to the correct level and following over an hour of testing the radon-222 concentrations were approaching zero. Considering the sample came from one of Dangila town’s deep supply boreholes a concentration of several thousand Bq/m³ would be expected. Later investigation revealed that a one-way valve, in place to prevent water from entering the RAD7 instrument, had been installed the wrong way round. Once the valve had been reinstalled correctly, the equipment operated satisfactorily.

Photographs of equipment set up and testing are shown in Figure S-1.
