A Small Robot to Repair Asphalt Road Potholes

Abstract: As part of the Horizon 2020 InfraROB project aimed at enhancing road safety through innovative robotic solutions, a compact autonomous vehicle has been developed to repair asphalt potholes. Central to this system is a 3D printer capable of extruding a novel cold-asphalt mixture, specifically designed for patching road surfaces. The printer is mounted on a small robot that autonomously navigates to potholes, while the human operator controls the operation from a secure location outside the traffic area. The system's development involved several key steps: designing the repair mixture, constructing the 3D printer for mixture extrusion, implementing a photogrammetric technique to accurately measure pothole geometry for printing, and integrating the extrusion system with the robotic platform. Two preliminary tests were conducted in controlled environments at Sapienza University of Rome to check the reliability of calculation of the amount of material needed to fill in the potholes. Finally, the entire procedure was tested on an Italian motorway, demonstrating the system's functionality without encountering operational issues.

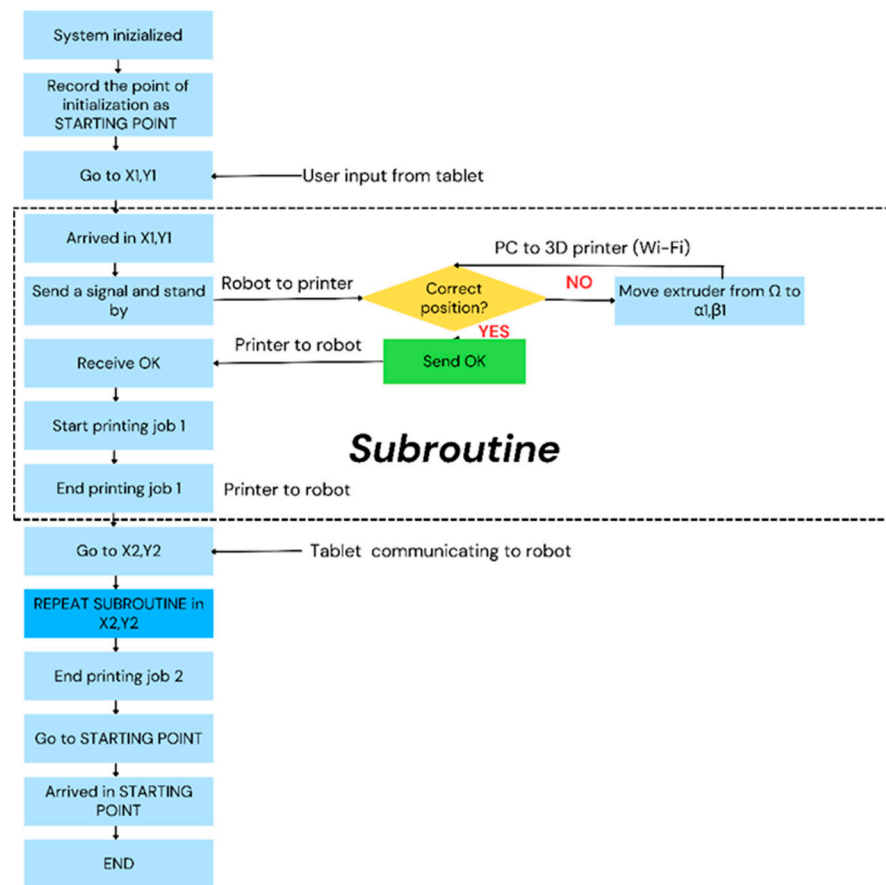
Figure 10. Flowchart of operations of the repair system.

The process involves repairing multiple potholes, each designated sequentially (e.g., HOLE00, HOLE01), with pregenerated G-code files containing the center coordinates of each pothole set to (0,0). The sequence of operations, outlined in the flowchart in Figure 10, begins with the operator manually centering the robot over the designated potholes to record the position coordinates. Once recorded, the robot returns to the starting point, and the autonomous procedure commences. The robot navigates autonomously to the first recorded pothole and sends an “Enter Connection Mode” command to the 3D printer. The printer responds by homing to its end-stops and entering connection mode, displaying ongoing communication with the robot. The robot then issues a “Select Print File” command, prompting the printer to locate and load the corresponding G-code file for

the pothole. The printing process begins with the robot’s “Start Print” command, using previously stored offsets to ensure accurate material placement.

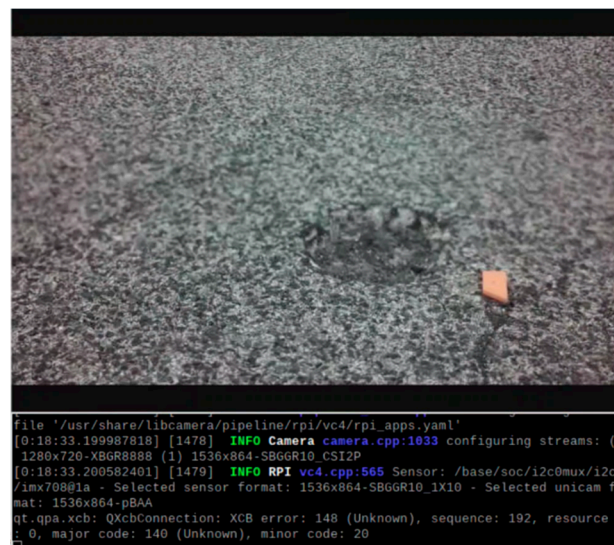
Figure 16. Pothole recording.

The demonstration was conducted in two stages to accommodate the mapping of the potholes’ geometry and volume, followed by the post-processing of the images collected during the mapping phase. The procedure was tested on two potholes, both surveyed and repaired within the same mission. The robot first navigated to the two potholes to record the GPS coordinates of their centers. It then deployed an object of known dimensions (the orange target shown in Figure 16) to serve as a reference for reconstructing the pothole using photogrammetric techniques. Next, the robot was guided back to each pothole to detect their shapes, capturing video recordings along two circular paths of different radii around each pothole. Figure 16 shows an example image of a pothole during the
