# A Small Robot to Repair Asphalt Road Potholes

**Abstract:** As part of the Horizon 2020 InfraROB project aimed at enhancing road safety through innovative robotic solutions, a compact autonomous vehicle has been developed to repair asphalt potholes. Central to this system is a 3D printer capable of extruding a novel cold-asphalt mixture, specifically designed for patching road surfaces. The printer is mounted on a small robot that autonomously navigates to potholes, while the human operator controls the operation from a secure location outside the traffic area. The system's development involved several key steps: designing the repair mixture, constructing the 3D printer for mixture extrusion, implementing a photogrammetric technique to accurately measure pothole geometry for printing, and integrating the extrusion system with the robotic platform. Two preliminary tests were conducted in controlled environments at Sapienza University of Rome to check the reliability of calculation of the amount of material needed to fill in the potholes. Finally, the entire procedure was tested on an Italian motorway, demonstrating the system's functionality without encountering operational issue

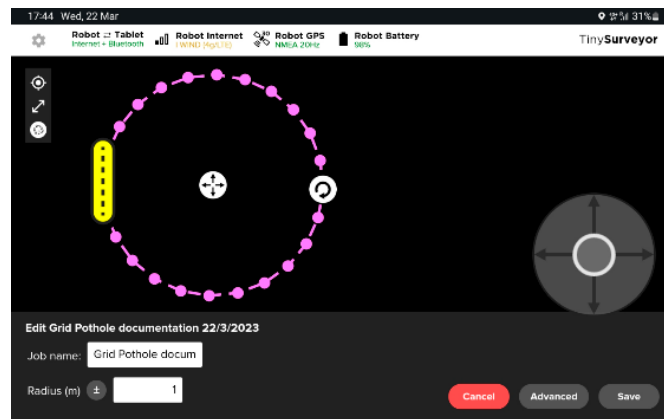
Figure 6. TMR path setting [30].

As shown in Figure 6, the video acquisition process is designed to center the camera’s focus on the pothole, with the robot following circular paths of varying radii (1.0–1.4 m) around the pothole. The robot’s speed during video capture is set to 0.4 m/s.

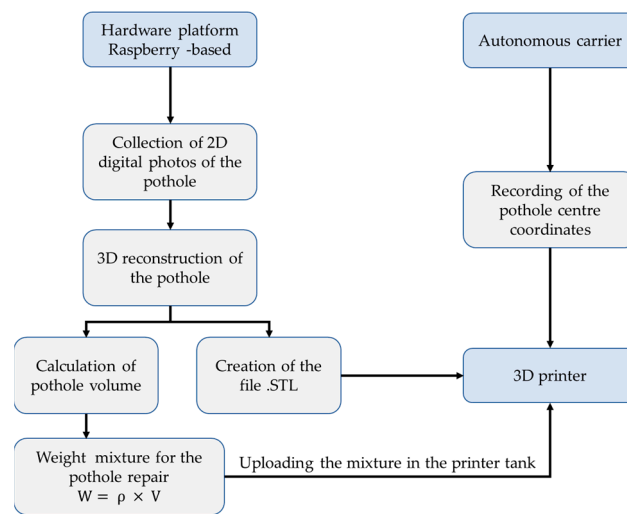
Figure 7. The procedure flowchart.

The camera automatically records a video, from which a series of 2D images is extracted, while the GPS module collects location data. These images are then processed using Bentley ContextCapture software [31], which employs photogrammetry techniques to reconstruct the 3D geometry of the pothole through aero-triangulation. The resulting 3D mesh is exported in STL format, which is compatible with the 3D printer. Additional tools within the software allow for the measurement of the pothole’s area and volume.

Figure 7 summarizes the overall procedure.

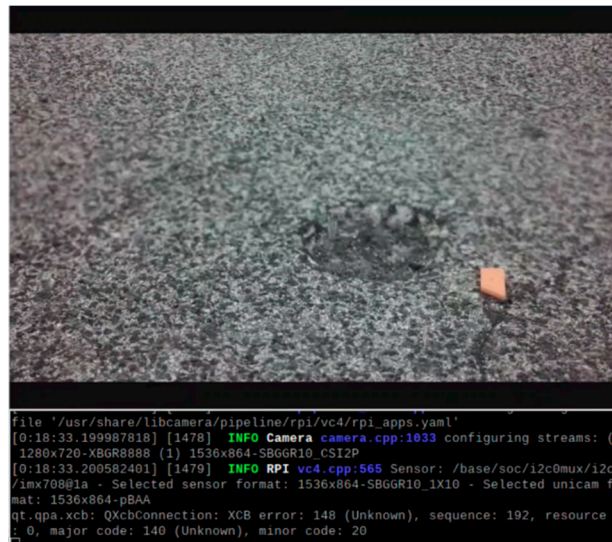
Figure 16. Pothole recording.

The demonstration was conducted in two stages to accommodate the mapping of the potholes’ geometry and volume, followed by the post-processing of the images collected during the mapping phase. The procedure was tested on two potholes, both surveyed and repaired within the same mission. The robot first navigated to the two potholes to record the GPS coordinates of their centers. It then deployed an object of known dimensions (the orange target shown in Figure 16) to serve as a reference for reconstructing the pothole using photogrammetric techniques. Next, the robot was guided back to each pothole to detect their shapes, capturing video recordings along two circular paths of different radii around each pothole. Figure 16 shows an example image of a pothole during the

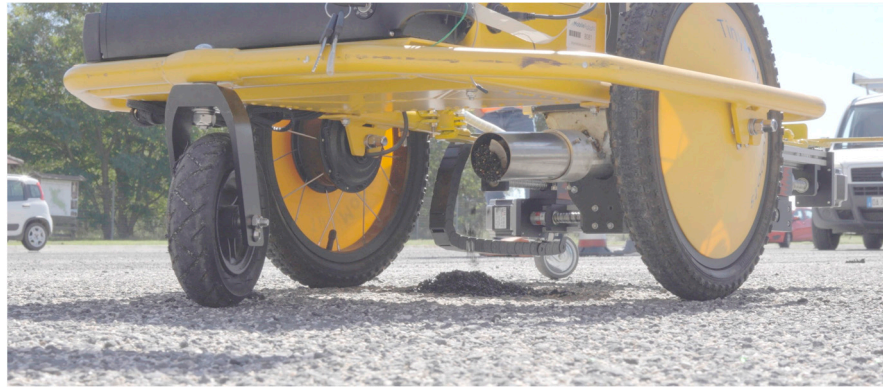
The robot was then brought back to the site, and the autonomous procedure was initiated. Using the GPS coordinates recorded during the initial phase, the robot navigated autonomously to each pothole in sequence, filled them with the repair material (Figure 18), and returned to the escort vehicle.

**Figure 18.** Pothole filling in a pothole.

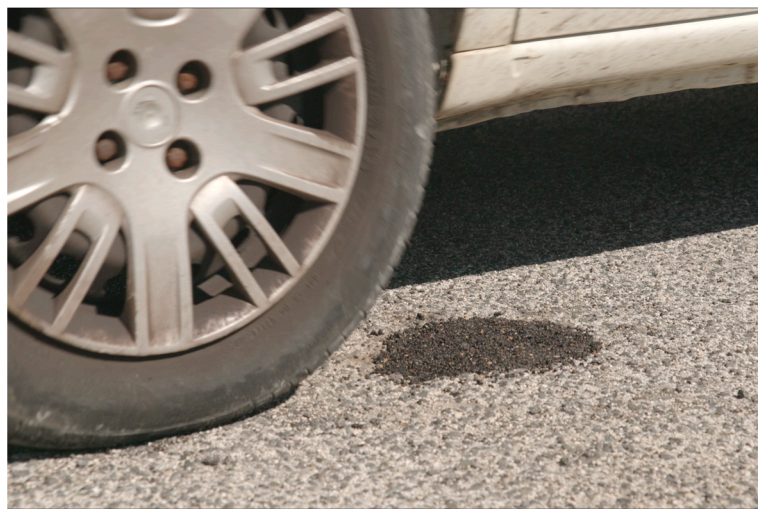
Right after the repairs were completed, the escort van drove over the potholes to smooth out the surface (Figure 19). The mixture did not require mechanical compaction, allowing the road to reopen to traffic without delay, as it did not stick to vehicle wheels. The natural compaction process would be completed by passing traffic over time.

**Figure 19.** Mixture compaction.
