Article

Chemical Durability of Thermal Insulating Materials in Hall-Héroult Electrolysis Cells

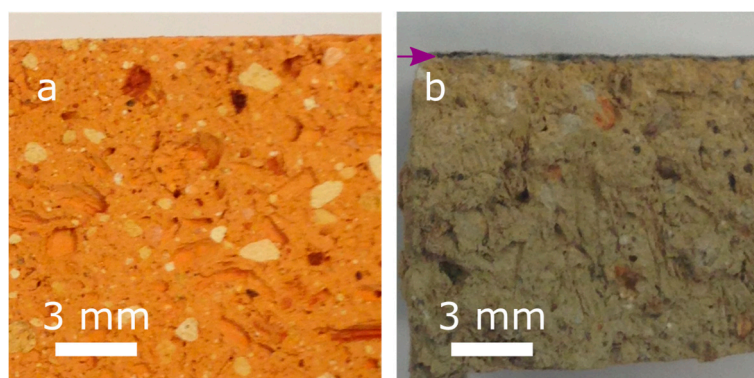
A cross section of the exposed Moler material is shown in Figure 1, next to the pristine material for comparison. A thin, glassy reaction layer (Rx-layer) formed on the surface closest to the carbon crucible. Below this Rx-layer the brick changed color from the pristine state, but no further macroscopic changes were observed.

Figure 1. Optical image of (a) the pristine Moler brick and (b) the Moler brick after Na-exposure with a thin, glassy reaction layer at the top surface (purple arrow).

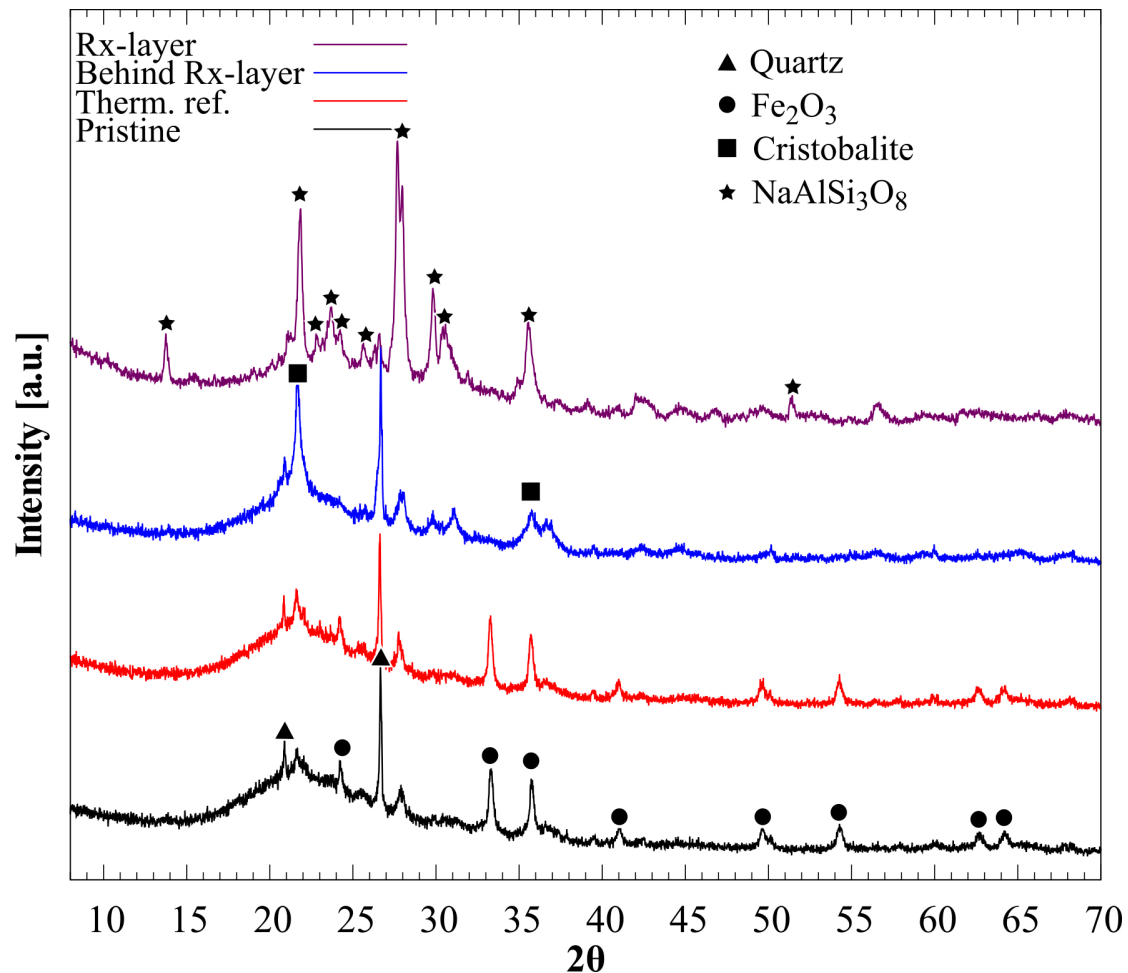
XRD diffractograms of the Moler material are shown in Figure 2. The Moler material has been calcined during manufacturing, and no mineralogical changes were observed between the pristine state and the thermal reference. Quartz (SiO_2) and iron oxide (Fe_2O_3) are the main crystalline phases

in addition to a significant amount of amorphous or nano-crystalline phase evidenced by the broad background in the diffractograms. Albite ($\text{NaAlSi}_3\text{O}_8$) was identified in the Rx-layer, while quartz and cristobalite were found beyond the surface Rx-layer. The iron oxide found in the pristine and thermal reference sample was not observed either in the Rx-layer or beyond.

Figure 2. XRD diffractograms of the Moler material. From top to bottom: Rx-layer, behind Rx-layer, thermal reference sample, and pristine sample. The most important reflections of the crystalline phases are marked.

Beyond the observable Rx-layer of Na-exposed Moler, cristobalite is identified by XRD (Figure 2). The diffraction lines had previously been thought to identify the phase Mg₂Al₄Si₅O₁₈ [15]. The conversion of quartz to cristobalite has been reported at temperatures close to the testing temperature in this work, in the presence of an alkali source such as sodium [23].

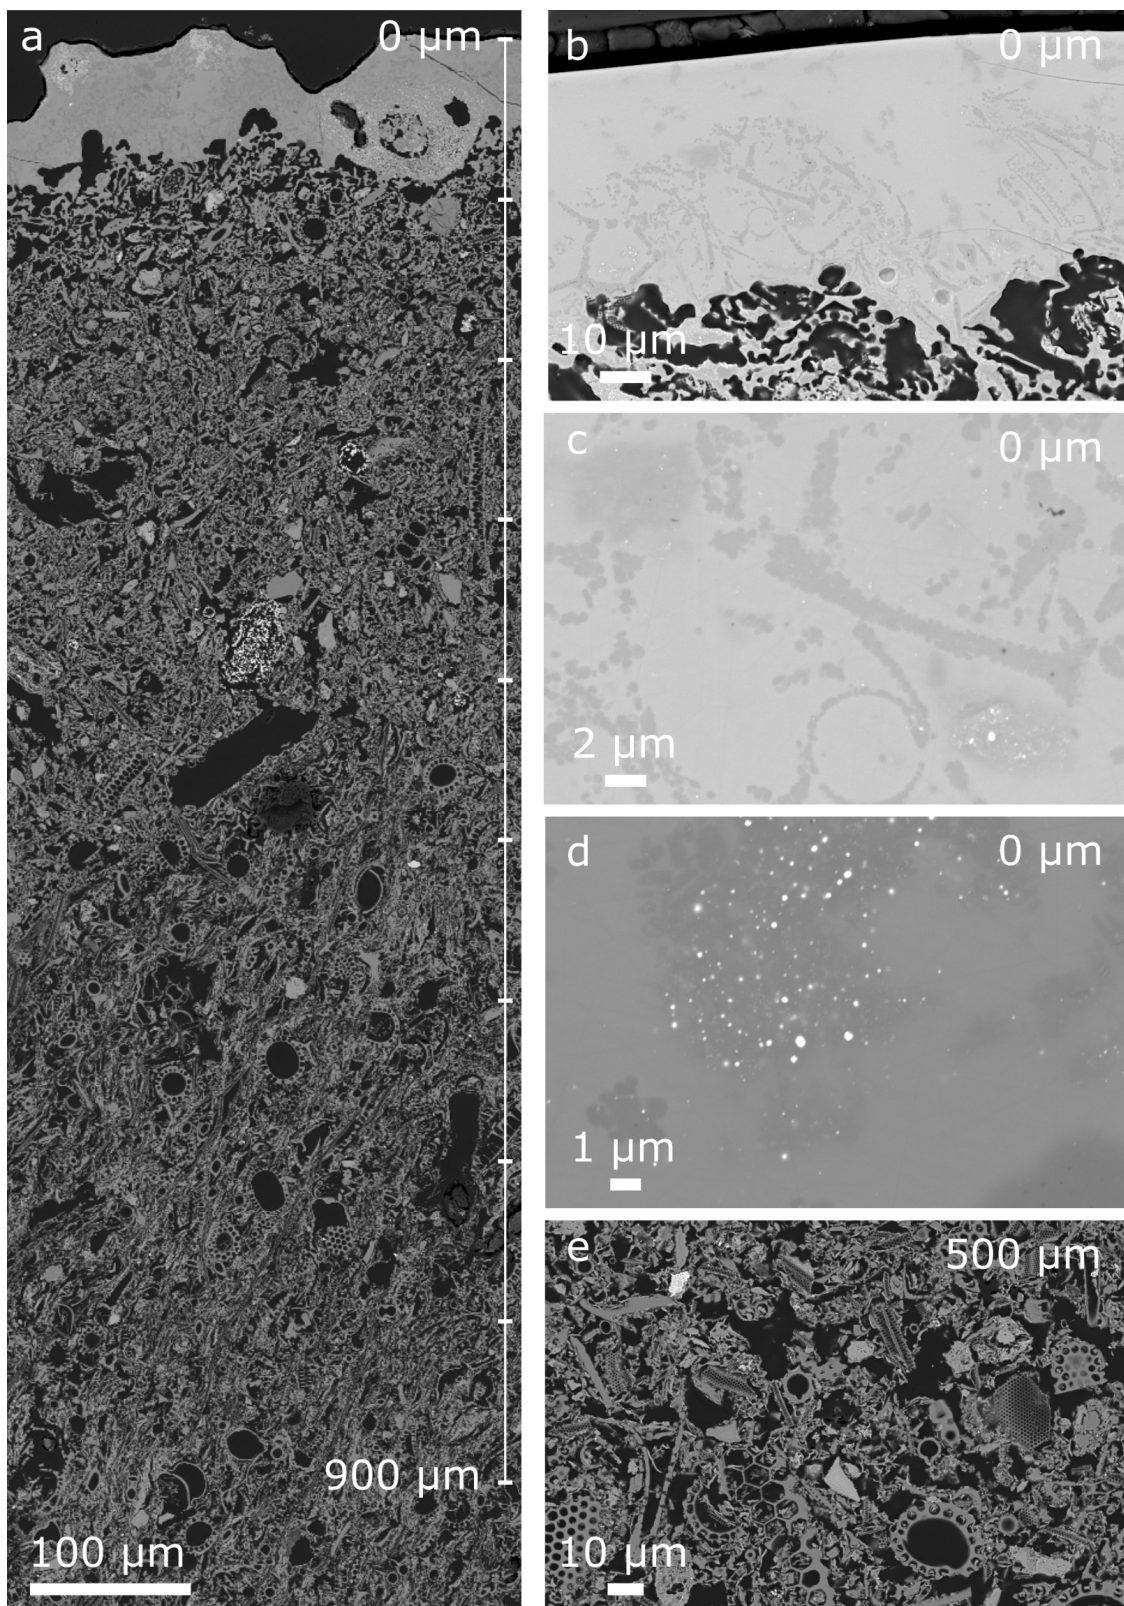
An overview of the microstructure of the sodium exposed Moler material is shown in Figure 3a, while higher resolution images at given depths into the interior of the brick are shown in Figure 3b–e. The backscattering SEM images of the outer reaction layer is heterogeneous corresponding to a glass ceramic with elongated crystals with a needle or plate-like shape. EDS analysis demonstrated that certain areas possess higher Na content than others.

Figure 3. (a) An overview image of Na-exposed Moler brick with the exposed surface at upper part of the image; (b) glassy Rx-layer; (c) high resolution of glassy Rx-layer; (d) metallic Fe in bright spots; (e) typical microstructure of unreacted material.

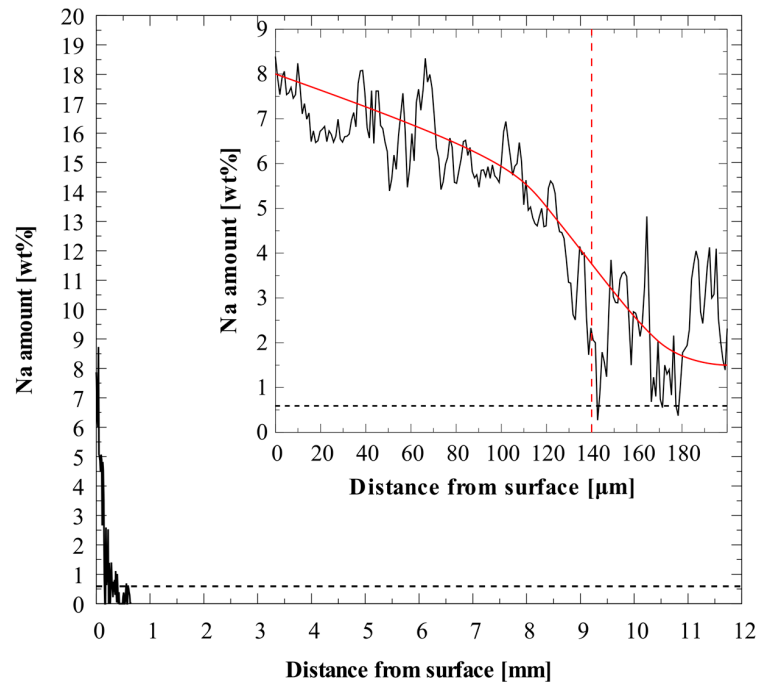
The decreasing Na content from the surface to the interior of the brick is shown in Figure 4, showing a typical EDS linescan across the Rx-layer (insert) with Na content as a function of depth into the brick. The inhomogeneous Na content through the reaction layer due to the complex microstructure is also reflected in Figure 4. The thickness of the Rx-layer varied at different positions in the brick with a maximum thickness of 200 μm . In addition, small bright particles, as seen in Figure 3d, were confirmed by EDS to correspond to precipitated metallic iron in the Rx-layer.

Figure 4. EDS linescan of a polished Moler sample from the exposed surface and 640 μm into the brick. Horizontal black dotted line gives the Na content in the pristine material. Inset: A typical EDS linescan of fracture surface from outer surface towards the interior of the Moler material. Red, vertical dotted line marks end of glassy layer.

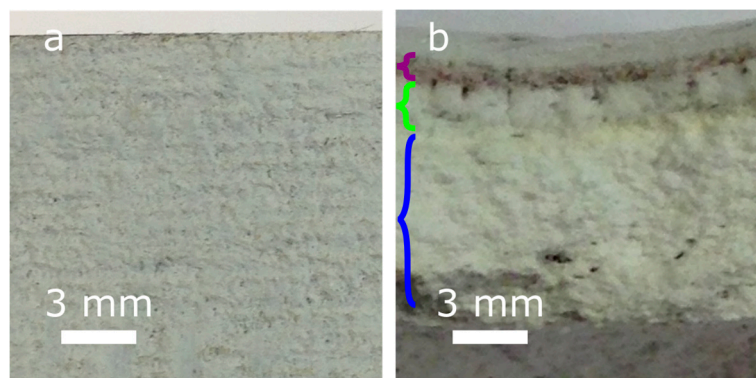
The calcium silicate material was deformed by creep during the Na vapor test, forming a reaction zone of approximately 1 cm. This Rx-zone can be seen divided into an outer, mid, and inner Rx-layer in Figure 5. The pristine material is included in the figure for comparison.

Figure 5. Optical images of (a) pristine calcium silicate brick, and (b) calcium silicate brick after Na-exposure. Upper surface in the image is the exposure surface. The reaction zone is divided into an outer (purple bracket), mid (green bracket), and inner (blue bracket) reaction layer.

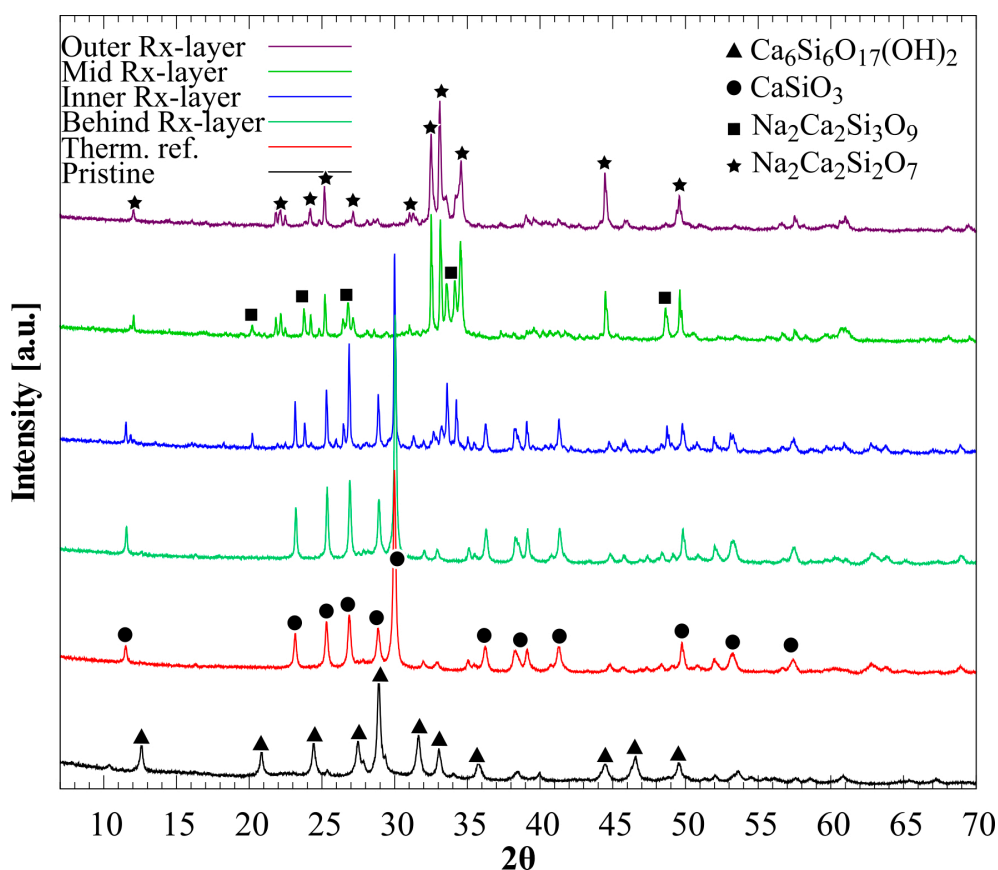
The XRD diffractograms of the calcium silicate material are shown in Figure 6. The pristine material consisted of xonotlite ($\text{Ca}_6\text{Si}_6\text{O}_{17}(\text{OH})_2$), while the thermal reference was converted to wollastonite (CaSiO_3) by thermal treatment. $\text{Na}_2\text{Ca}_2\text{Si}_2\text{O}_7$ was identified in the outer Rx-layer, while $\text{Na}_2\text{Ca}_2\text{Si}_3\text{O}_9$ was found in addition in the middle part of the Rx-layer. Wollastonite and $\text{Na}_2\text{Ca}_2\text{Si}_3\text{O}_9$ were the main crystalline phases in the inner Rx-layer, while only wollastonite was found in the interior of the brick beyond the Rx-layer.

Figure 6. XRD diffractograms of the calcium silicate material. From top to bottom: Outer Rx-layer, mid Rx-layer, inner Rx-layer, behind Rx-layer, thermal reference sample, and pristine sample. The most important reflections due to crystalline phases are marked.

Na₂C_aSi₂O₇ and Na₂C_aSi₃O₉ were the two main Na-containing crystalline phases observed in the Rx-zone of calcium silicate. However, thermodynamic calculations (Figure 14) predict the formation of the two phases Na₄CaSi₃O₉ and Na₂CaSiO₄. The deviation between the experiments and thermodynamics demonstrates that the kinetics of the reaction with Na are also important since the predicted equilibrium phase composition was not observed. Na₂CaSiO₄ has been observed in a different laboratory test at 800 °C, which is lower than the current temperature of the test [18]. SiO₂ and CaO are the two main principle oxides in calcium silicate (Table 1). The isothermal SiO₂-CaO-Na₂O ternary phase diagram at 970 °C is given in Figure 17, showing the initial chemical composition by the red dot. The reaction path with increasing Na content follows the dotted line. The coexisting phases in the marked regions are given in Table 5. In this case, there is no slag formation, and the possible Na-containing phases are Na₄CaSi₃O₉ and Na₂CaSiO₄, as predicted by the equilibrium calculations (Figure 14), but not observed by the current experiment (Figure 6).

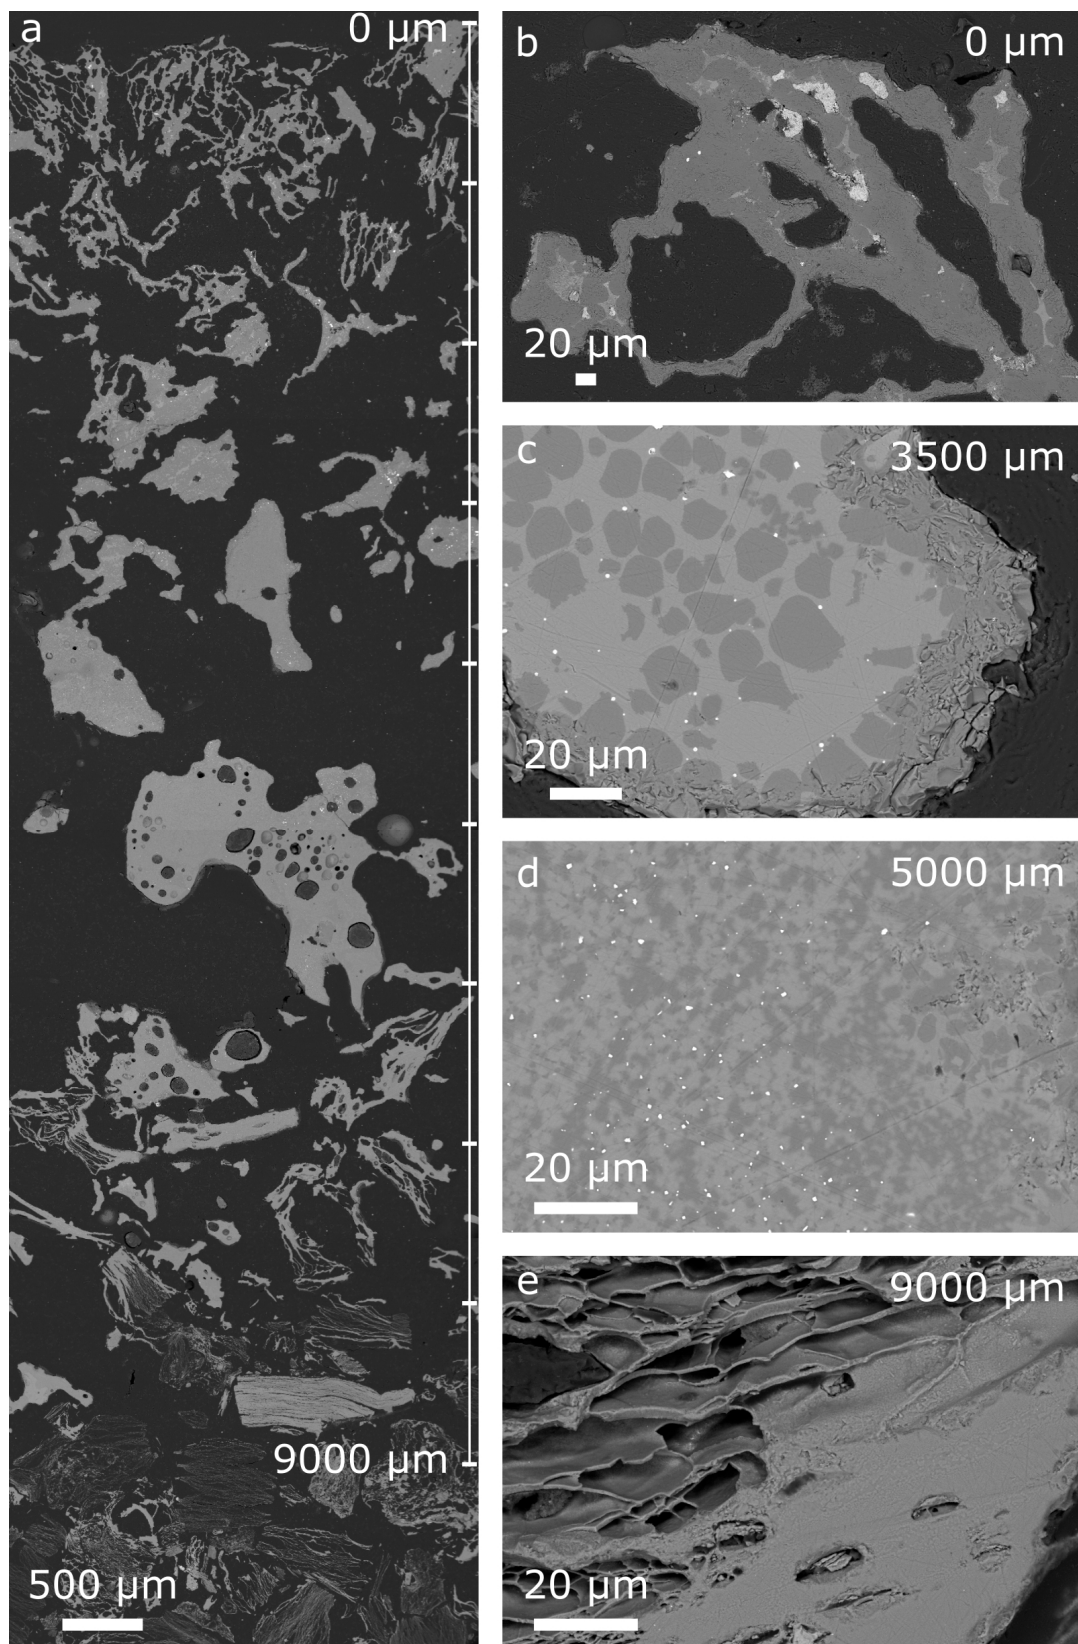
An overview of the microstructure of the sodium exposed calcium silicate material is shown in Figure 7a. High-resolution images of the fracture surface at given depths into the material are shown in Figure 7b–e. The needle-like microstructure characteristic of pristine calcium silicate is observed below the Rx-zone, 1 cm into the brick, see Figure 7e. The needles are only a few hundred nm in diameter. A significant coarsening of the microstructure is observed closer to the outer surface, being closest to the sodium vapor source. The diameter of the needles has increased as much as an order of magnitude from e to c, and at the outer Rx-layer in b the microstructure is much coarser and no longer resembling the needle-like network.

Figure 7. (a) An overview image of a Na-exposed calcium silicate sample with the exposed surface at upper part of the image; (b–d) microstructure of fracture surfaces at increasing depths into the reaction zone. Typical microstructure of unreacted material shown in (e).

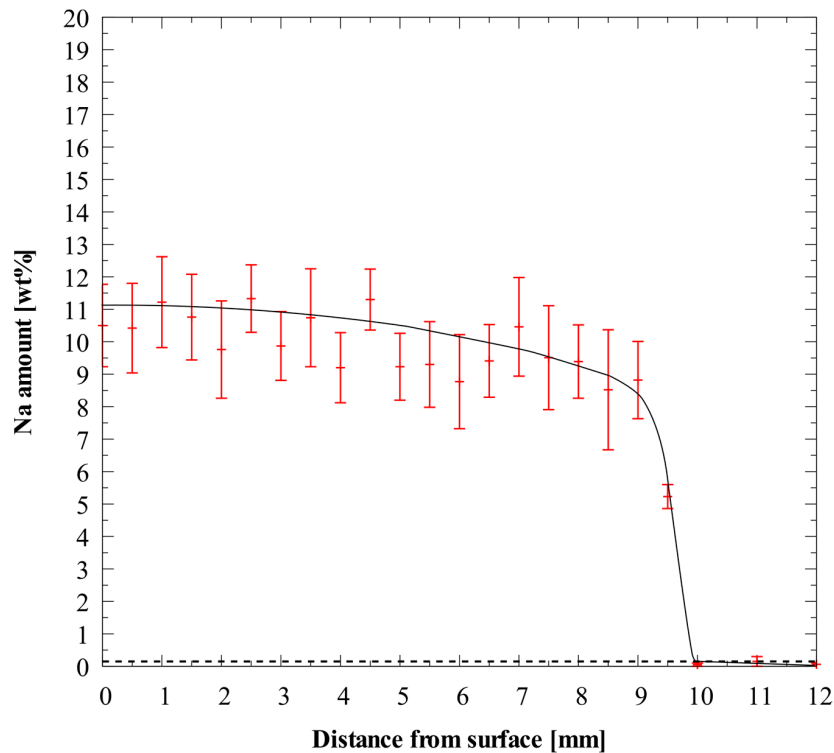
The Na content measured by EDS in the calcium silicate material as a function of the distance from the exposed surface is shown in Figure 8. The Na content is generally high throughout the Rx-zone, and the standard deviations of the measurements are significant due to the complex microstructure and porosity. One centimeter (10,000 μm) into the sample, the Na content drops to levels indistinguishable from the pristine material.

Figure 8. Na content across the reaction zone of the calcium silicate material. Black dotted line gives the Na content in pristine material.

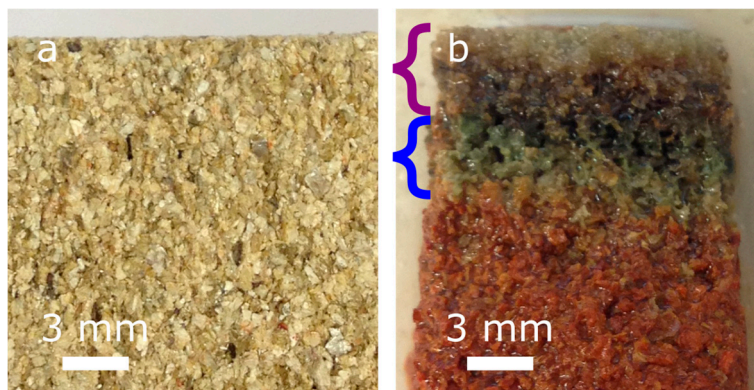
The vermiculite material formed a total reaction zone of an approximate depth of 9 mm, which is divided into an outer and inner Rx-layer, as shown in the optical image in Figure 9. Behind the Rx-zone, the color of the sodium exposed sample changed from the pristine state, but with no further macroscopic changes observed.

Figure 9. Optical images of (a) pristine vermiculite brick and (b) vermiculite brick after Na-exposure, top surface in the image is exposure surface. The reaction zone has been divided into an outer (purple bracket), and inner (blue bracket) reaction layer.

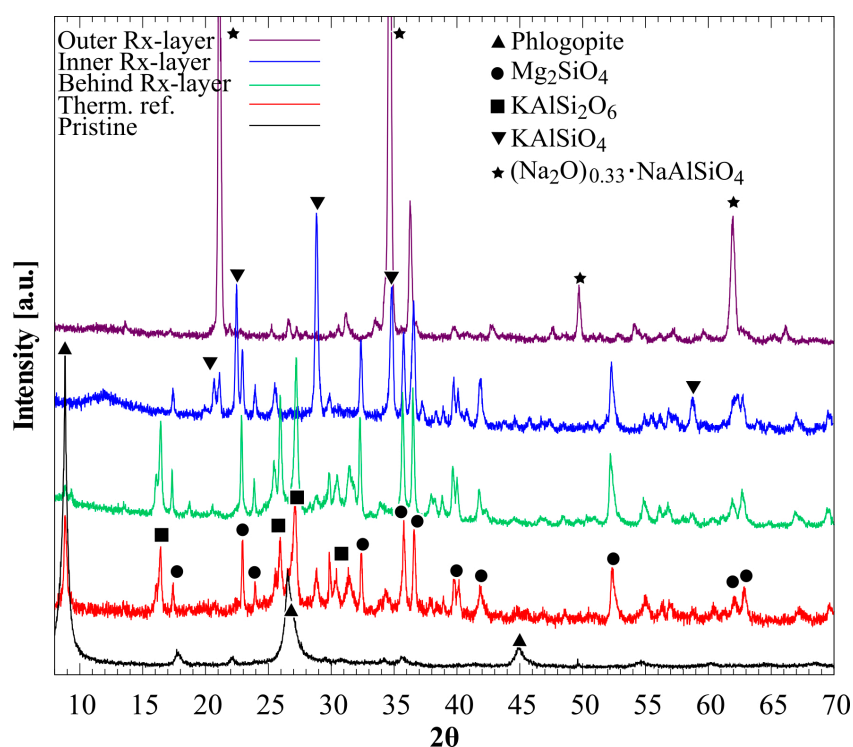
The XRD diffractograms of the vermiculite material are shown in Figure 10. The pristine material consists of the crystalline phase phlogopite, while forsterite (Mg_2SiO_4) and leucite ($KAlSi_2O_6$) are found in addition in the thermal reference. Forsterite and leucite are also the major phases identified behind the Rx-zone in the sodium exposed sample. $(Na_2O)_{0.33} \cdot NaAlSiO_4$ was found in the outer Rx-layer, while forsterite and kaliophilite ($KAlSiO_4$) were identified in the inner Rx-layer.

Figure 10. XRD diffractograms of the vermiculite material. From top to bottom: Outer Rx-layer, inner Rx-layer, behind Rx-layer, thermal reference sample, and pristine sample. The most important reflections are marked.

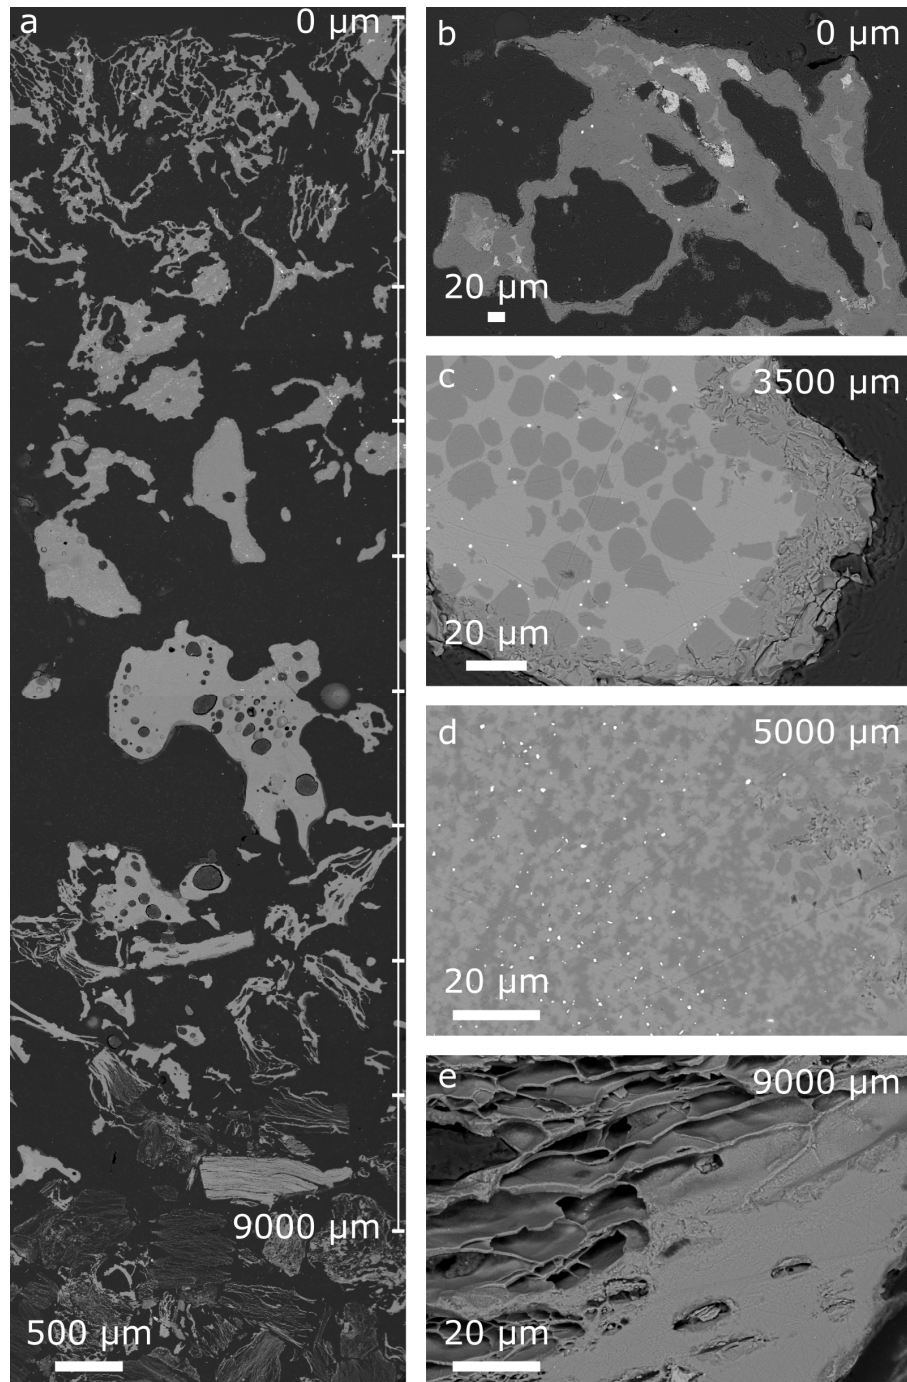
The microstructure of the sodium exposed vermiculite material is shown in Figure 11, with an overview in (a), and higher resolution images at certain depths into the sample in (b–e). The characteristic parallel sheet microstructure of vermiculite grains can be observed in the interior behind the Rx-zone in Figure 11e. This sheet microstructure was no longer present in the Rx-zone. The severe

coarsening of the microstructure in Figure 11a, especially in the area 2–7 mm from the surface, suggests the formation of a liquid phase during the sodium exposure.

Figure 11. (a) An overview SEM image of a Na-exposed vermiculite sample with the exposed surface at upper part of the image. (b–e) higher resolution images showing the microstructure at different depths into the reaction zone.

in calculations not including the FTOrig database [17]. No Na-containing crystalline phase was found in the inner Rx-layer, which indicates that the sodium in this layer must be present in an amorphous phase, supporting the prediction of slag formation. Phlogopite and leucite reacted first with Na before forsterite when the material is exposed to sodium, showing forsterite to be more chemically stable under the current conditions. This is also predicted by the thermodynamic calculations. Similarly to Moler, metallic iron (bright spots in Figure 11d) is found in the Rx-zone of vermiculite as iron oxide is reduced.

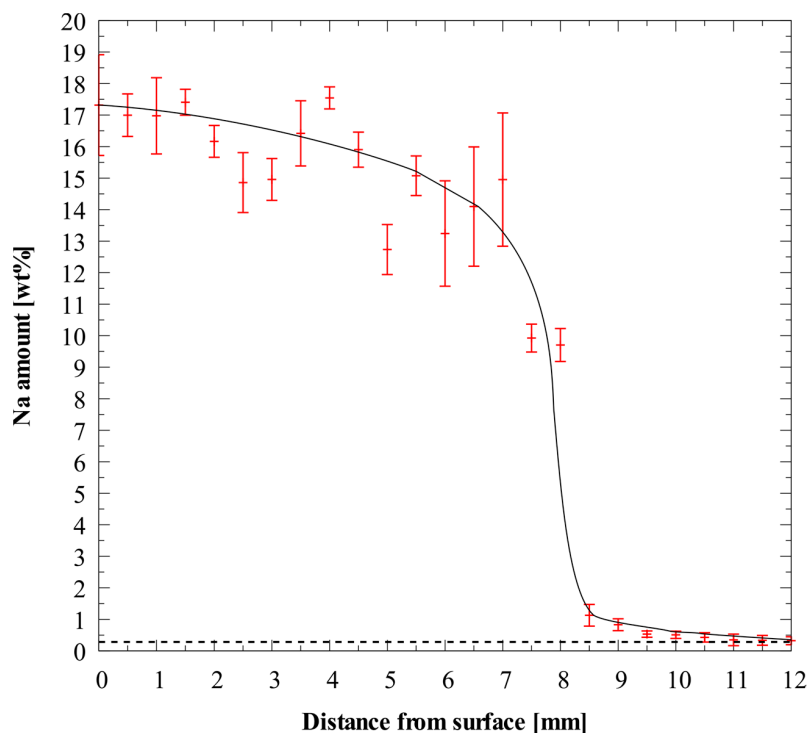
The Na content in the sodium exposed vermiculite material, as measured by EDS, is shown in Figure 12. The Na content is generally high throughout the Rx-zone and drops to levels indistinguishable from the pristine material from 9.5–10 mm inwards. The scatter in the data are large, reflecting the heterogeneous nature of the reaction zone as can be seen in Figure 11c,d.

Figure 12. Na content across the reaction zone of the vermiculite material. Na content in the pristine material given by the horizontal dotted line.

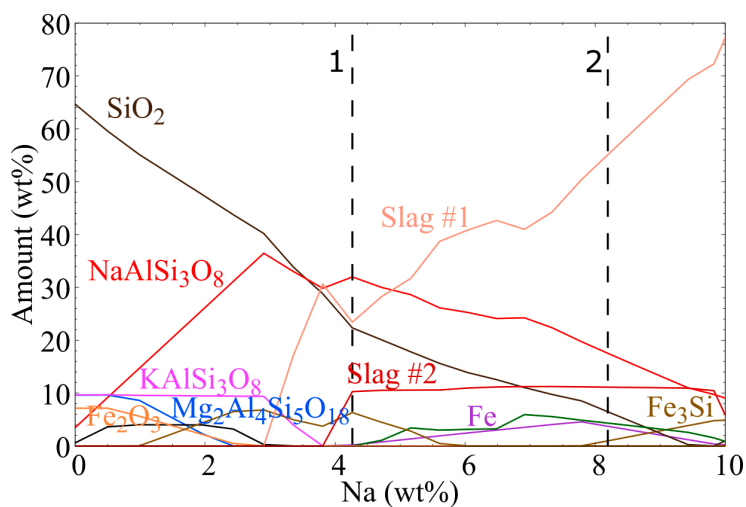
The calculated stable phases present in the case of Moler material with increasing amounts of sodium are shown in Figure 13. The most important stable phases present before Na exposure are SiO_2 , KAlSi_3O_8 , $\text{Mg}_2\text{Al}_4\text{Si}_5\text{O}_{18}$, and Fe_2O_3 . An increasing amount of albite ($\text{NaAlSi}_3\text{O}_8$) is formed up to 3 wt % Na, followed by the formation of two different slag phases. The three most abundant components in the two slag phases are given for Na-content 1 and 2 (Figure 13) in Table 2. The pristine iron oxide in Moler is reduced to metallic iron and further to Fe_3Si with increasing Na content.

Figure 13. Phase composition (excluding minor phases below 4 wt %) of Moler with increasing amounts of Na. Formation of slag #1 at ~3 wt % Na, and slag #2 at ~4 wt % Na.

Slag #1 is a silica-rich slag that has comparable amounts of K and Na at point 1, but with much higher Na content at point 2. Slag #2 is also silica-rich and contains considerable amounts of Na₂O and TiO₂, but changes little in composition from point 1 to point 2.

When exposed to Na vapor, albite was found in the glassy Rx-layer of Moler, which is in agreement with the thermodynamic calculations (Figure 13), which also predicted the formation of albite. At higher concentration of Na, albite is consumed, resulting in the formation of two slag phases. Albite has a strong tendency to form glass and is, therefore, not usually found in its crystalline state [19]. Furthermore, iron oxide is reduced to metallic iron under the reducing conditions of the test, also in good agreement with the thermodynamic calculations. Metallic silicon has been observed to form in the refractory material above the insulation layer both in laboratory testing and samples from spent potlining [5,20,21]. Assuming a simplified chemical composition of the Moler brick, where only SiO_2 and Al_2O_3 are considered, the isothermal ternary phase diagram of $\text{SiO}_2\text{-Al}_2\text{O}_3\text{-Na}_2\text{O}$, shown in Figure 16, can be used to evaluate the reaction path during Na exposure. The initial composition is given by the red dot at 89.5 wt % SiO_2 and 10.5 wt % Al_2O_3 . With an increasing amount of sodium, the composition pathway follows the dotted line. The coexisting phases in the marked regions are given in Table 4. Slag formation is clearly unavoidable at the given conditions and initiates at only a few wt % of Na_2O . Albite is predicted to form at the initial stage, and albite is known to not crystallize easily. Formation of a viscous liquid or slag [22] in Moler exposed to Na is therefore likely even at a low amount of Na.

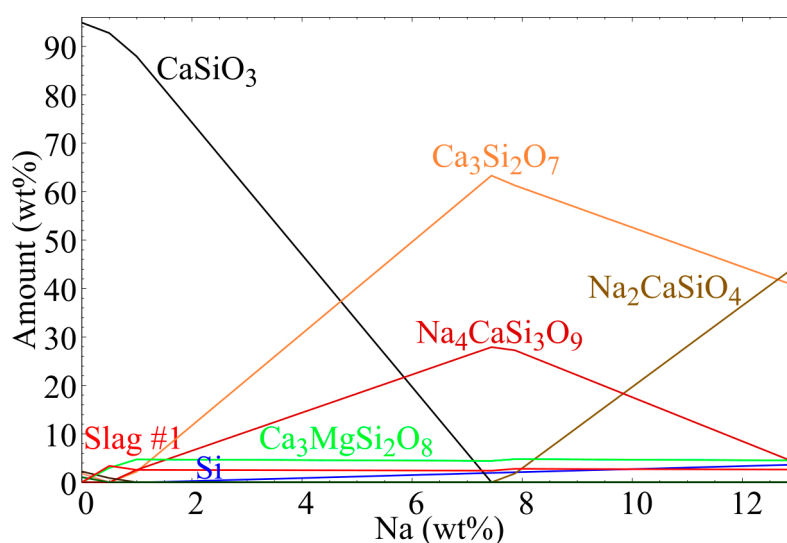
The equilibrium phase content in cases of calcium silicate with increasing amounts of sodium are shown in Figure 14. Wollastonite (CaSiO₃) is the major phase present before Na is introduced. Wollastonite is consumed in the reaction with Na, where Ca₃Si₂O₇ and Na₄CaSi₃O₉ are formed, and lastly, there is the formation of Na₂CaSiO₄. Only minor slag formation is predicted. Metallic silicon is formed by the reducing conditions.

Figure 14. Phase composition of calcium silicate with increasing amounts of Na.

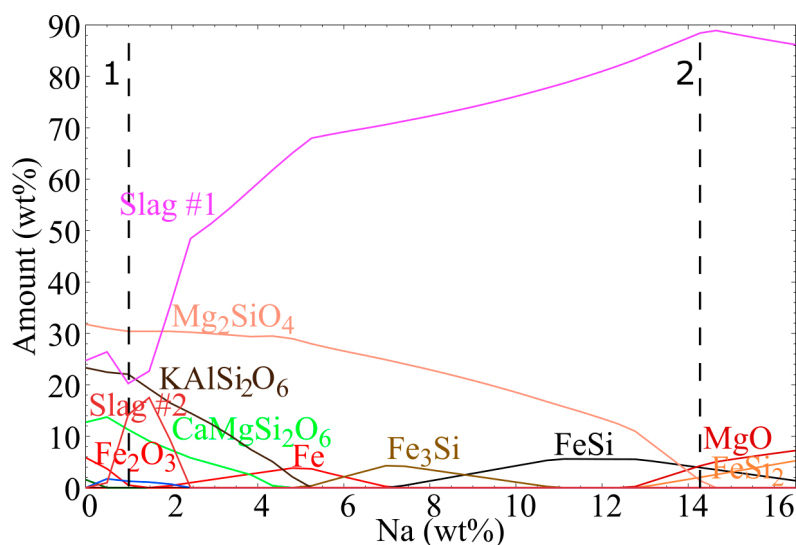
The equilibrium phase composition in vermiculite with increasing amounts of sodium are shown in Figure 15. The major initial phases are predicted to be forsterite (Mg₂SiO₄), leucite (KAlSi₂O₆), CaMgSi₂O₆, Fe₂O₃, and a slag. A second slag is formed with small amounts of Na (<2 wt %), but with increasing amounts of Na, the formation of slag #1 is dominant at the expense of the initial phases. The abundance of the three most important species in the slag phases are given for point 1 and 2 in Table 3. The initial iron oxide is reduced to metallic iron and other iron-containing phases due to the reducing conditions with increasing Na content.

Figure 15. Phase composition of vermiculite with increasing amounts of Na. Major slag formation at low Na content. Reduction of iron oxide to other iron species.

Slag #1 is silica-rich, with predominantly potassium at point 1, while sodium and magnesium are more present at point 2. Slag #2 is also silica-rich, but with significant amounts of iron and some sodium.

Phlogopite, forsterite, and leucite are present in the thermal reference sample of vermiculite, in fair agreement with the thermodynamic equilibrium calculations (Figure 15). However, the calculations predict significant slag formation with increasing Na content, even before exposure to Na. The severe coarsening of the microstructure (Figure 11) does indicate the presence of a viscous phase during the test as this change in microstructure is unlikely to occur by solid state diffusion alone. Nepheline ((Na₂O)_{0.33} · NaAlSiO₄) and kaliophilite (KAlSiO₄) are identified in the outer and inner Rx-layers, respectively. These phases are not predicted by the present calculations, however, they were predicted

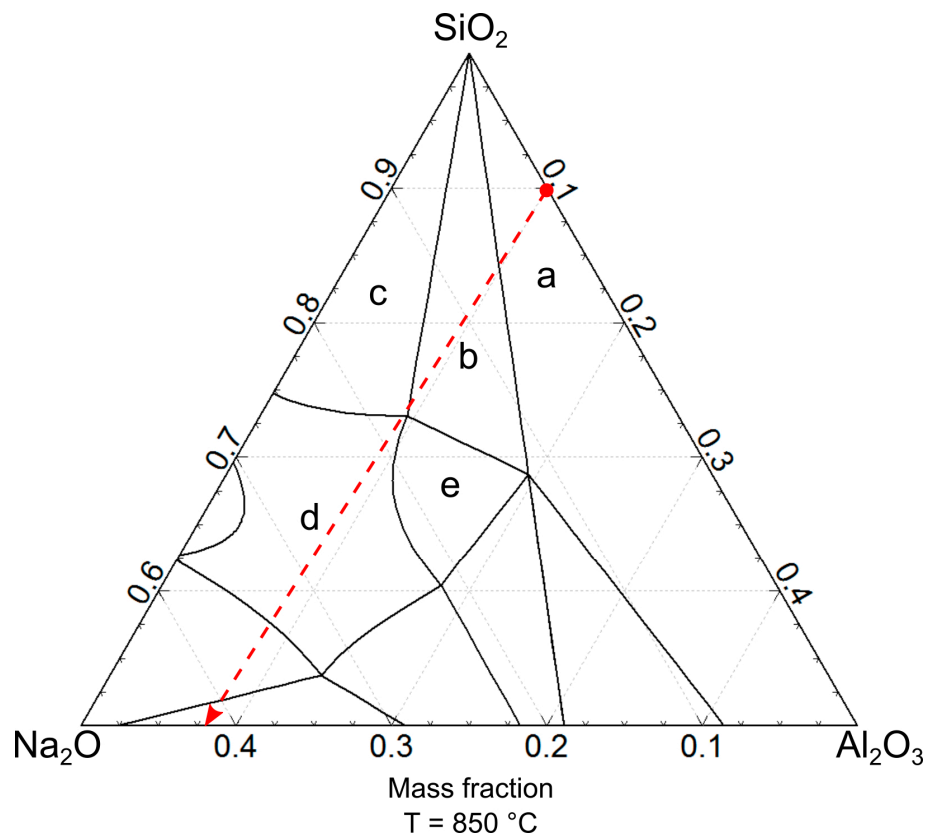
Figure 16. 850 °C isotherm in the SiO₂-Al₂O₃-Na₂O system. The red dot marks the initial, simplified starting point of the Moler material, while the dotted line projects increasing amounts of sodium. The coexisting phases for each marked region are given in Table 4.

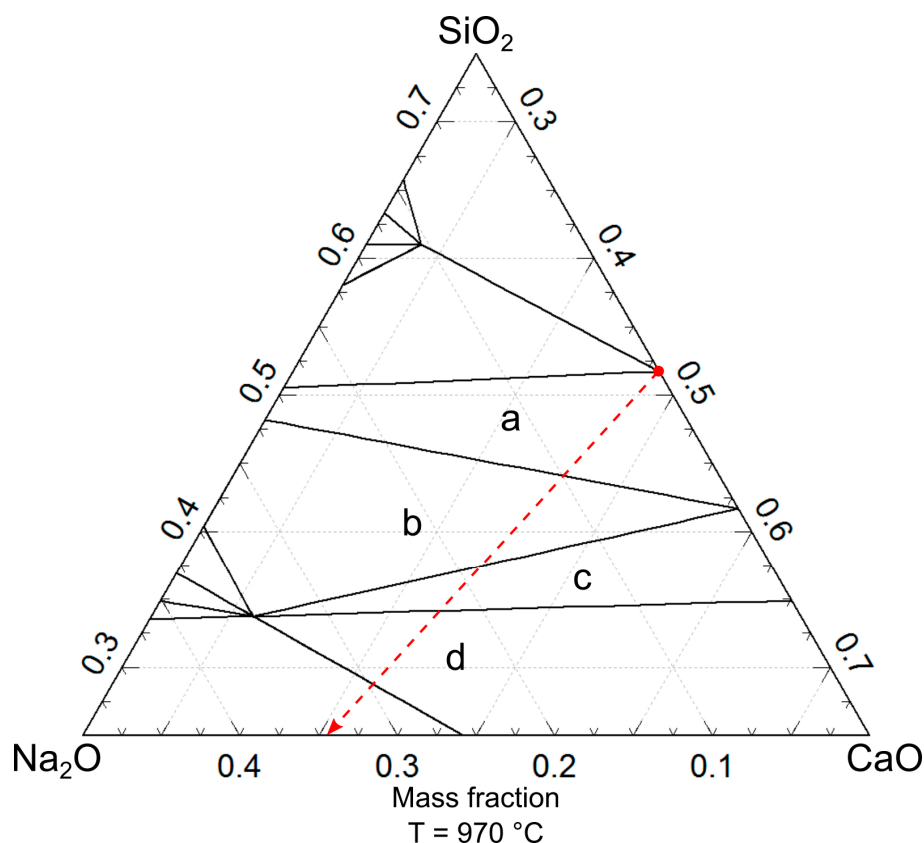
Figure 17. 970 °C isotherm in the SiO₂-CaO-Na₂O system. The red dot marks the initial, simplified starting point of the calcium silicate material, while the dotted line projects increasing amounts of sodium. The coexisting phases for each marked region are given in Table 5.
