Adaptive Reuse of Religious and Sacred Heritage: Preserving Material Traces and Spirit of Place

Giovanna Franco

Abstract: The theme of adaptive reuse, of great topicality for those who deal with built heritage, has its roots in the recent past, dating back to the end of the last century, when the problem of reuse proved to be competitive, for economic and cultural reasons, with respect to total demolition and reconstruction. Since then, various disciplinary and methodological approaches have been confronted with theories and methods of intervention, on an ever-expanding cultural heritage. This article offers a research perspective, with application of a case study of particular relevance to the city of Genoa, Italy. Adaptive reuse, in the text, is specifically dedicated to religious and sacred heritage that has lost its original function but has retained material traces and intangible values. The methodological approach, shared by several European architectural schools, is multi-disciplinary in nature and stems from the need to preserve material traces but, at the same time, preserve the spirit of the place, according to what is defined by the international community. The methodo

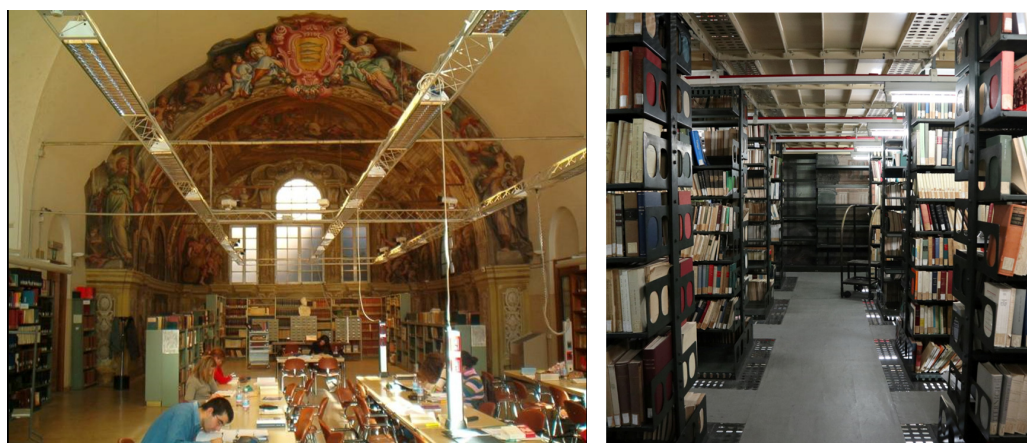
The project for the new headquarters of the University Library was drawn up by the engineer Carlo Fuselli (Chief Engineer of the University Technical Department until 1931, the year of his death) in two stages: a first version in 1926 and a second, completed, in 1928 [47]. The solution adopted, to contain the important book depository and the reading room, was to divide the large hall and the abyssal choir into two spaces, building a large reinforced concrete slab (with Hennebique patent, built by the company G.A. Porcheddu of Turin). The depository space, from ground level to the reinforced concrete floor, was further divided into five floors consisting of a self-supporting shelving system and steel walking surfaces (Lips-Vago patent), while the upper space was completely unusual because above the level of the first frame of the church it was used as a reading and consultation room (Figure 6). An important intervention was also that of the replacement—with relative change of height—of the roofing structure, previously wooden, with reinforced concrete beams and trusses and the insertion of two reinforced concrete skylights and glass roofing, creating two circular cuts in the wall vault of the nave, to ensure greater natural lighting.

Figure 6. The transformation of into University Library (1937). At the left side, the reading room, at the same level of the baroque frescoes of the apse; at the right side, the metal shelves of the book repository, below the reading room.

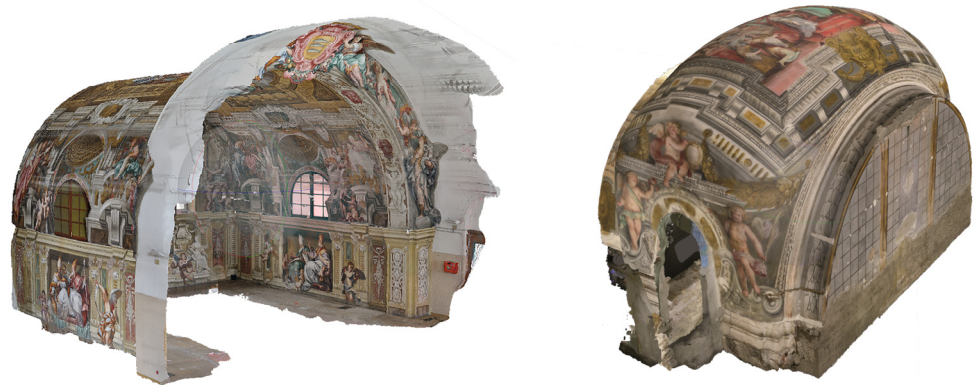
The survey in digital photogrammetry with photoscan (performed thanks to the collaboration and assistance of the MARSC Laboratory, in particular of architect Gabriella Garello) and was limited to the frescoed apse of the reading room and the frescoed chapel on the third floor of the side rooms, thereby obtaining—using dedicated software—the three-dimensional model of the two most valuable environments (Figure 8). The georeferencing phase of the model was performed by inserting support points determined through the previous topographic survey. The abundance of points detected ensured a good distribution and an excellent result from the point of view of evaluating residual errors.

Figure 8. The survey in digital photogrammetry of the apse and a side chapel, still decorated (Gabriella Garello and students of the post-graduate programme, School of Specialisation in Architectural Heritage and Landscape).

The generation of the model and the production of orthophotos required careful masking of the images to exclude irrelevant parts. Particularly relevant was the use of the photogrammetric 3D model to extract orthophotos and photoplans, useful as a basis for the subsequent mapping of the frescoed walls.

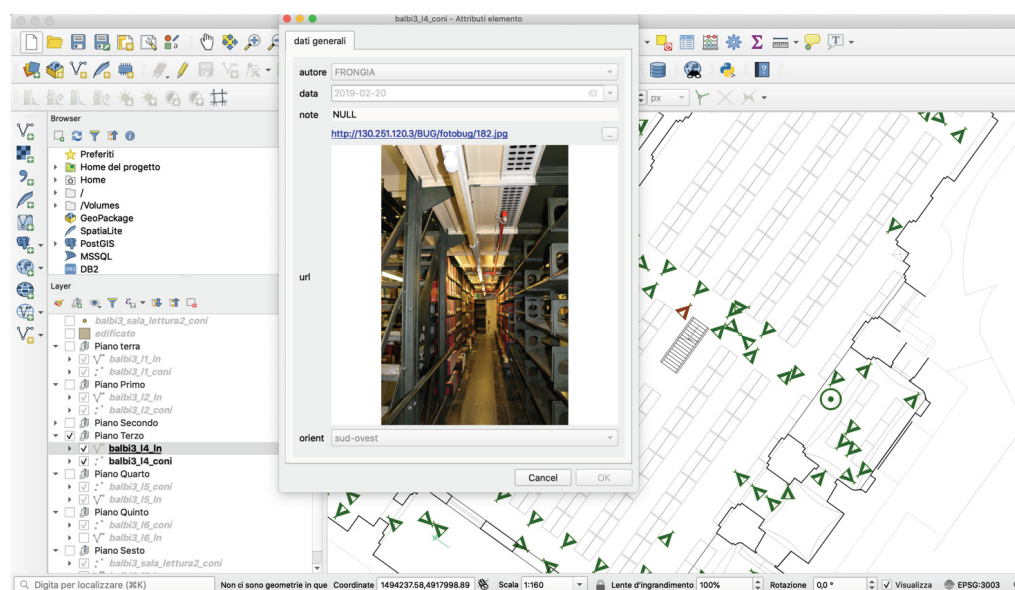
The specific information relating to individual environments can therefore be consulted through a searchable and interconnected floor plan, where each user can also implement and update the information already present. The survey plans and all the photographic documentation acquired were imported into the QGIS environment so that, in each environment, it is possible to query the optical cones present and view the related shot. Each optical cone is connected to a series of attributes that contain various types of information, including author, capture date, orientation and any additional notes. Furthermore, with a similar procedure, it was also possible to insert historical information, archive documents, iconographic sources and historical photos referring to a specific environment. Another point in favour of the use of the GIS tool is the possibility of accessing and modifying the information contained in the project and of having updated information that can be shared with the working group at any time (Figure 11).

Figure 11. Image of the GIS interface showing the photographic documentation (elaboration of the students of the post-graduate programme, School of Specialisation in Architectural Heritage and Landscape).

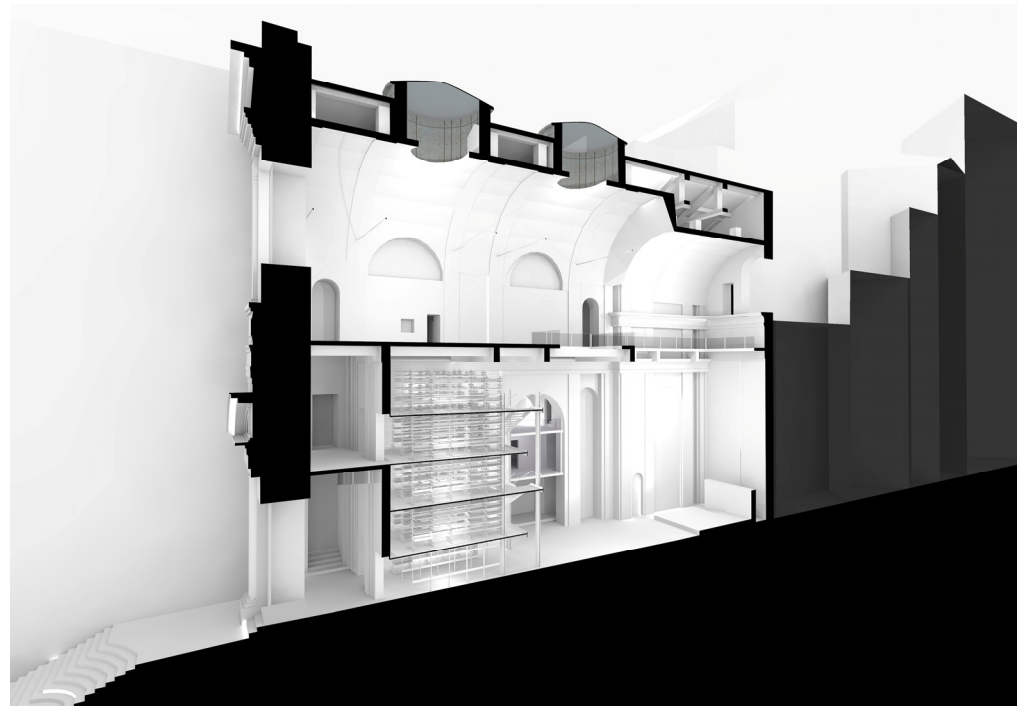
The new use therefore requires important modification interventions, following a path and a process hopefully shared with the protection bodies which, before the in-depth study on the artefact, implicitly attributed a historical-artistic value also to the metal shelving of the book depository beneath the reading room, erroneously considered by the literature to be the work of the most significant witnesses of Genoese architecture of the period. Both the shelving and the reinforced concrete floor are in fact historical evidence of interest, an important example of engineering and architecture from the 1930s and episodes of the diachronic processes that accompany the life of every architectural work. A fundamental part of the design process was to understand to what extent these twentieth-century structures should be preserved and to what extent—and how—they could be modified both to reconfigure, even if partially, a lost unity, and to allow a new perception of it (Figure 12).

Figure 12. 3D model of the proposal for an adaptive reuse of the former Library and former church as the new library for the Genoa Superintendence of the Ministry of Culture (elaboration of the students of the post-graduate programme, School of Specialisation in Architectural Heritage and Landscape).

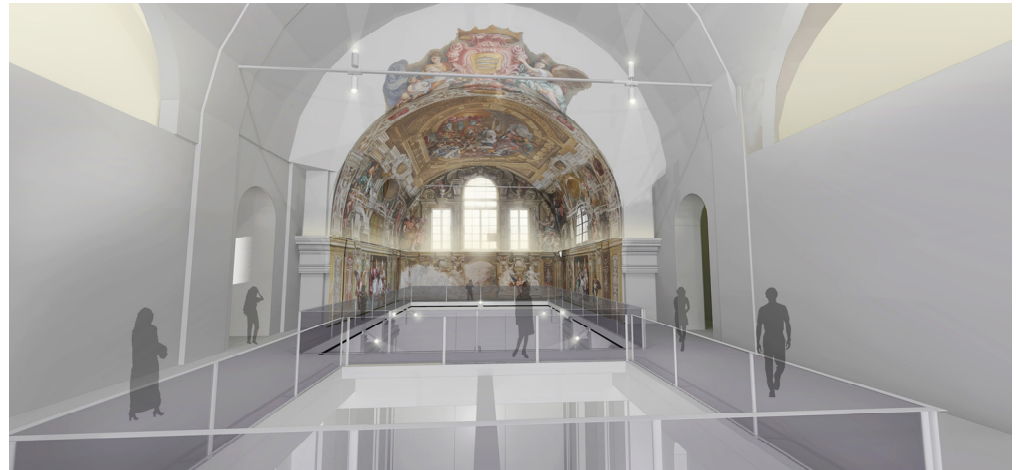
In order to obtain greater spatial permeability between the large volumes of the building, ideally reaching a new formal unity, and to allow greater natural lighting at the lower levels of the “metal machine”, it was initially considered to demolish the “large slab” both in the apse area, and above the shelving at the skylights also using walkable glass surfaces. However, removing part of the slab, keeping the shelving at the levels below, would be too complex and expensive. It was decided to make holes inside the reinforced concrete slab of the former reading room at areas free from shelving on the levels below, following structural consolidation work on the beams affected by partial cutting. Holes were thus made in the slab of the fifth floor which allowed, on the one hand, re-proposal of the original points of view of the frescoes from the ground floor and, on the other, guaranteeing better natural lighting towards the lower rooms. The various intervention hypotheses have always taken into account the maintaining of a small portion of the slab in order to be able to cover the area of the apse and to preserve the existing masonry. This would allow both observing of the frescoes from a privileged position, also from an educational point of view, and being able to monitor and restore the pictorial decorations, thereby avoiding the onerous use of scaffolding (Figure 13).

Figure 13. View of the new public space at the level of the former reading room and of the big “holes” in the reinforced concrete foal that allow to perceive, from the ground floor, the original holy space (elaboration of the students of the post-graduate programme, School of Specialisation in Architectural Heritage and Landscape).

The planned cuts on the large reinforced concrete slab are intended to promote the perception of what must have once been the spatiality of the church and allow light to spread to the space located at the lower elevations.

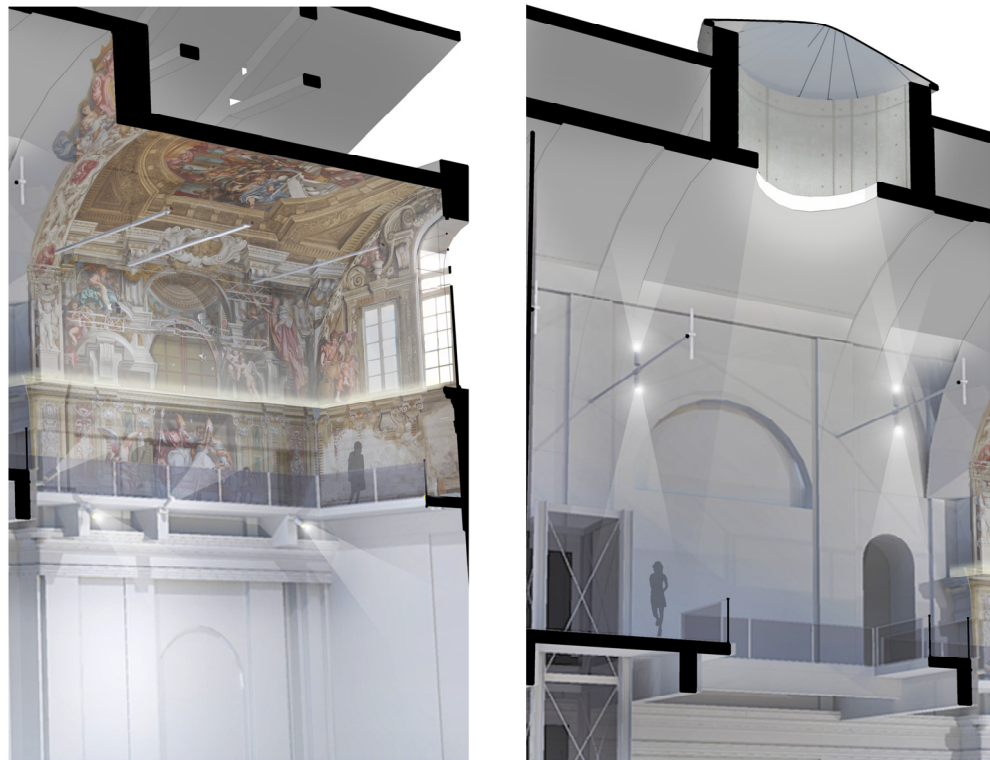
As a result, the project provides, on the one hand, for the preservation of a historical phase of a certain importance, without necessarily removing it entirely, opting for a “selective” demolition with techniques that do not destroy the pre-existence and, on the other hand, introduces a new value, in the possibility, for the public, to walk along the new walkway thus created and admire the frescoes from a close position. A lighting system specifically designed for the space below the new walkway and above, with spotlights, emphasizes the decorative and architectural value, revealing a space that is no longer perceptible (Figure 16).

Figure 16. Detailed views of the walkway and lighting solutions for the sacred space of the church to be enhanced and returned to public use (elaboration of the students of the post-graduate programme, School of Specialisation in Architectural Heritage and Landscape).

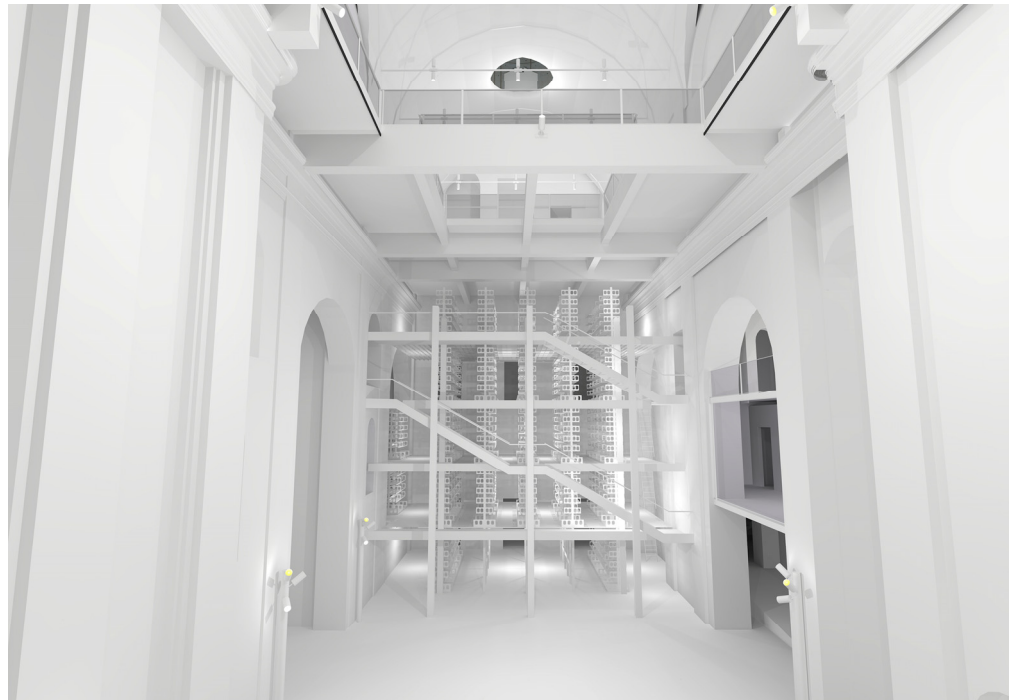
In fact, the metal structure of the shelving consists of five superimposed self-supporting levels organised on five parallel rows which extend longitudinally and occupy the entire volume of the hall, between the walking level and the reinforced concrete cement floor of the reading room, also occupying, on the right side, the space of the side chapels. In fact, in subsequent times, shelves and filing cabinets were added to the original system simply placed against the perimeter walls and located at all levels. The connections of the various levels of the “machine” are guaranteed by a metal ladder with a ramp in a central position and by a small ladder positioned on the left side of the storage area. The metal structure of the book storage area is self-supporting and the entire load is supported by flat uprights which, when coupled, constitute the pillars of the space frame (Figure 17).

Figure 17. View of the conserved and restored shelves from the ground floor (facing main entrance and street), of the new staircase and of the upper space (elaboration of the students of the post-graduate programme, School of Specialisation in Architectural Heritage and Landscape).

The coupled behaviour is guaranteed by the connection of the flat uprights of two consecutive modules, achieved using clamps. The combination of these twinned elements constitutes the pillars that punctuate the shelving modules longitudinally and the storage corridors transversely. The connections of the elements mainly consist of nails and bolts. The pillars are also connected to each other through stiffening elements. The walkways on each level are made of solid and perforated sheets, fixed on L-section crosspieces. They transfer the load to the pillars through perforated and nailed rectangular plates on the internal surfaces of the twin elements of the pillars. On each of the two uprights, which constitute the composite pillars, a notched profile is nailed externally which constitutes the shelves anchoring guide.
