A Review of Plastic Contamination Challenges and Mitigation Efforts in Cotton and Textile Milling Industries

Adeyemi Adegoke Adeleke

AgriEngineering **2023**, *5*, 193–217.
<https://doi.org/10.3390/agriengineering5010014>

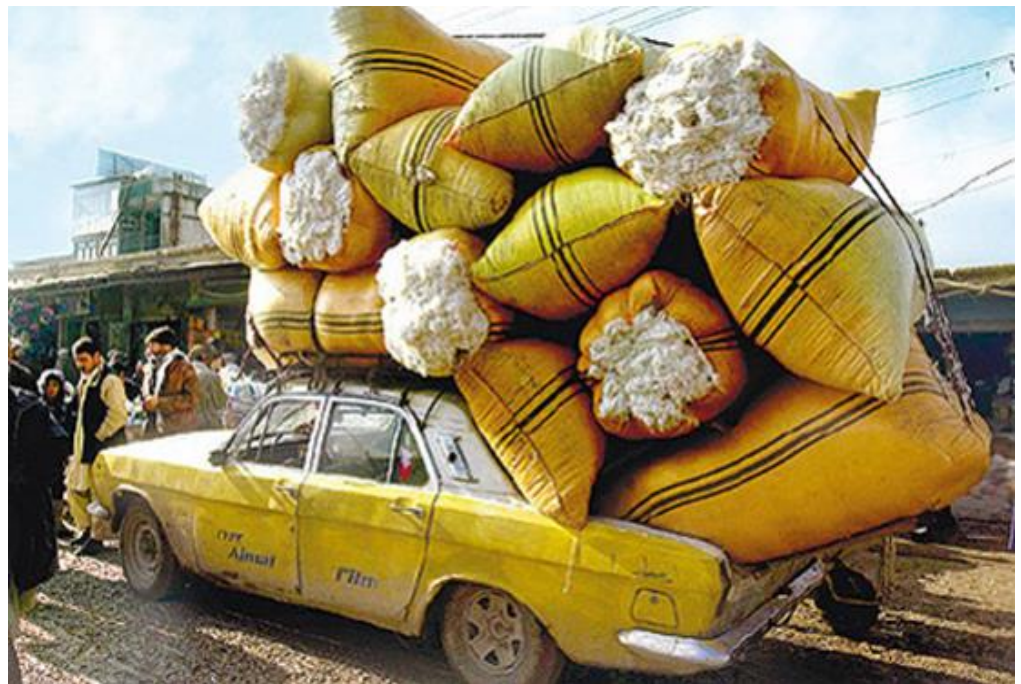
Figure 2. Manual Seed cotton harvesting: an example mode of transporting such harvested seed cotton to the gin (adopted with permission from [63]).

On the other hand, although there is a very minimal probability of hand-picking the plastic residues and trash in the field together with manually harvested seed cotton in countries where cotton harvesting is unautomated, there are other sources of plastic contamination that may need attention. For instance, manually picked cotton is usually dropped into woven baskets or plastic bags (see Figure 2). With constant usage over many seasons, those bags wear and tear and may terminate as plastic foreign matter in the seed cotton [35–37].

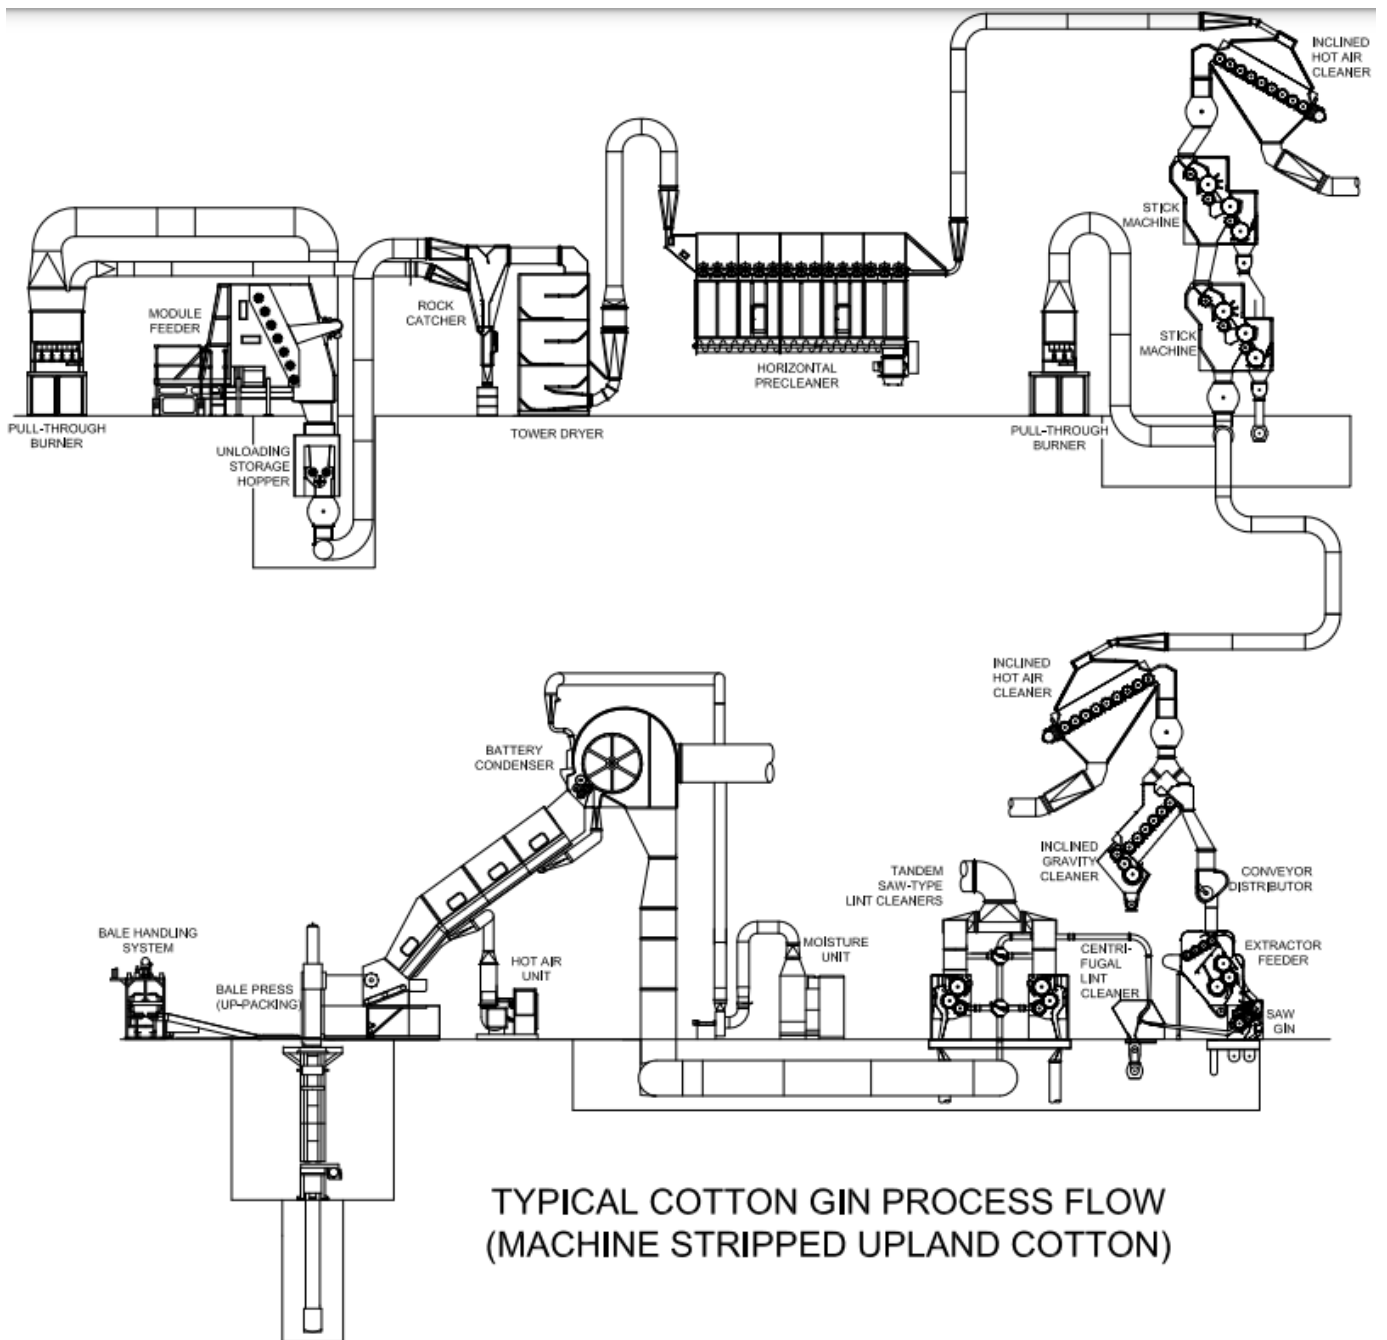
Figure 3. A typical sequence/layout of cotton gin equipment (Provided by Lummus Corporation, Savannah, GA, USA).

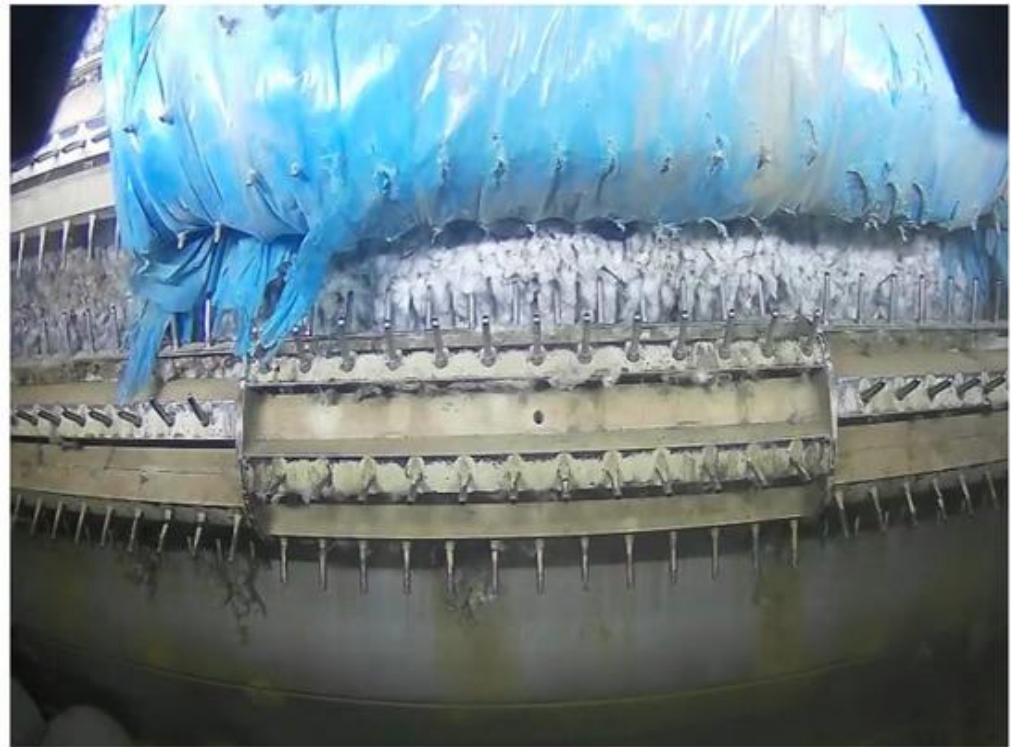
Figure 4. An example module cover trapped on dispersing cylinders of a cotton gin module feeder [73].

To a large extent, some research works have shown that eliminating most plastic contamination risks in the cotton value chain is possible if harvesting and post-harvest pre-ginning material flow activities are cautiously executed [32,67,72]. However, there are still instances of plastic contamination initiation during seed cotton unloading at cotton gin module feeders (see Figure 3 for the general sequence and layout of a typical cotton gin machinery). These contamination incidents occur when cotton gin workers disobey manufacturer-recommended cutting techniques for round seed cotton module covers (see Appendix A) and the plastic wraps get caught by module feeder floor rollers, causing them to flow into the module feeder with seed cotton and, if big enough, to get trapped on the dispersing cylinders as depicted in Figure 4.

When such an incident occurs at the module feeder, the plastics break up into smaller fragments that contaminate uncountable lint bales if they are not promptly removed [3,74]. Conventional gin cleaning equipment (cylinder cleaners) are undesigned for removing plastic, and research has shown that they are ineffective in ejecting thick module wrap pieces from ginning operations [74]. Hence, small plastic pieces from module covers left for too long on the module feeder dispersing cylinders end up in the final lint bales and create plastic call scenarios for such bales, implying financial loss to the primary producers and friction between different stakeholders. Article [75] estimates that 15% of total contamination originated from the cotton gins (both before and during ginning process).

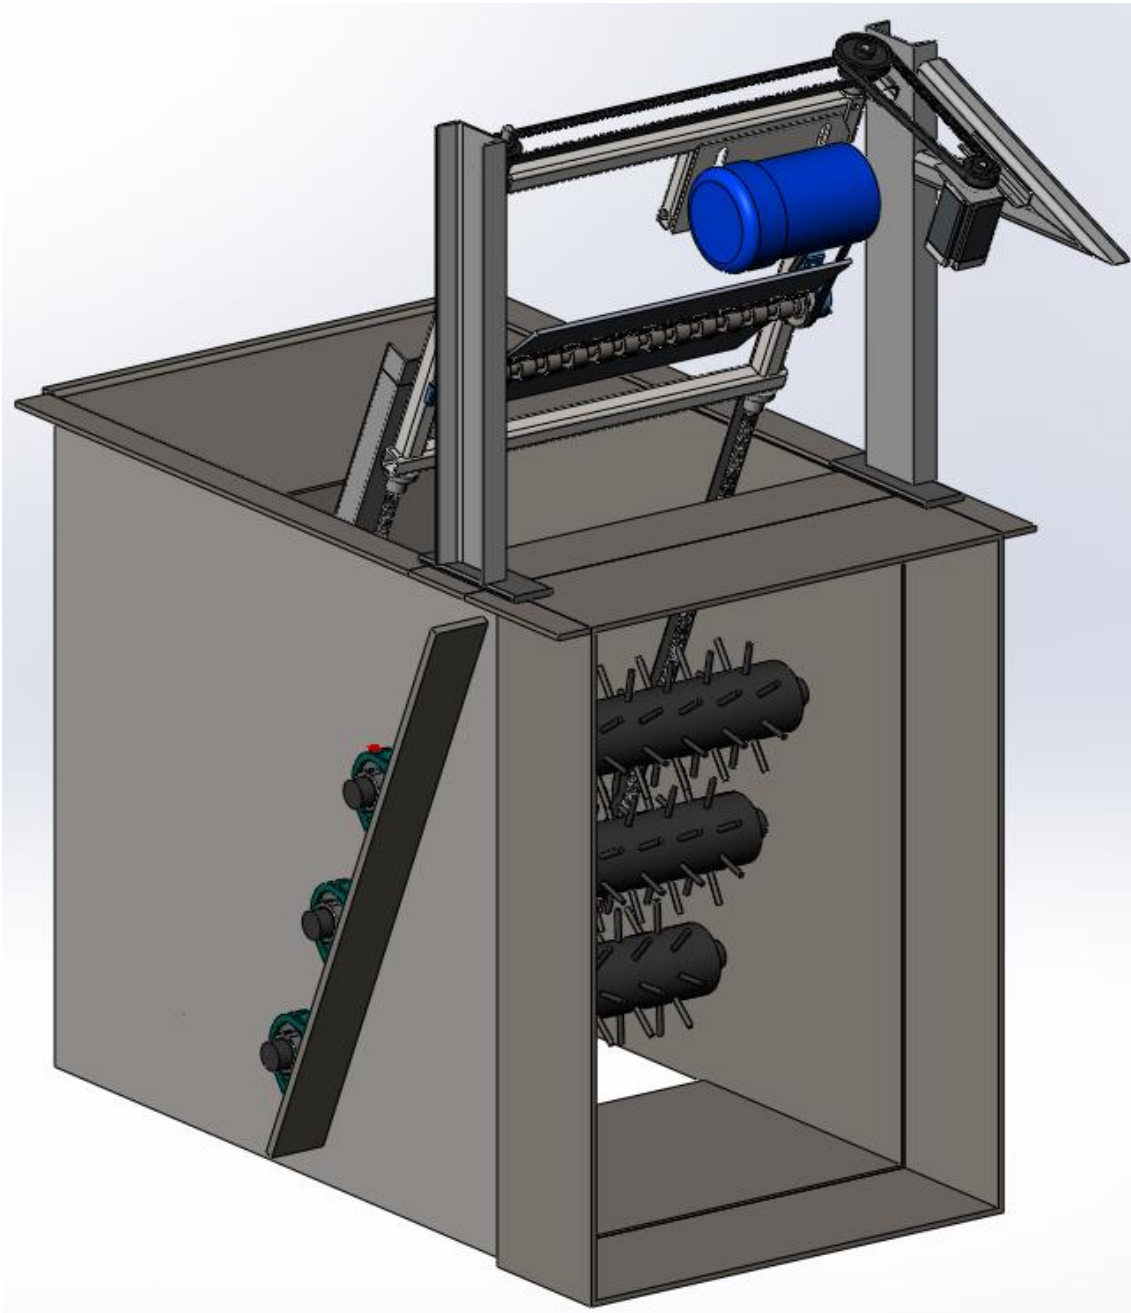
Figure 5. 3D model of the Texas A&M University-designed brush-based plastic removal mechanism installed on a mini module feeder.

Moreover, researchers at Texas A&M University who hold the paradigm that plastic contamination can be better mitigated at the gin if plastics are intercepted and eliminated earlier in the ginning line proposed, designed, and fabricated a brush-based plastic removal mechanism for installation at cotton gin module feeder [3]. The conceptualized idea is to have a brush mechanism which is integrable with the USDA's automatic module feeder inspection system and is automatically deployable to run against plastic pieces detected on any of the module feeder's dispersing cylinders and to remove them by abrasive forces. The brush system (see Figure 5) has been designed, fabricated, installed on a micro gin module feeder at Texas A&M University, and optimized for maximum plastic removal efficiency based on some identified explanatory factors [88]. Efforts are ongoing to fully integrate the optimized brush mechanism and the optical sensor for plastics—the USDA's automatic module feeder inspection system—to form an optimized closed-loop plastic detection removal system. Successful completion of this system will ensure earlier detection and removal of plastics upstream of the ginning operation with minimal human intervention.

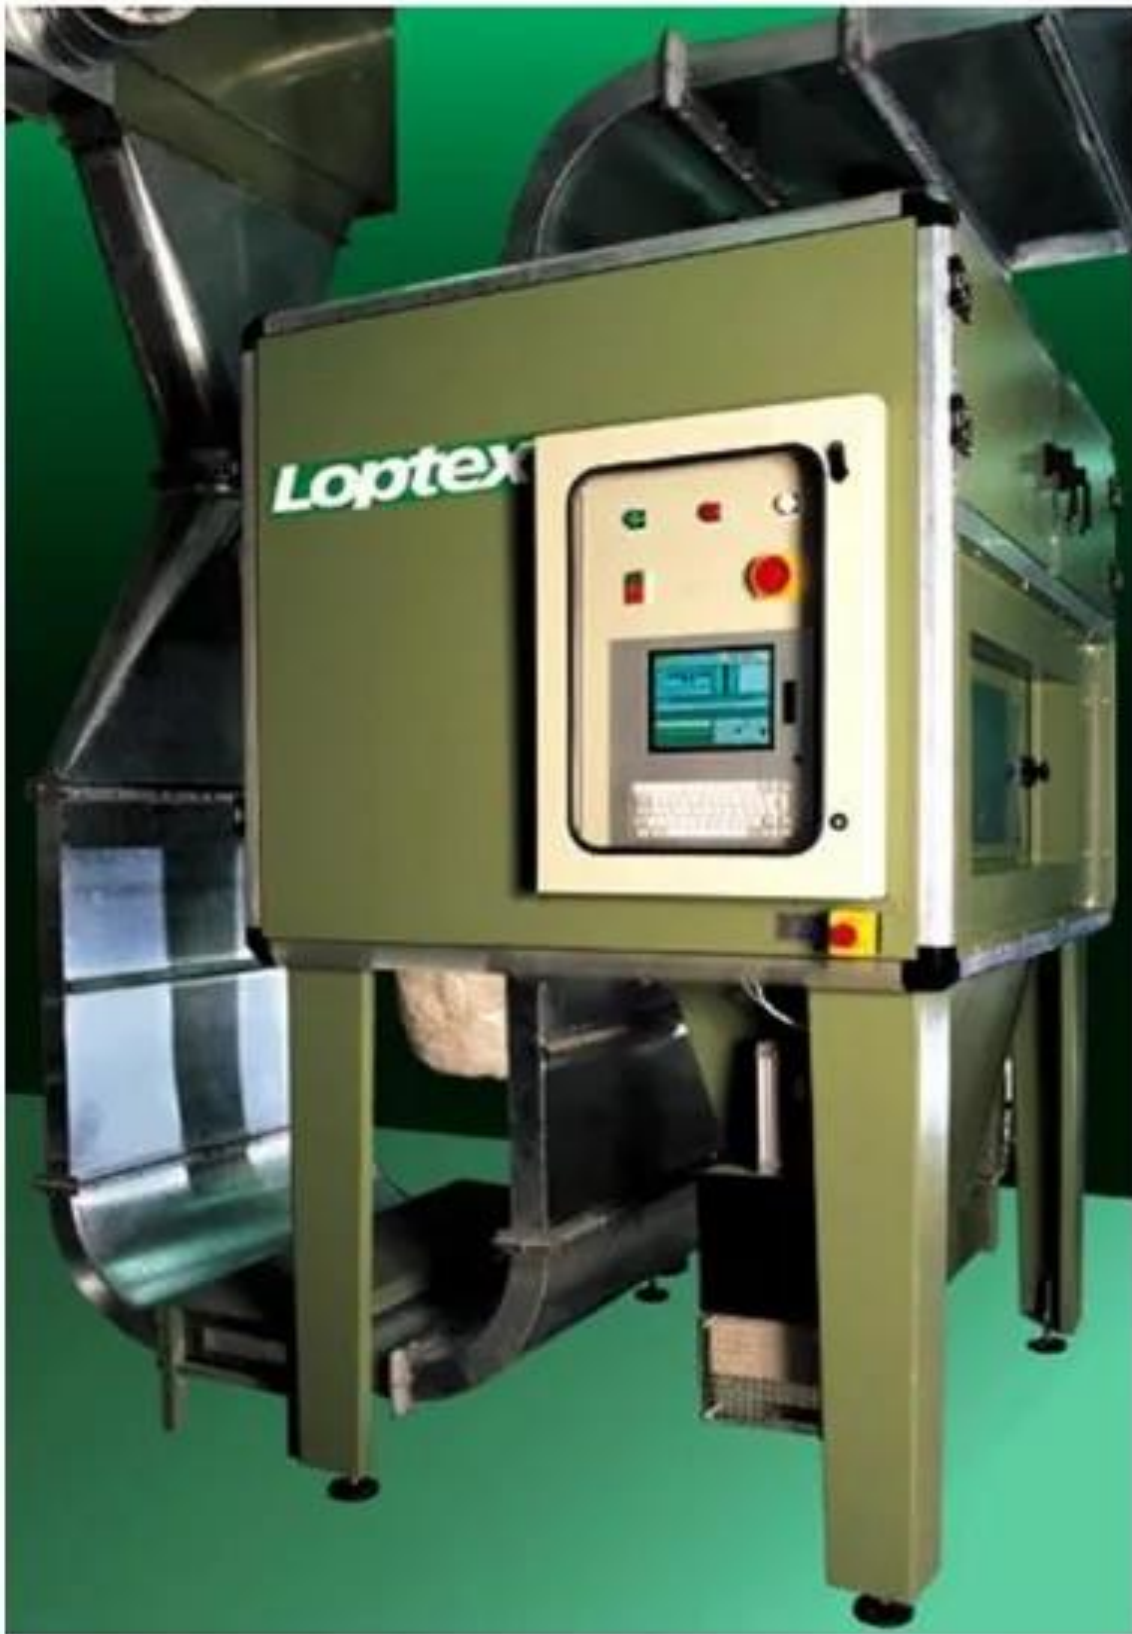
Figure 6. Example Loptex sorter that uses both optical and ultrasonic sensors (adopted with permission from [95]).

The first of these commercial solutions, known as Loptex Sorter (Loptex SRL, Como, Italy), shown in Figure 6, came in many years ago with significant success and improvements afterward [93,94]. Loptex’s system uses pneumatic valves (see Figure 7 for detailed schematics of the system’s parts) at the start of the spinning process, i.e., before carding machinery, and is integrable into existing and new blowroom lines. The system is modular in design and has a high detection resolution and accuracy afforded by a combination of a camera and ultrasonic sensor systems, multiple light sources, and bespoke software, which synergistically detect contaminants as being darker than cotton fiber as shown by the dark-colored substances in Figure 7. It removes hazardous trash, including plastic (PP), upon detection by activating the variable electronic control signals for the pneumatic valves—which depend on the contaminant size—to enhance the spinnability and dyeability of cotton fibers [92]. The Loptex Sorter was successful because of these unique features, which made other competing manufacturers adopt a similar approach. The other technological solutions (e.g., Barco Vision Cotton Sorter, Premier Fiber Eye, Uster Optiscan, and Vision Shield) are installed in the blowroom to detect and remove contaminants that are detectable by spectral (color) characteristics.

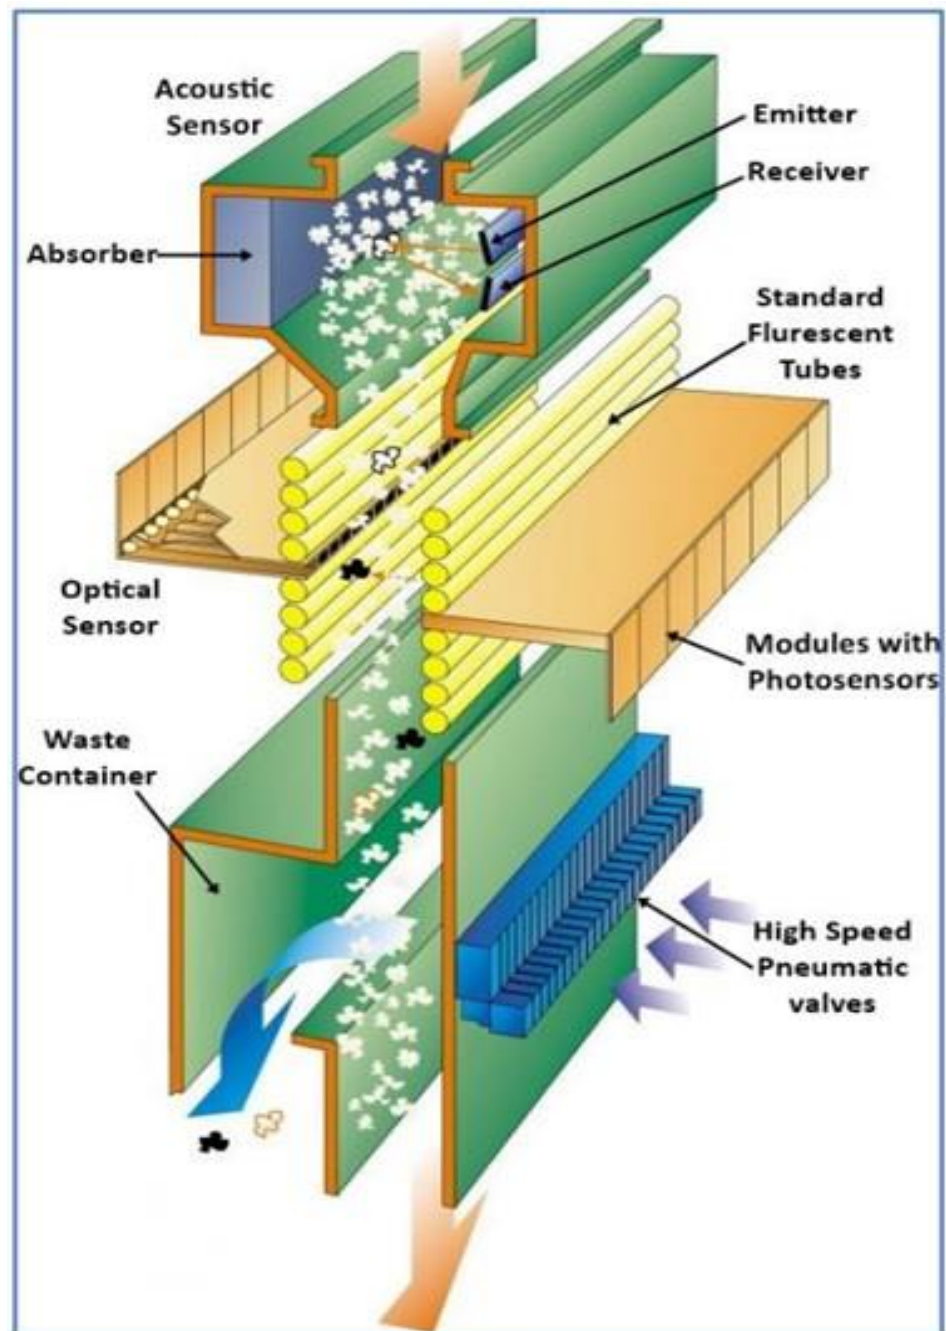
Figure 7. Internal structure and arrangement of components of the Loptex sorter. The black and dark-colored substances are detected as contaminants (adopted with permission from [95]).
